IMPORTANT SAFETY RECALL 22508 NHTSA RECALL NO. 22V-282

Navistar has decided that a defect which relates to motor vehicle safety exists in certain 2022 and 2023 HV and MV series trucks built 08/26/2021 thru 03/18/2022 and 2022 RE commercial buses built on 10/27/2021 with feature code 08TXK or 08TXM (Bendix Wingman Prewire option).

REASON FOR THIS RECALL

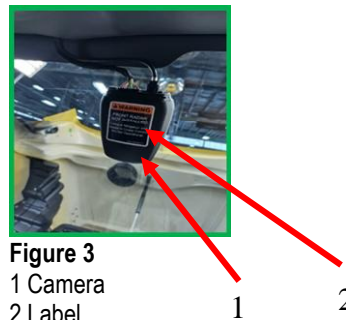
Figure 3

1 Camera
2 Label

4. Inspect for camera (Figure 3, Item 1) mounted to center top section of windshield.
 - a. Camera is present. Clean back of camera and install label (Figure 3, Item 2).
 - b. Camera is not present. Proceed to Step 5 (MV) or Step 6 (RE).

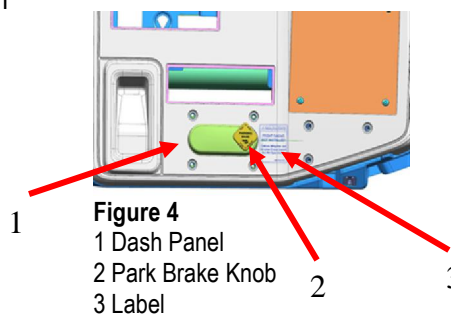
Figure 4

1 Dash Panel
2 Park Brake Knob
3 Label

5. For MV series trucks, clean dash panel (Figure 4, Item 1) next to park brake knob (Figure 4, Item 2) and install label (Figure 4, Item 3).

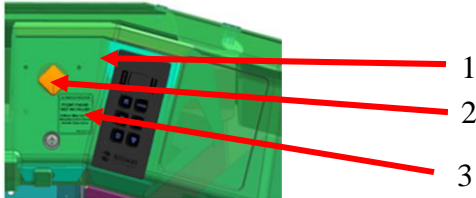
Figure 5

- 1 Dash Panel
- 2 Park Brake Knob

6. For RE series buses, clean dash panel (Figure 5, Item 1) to lower right of park brake knob (Figure 5, Item 2) and install label (Figure 5, Item 3).
