Technical Service Bulletin

22-01-047H

SONATA (YFa)

SUBJECT: 2013–2014MY SONATA (YF)
FUEL TUBE REPLACEMENT (RECALL 227)

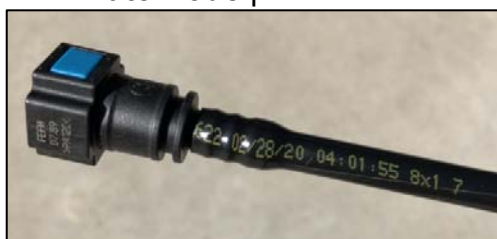
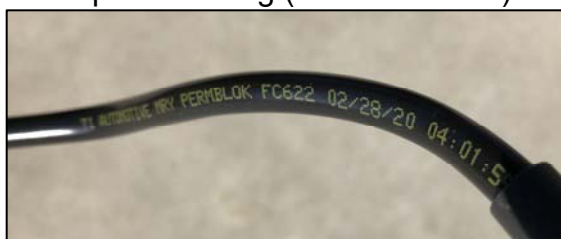
1. Capture STUI video of the 3 items in one continuous video.
 - Show VIN plate and/or RO (with the VIN) to record the **VIN for 3 seconds**.
 - Show **Date Code** printed located on the exposed tubing (rear connector) for 3 seconds.

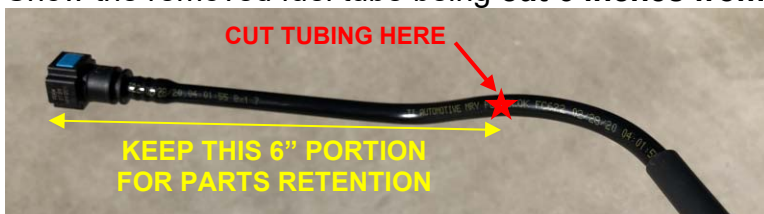
- Show the removed fuel tube being **cut 6 inches from black colored quick connector**.
