June 3, 2022

Recall Notice

Recall #TS-0041: Trailer Hub Bearing Torque

Condition: Hub bearings under torqued.

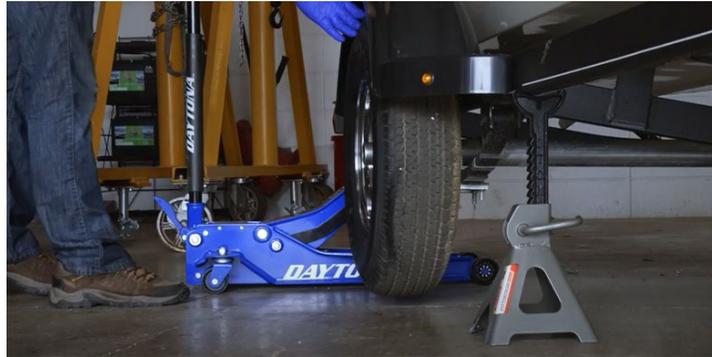
1. Elevate the trailer on level ground. Always use jack stands or other solid supports. Do not rely on a jack to support the trailer. Block wheels to keep the trailer from rolling.

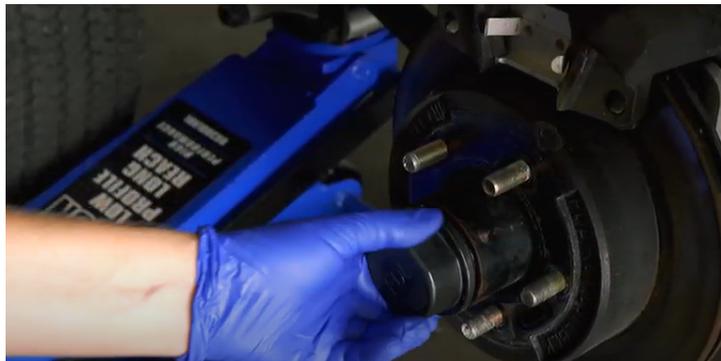
2. If 18-inch wheels are installed on the trailer, remove the wheel. All others, service can be done with wheels installed.
3. Place a newspaper or cloth on the ground under the hub to keep any parts from falling onto a dirty surface.
4. Remove the grease cap.
 - a. If the hub has a screw on grease cap, remove the cap by unscrewing in a counterclockwise rotation.

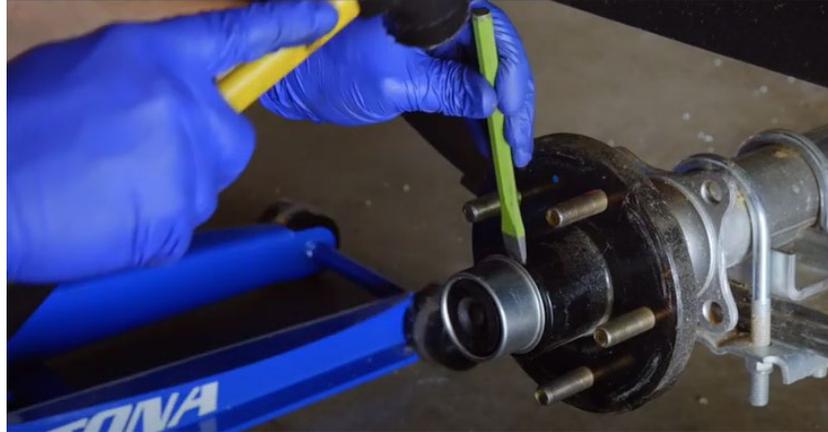
- b. If the hub has press in cap, remove the metal cap from hub assembly.

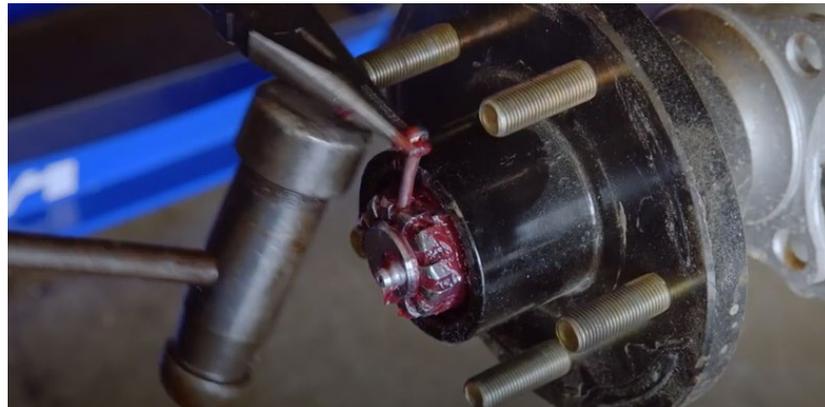
5. Look for debris or discoloration around the hub assembly. If you see any metal shavings, this is a positive indicator that damage has occurred and the hub will need to be replaced. Check the color of the grease surrounding the hub. The grease should either be blue or red. If the grease is black or brown, this indicated the grease was super-heated during use and is also an indication that damage has occurred in the hub. Contact your regional warranty administrator at 866-378-2529 before continuing with the seating of the bearings for further directions.
6. Remove the cotter pin and dispose of it.

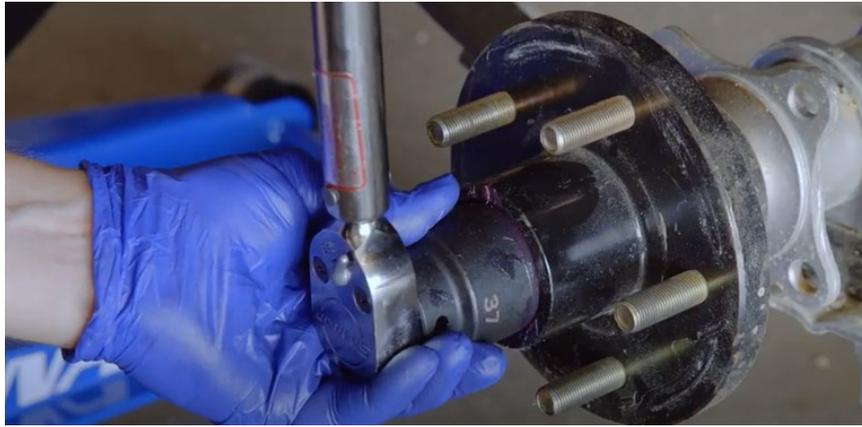
7. Apply 50 ft. lbs. of torque to the 27 mm castle nut. This “seats” the bearings.

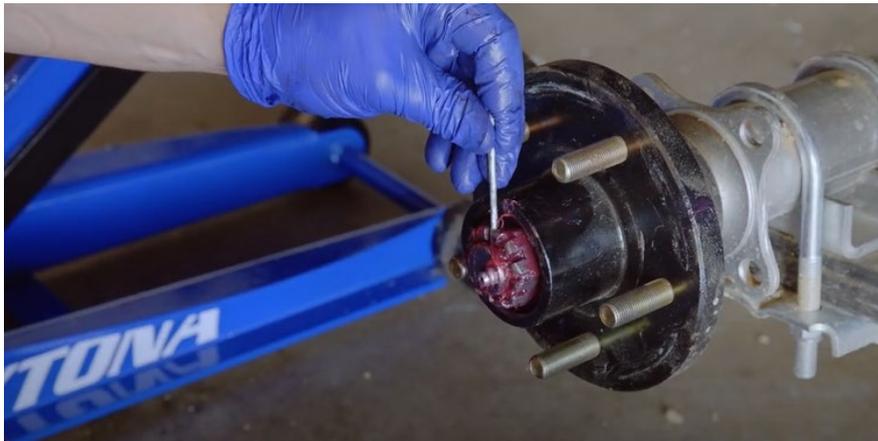
8. Loosen the castle nut to remove the torque applied. DO NOT ROTATE THE HUB.
9. Tighten the castle nut until snug, back off only enough to line up the new cotter pin with the hole in the spindle.

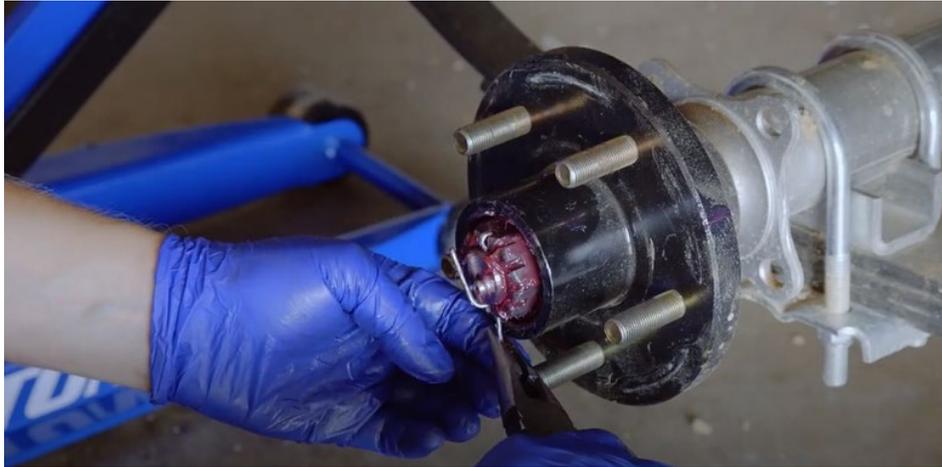
10. Spin the hub to ensure it moves freely.

11. Bend the cotter pin into place.

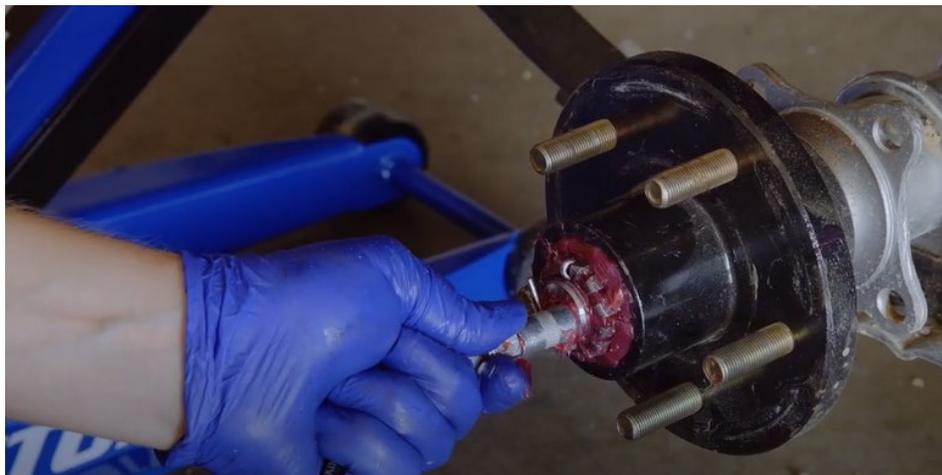
12. Apply grease as needed

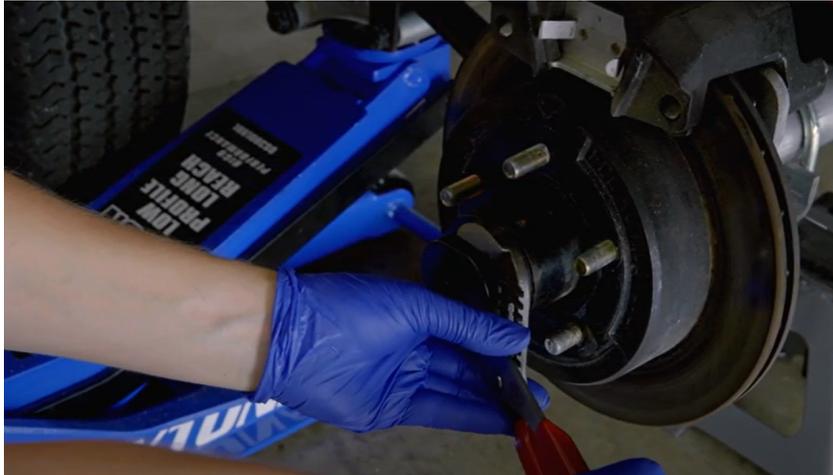
13. Reinstall the cap removed in step 4.

- a. If the hub has a screw on grease cap, turn in a clockwise rotation until the O-ring on the cap meets the hub surface. Turn an additional 1/4 turn to seal the cap to the hub.

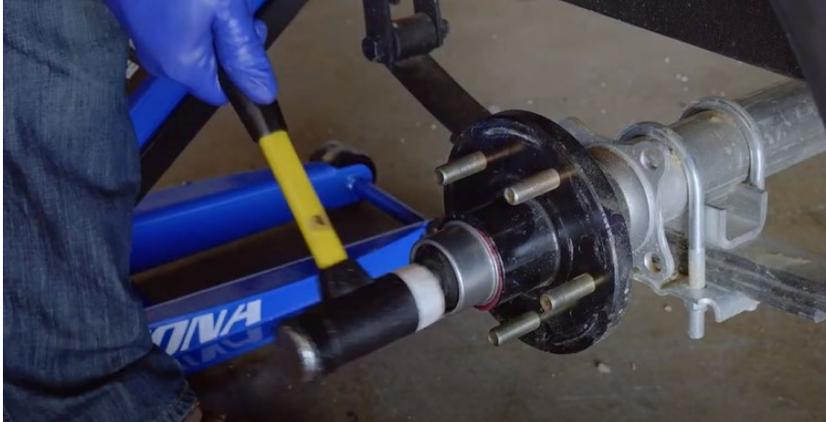
- b. If the hub has a press in grease cap. Reinstall the cap with a rubber mallet.
