Technical Instructions
Lucid Non-Compliance Recall NCR-22-01-0
Securing Center and Left Display Wiring Harness

Non-Compliance Recall NCR-22-01-0 Securing Center and Left Display Wiring Harness

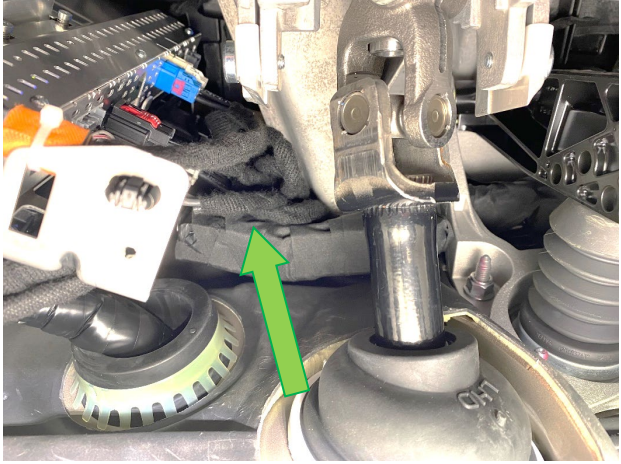
<p>1. Confirm VIN Eligibility</p> <p>a) Eligible vehicles will have a Recall Flag in Salesforce</p>	<p>Please be aware, there is at least one RECALL for this vehicle!</p> <p>If work is required, click on the VIN Recall record under Related to link the work order to the recall to automatically populate the required job code(s).</p>
<p>2. Remove Hush Panel</p> <p>a) Remove driver’s side hush panel</p>	<p>Refer to “Hush Panel – DS Remove and Replace” in the Service Manual</p>
<p>3. Identify ICC / BMC Harness Loops</p> <p>a) Check for Loops in the harness that will be underneath the driver side Instrument Panel (IP) Assembly, left of Intermediate Steering Shaft (I-Shaft).</p>

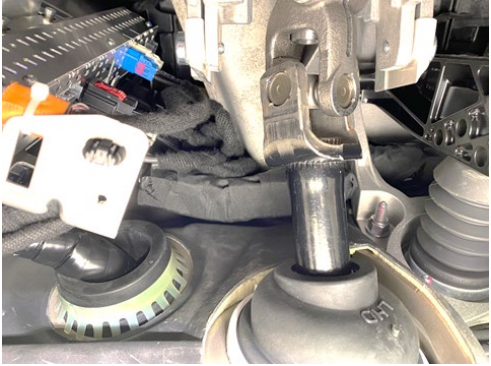
<p>4. Photograph Original Condition</p> <p>a) Photograph ICC / BMC Harness before any work is performed.</p> <p>b) Document by attaching photos to work order.</p> <p>NOTE: Capture ICC / BMC harness and I-shaft in the same photograph as in example picture to the right.</p>

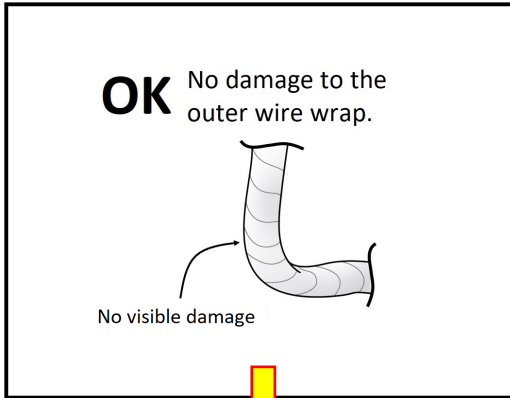
a) Inspect harness wrap for damage that may have been caused from contact with the steering intermediate shaft.

Proceed to Step #7

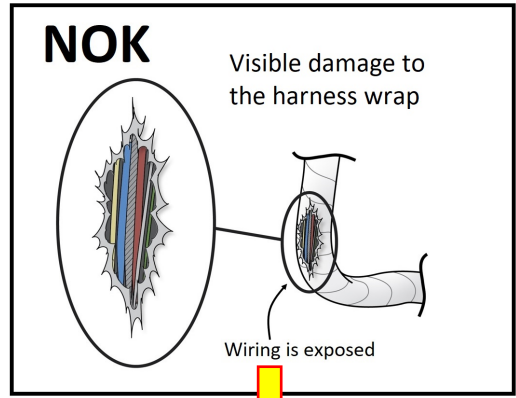
- IF damage is found, photograph the damage to the harness, the internal wires, or both, and attach photos to the work order.

Proceed to Step #6

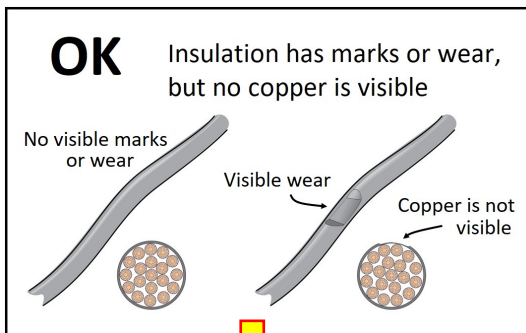
a) Open the wrap around the wires in the damaged area to be able to clearly see the wires inside the wrapped harness. Inspect each of the wires of the harness against the images below to determine the next steps. If any one of the wires found to be NOK, proceed to with the NOK instructions.

Re-Wrap Harness and Proceed to Step #7

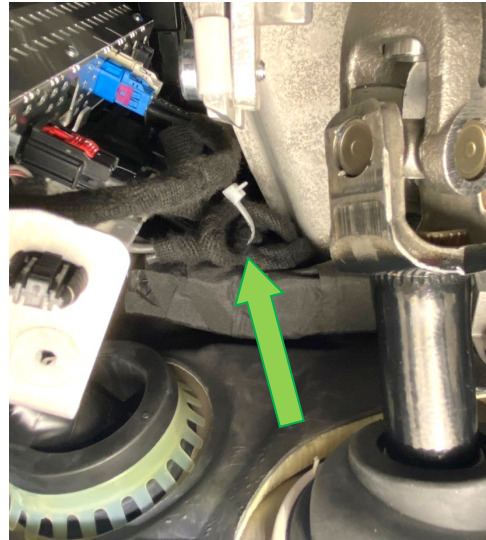
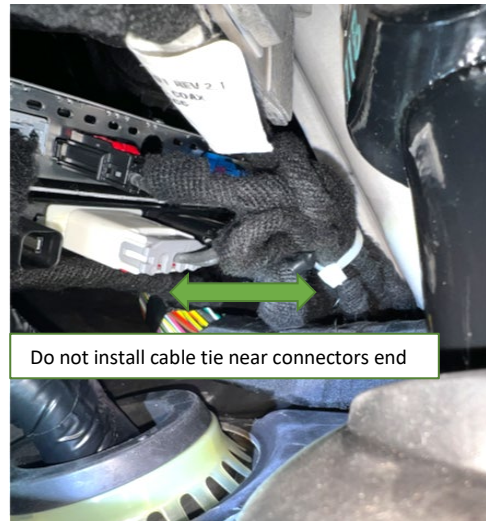
7. Secure ICC / BCM Harness Loops

CAUTION: The minimum bend radius of a wiring loop is 15mm.

CAUTION: Do not install the cable tie near connectors end or around individual wires.

- a) Reposition the ICC/BCM loop of the wiring harness ensuring at least the minimum required 20mm distance from the I-Shaft is achieved.
- b) Apply specified cable tie around the ICC/BCM loop to the adjacent harness bundle.
- c) Tighten the cable tie to secure the ICC/BCM connector harnesses away from the I-Shaft.

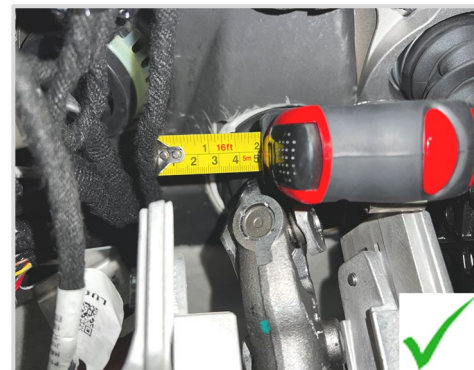
8. Inspect Harness to I-Shaft Clearance

NOTE: Ensure all wire harnesses cannot freely move within 20mm of the I-Shaft.

- a) Using a measuring device, confirm that the ICC/BCM wiring harness and all other cables are at a minimum clearance of 20 mm from the I-Shaft.

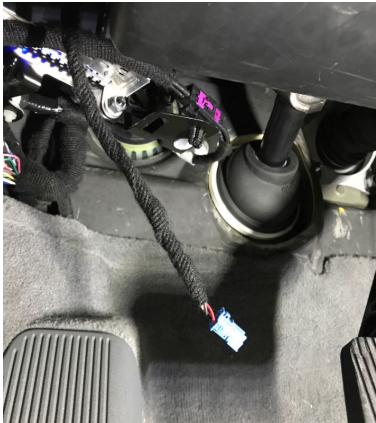
<p>9. Locate Ambient Light Harness</p> <p>a) Locate the ambient light harness that was removed from the driver's side hush panel on Step #2.</p>

<p>10. Photograph Current Condition</p> <p>a) Photograph Ambient Light Harness before any work is performed.</p> <p>b) Document by attaching photos to work order.</p> <p>NOTE: Capture Ambient Light harness as the example picture on Step #9</p>	<p>Refer to image in Step #9</p>
<p>11. Inspect Ambient Light Harness for Damage</p> <p>a) Inspect harness wrap for damage as described in Step #5 and #6.</p>	<div style="display: flex; flex-wrap: wrap;"> <div style="width: 50%; border: 1px solid black; padding: 5px;"> <p>OK No damage to the outer wire wrap.</p>

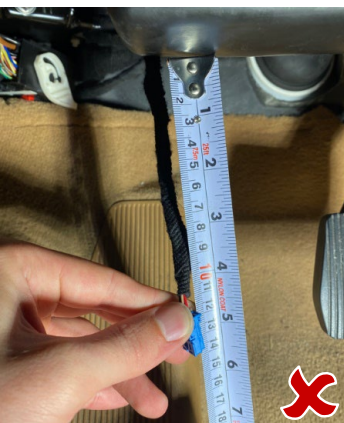
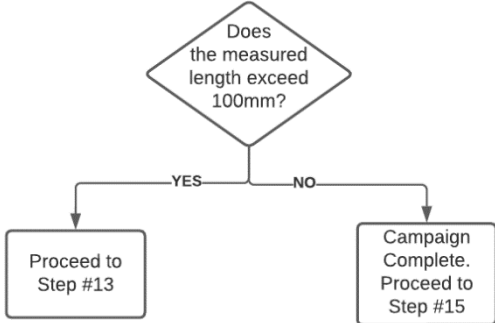
<p>12. Inspect driver's side Ambient Light Harness Length</p> <p>a) Extend driver's side Hush Panel Ambient light harness downward.</p> <p>b) Measure the length of the harness from the end of the Connector to the bottom of the driver's Knee Airbag.</p>

<pre> graph TD A{Does the measured length exceed 100mm?} -- YES --> B[Proceed to Step #13] A -- NO --> C[Campaign Complete. Proceed to Step #15] </pre>
<p>13. Adjust driver's side Hush Panel Ambient Light Harness</p> <p>a) Measure 100 mm of the Harness from the end of the Connector.</p> <p>b) Perform a 25 – 30 mm double fold of the Ambient Light Harness away from the Connector end.</p> <p>CAUTION: Ensure "double-fold" is done as far away as possible from the connector end.</p> <p>c) At the double fold of the Ambient Light Harness, as centered as possible, secure the harness together with the Cable Tie.</p> <p>NOTE: Ensure the harness from the end of the Connector to the bottom of the driver's knee Airbag is no longer than 100 mm.</p>

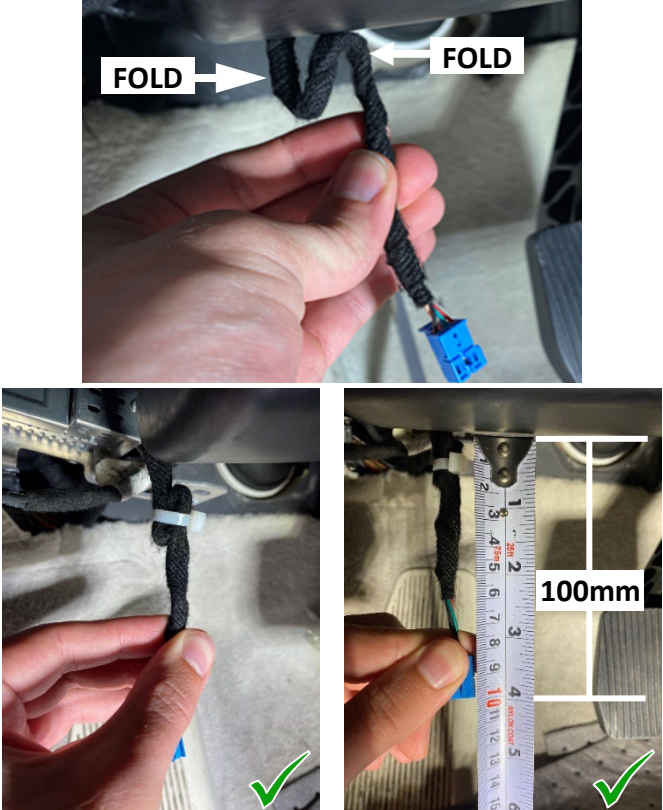
<p>The top photo shows a hand holding a black braided harness with a blue connector. Two arrows labeled 'FOLD' point to the harness being folded. The bottom-left photo shows the harness secured with a white cable tie. The bottom-right photo shows a hand holding a ruler against the harness, with a white box and arrow indicating a 100mm measurement. Green checkmarks are present in the bottom-right corners of the two bottom photos.</p>
