# Keystone RV Company

## SAFETY ADVISORY # 22-433

### Red Rock Table/Bed Base

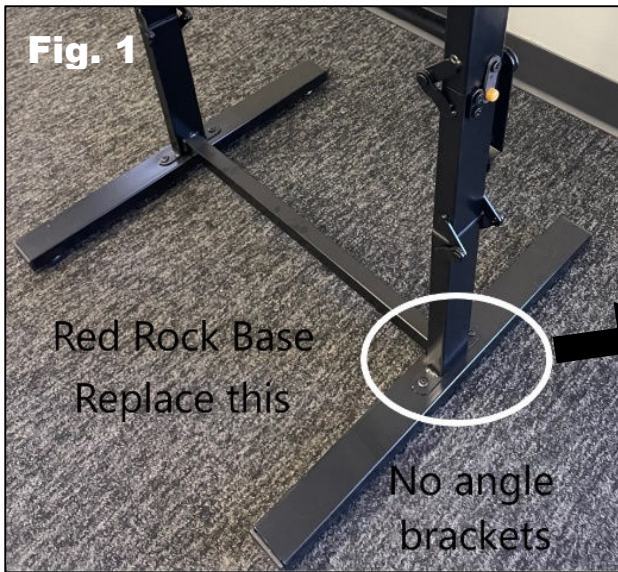
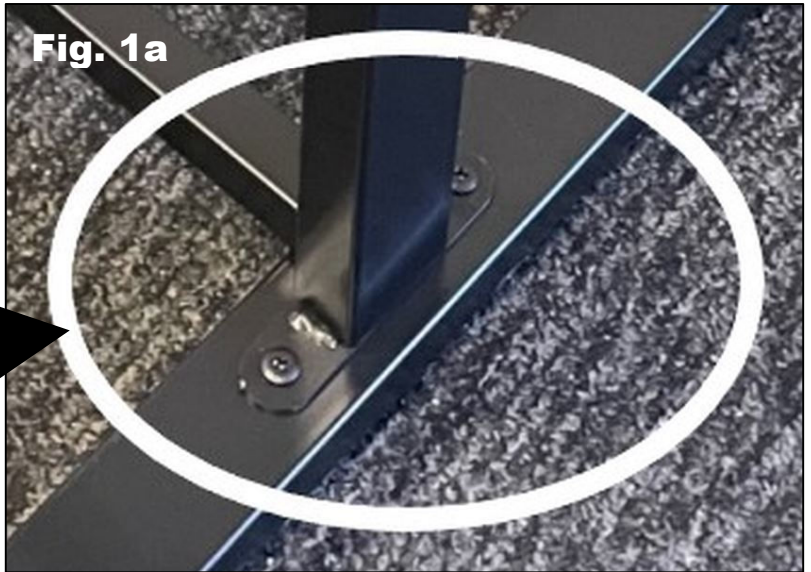
Keystone is conducting a voluntary RECALL notification campaign in accordance with the National Highway Transportation and Safety Act. It has been decided that vehicles in the recall population were built with a Red Rock brand table/bed base that may have incomplete welds on the hinges of the base. Under certain conditions during use, the welds on the table/bed base can fail leading to an increased risk of personal injury.

The remedy is to inspect the table/bed base and replace if it is a Red Rock brand, see Figure 1. Pictures required of base, as identified in Figures 1 through 3 below.

Inspect the base. See the Red Rock Table base in Figure 1 and 1a. If the base is not a Red Rock brand table/bed base as seen in Figures 2 and 3 no further action is needed, proceed to warranty reimbursement. If the base is a Red Rock proceed to step 3.

Remove the table top from the Red Rock table/bed base and install it on the 596844 - Table - Leg/Bed Base - 28 1/8".

In the Correction section note: Replaced Red Rock Table Base as described in Figure 1.
