F/CMVSS Noncompliance Recall

N222369130 Noncompliant Brake Fluid Reservoir Cap

Release Date: June 2022

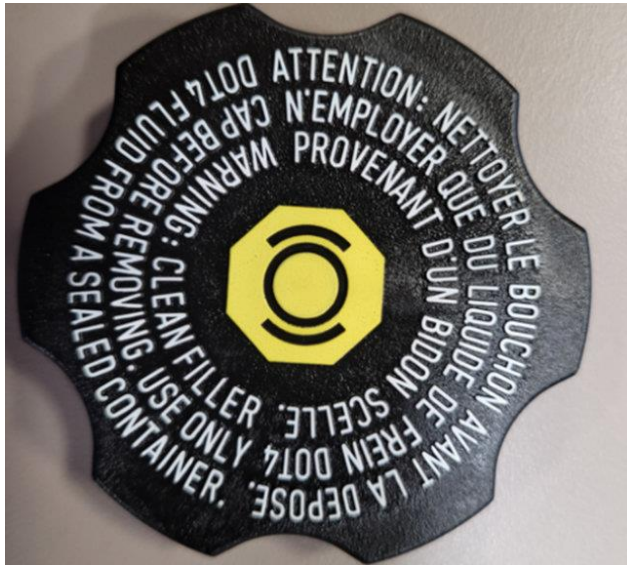
6084384

1. Open the hood.
2. Inspect the Brake Fluid Reservoir Cap.

- If the Brake Fluid Reservoir Cap matches the cap shown above, no further action is required. Proceed to step 5.
 - If the Brake Fluid Reservoir Cap DOES NOT match the cap shown above, replace the cap. Proceed to step 3.
3. Remove the Brake Fluid Reservoir cap.
 - Discard the old brake fluid reservoir cap.
 4. Install the new Brake Fluid Reservoir cap.
 5. Close the hood.

Condition	General Motors has decided that certain 2022 model year Cadillac XT6 vehicles may fail to conform to S5.4.3 of Federal/Canada Motor Vehicle Safety Standard (F/CMVSS) No. 135, "Light vehicle brake systems." The brake fluid reservoir cap on these vehicles may be missing the reservoir labeling required by S5.4.3: "WARNING: Clean filler cap before removing. Use only ____ [DOT4] fluid from a sealed container." A failure to prevent introduction of debris into the brake fluid reservoir after removing the cap could degrade brake performance over time, increasing the risk of a crash.
Correction	Dealers will inspect the brake fluid reservoir cap and replace it if necessary.
