TECHNICAL INSTRUCTIONS

SAFETY RECALL 22TA05

REAR AXLE SHAFTS MAY SEPARATE FROM VEHICLE DURING DRIVING
(INSPECTION)

CERTAIN 2022 MODEL YEAR TUNDRA AND TUNDRA HV

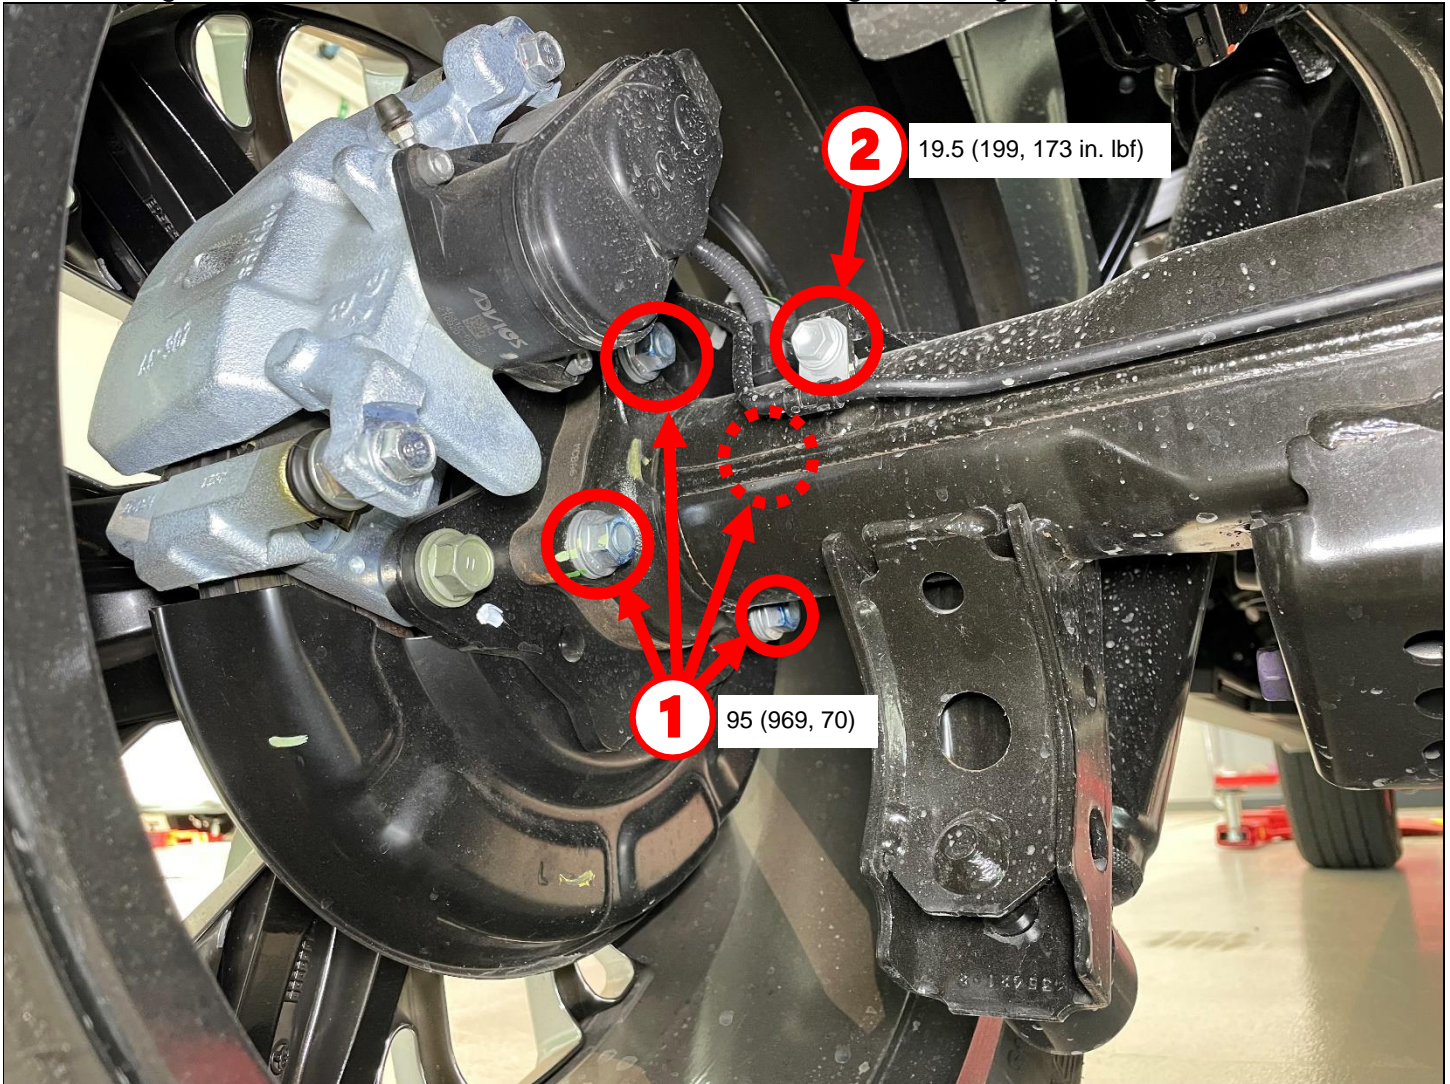
V. COMPONENTS

The image below is for the left (driver) side. Reference this image for the right (passenger) side as well.

PART NAME	QUANTITY (PER SIDE)	QUANTITY (TOTAL)	TORQUE SPECIFICATION
1	Nut, Flange (Axle)	4	8	95 Nm (969 kgf cm, 70 ft. lbf)
2	Bolt, W/Washer (Brake Line)	1	2	19.5 Nm (199 kgf cm, 173 in. lbf)

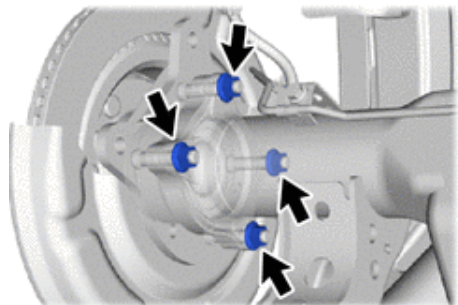
3. CHECK FOR MISSING AXLE SHAFT FLANGE NUTS

- a. Release the parking brake.
- b. Lift the vehicle.
- c. Remove the left (driver) rear tire.
- d. Check to see if all 4 nuts are present on the axle housing flange. If one or more nuts are missing, this side has failed inspection.

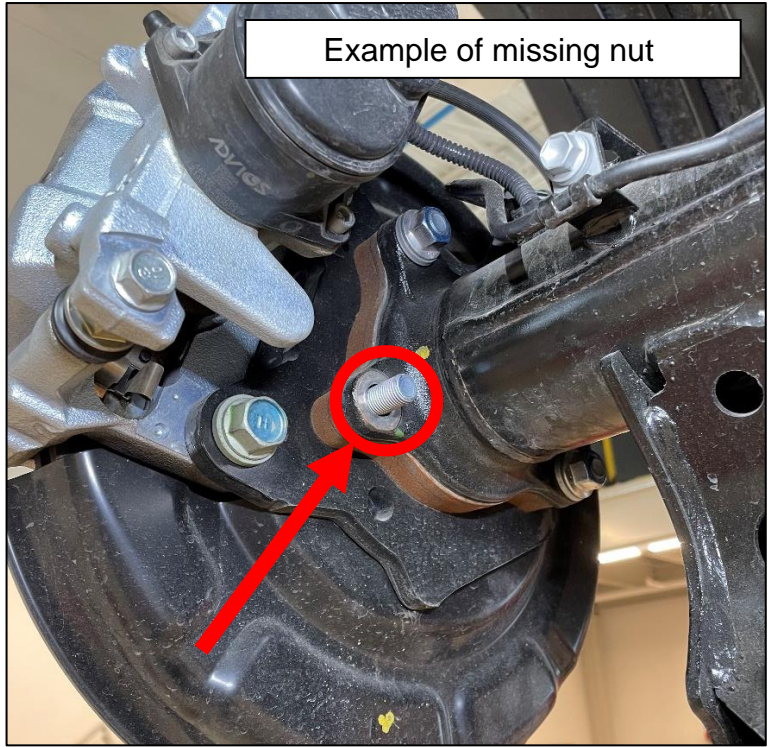
Is there **at least one** nut missing on the LEFT (Driver) Side?

Upload photo to website as prompted then proceed to section VII. RIGHT REAR AXLE HOUSING FLANGE NUT INSPECTION

Proceed to step 4

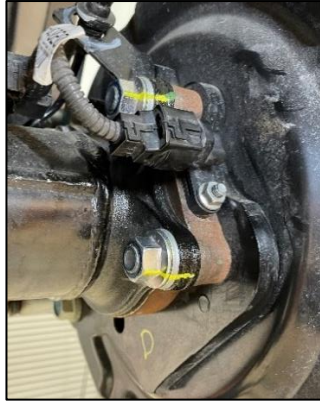
4. MATCHMARK NUTS ON LEFT SIDE

- a. Using a fine tip paint marker, matchmark all 4 nuts, washers, and the axle housing flange.
- b. Mark "D" for "Driver" close to the axle shaft flange so it will be visible while taking photos of the nuts/studs.

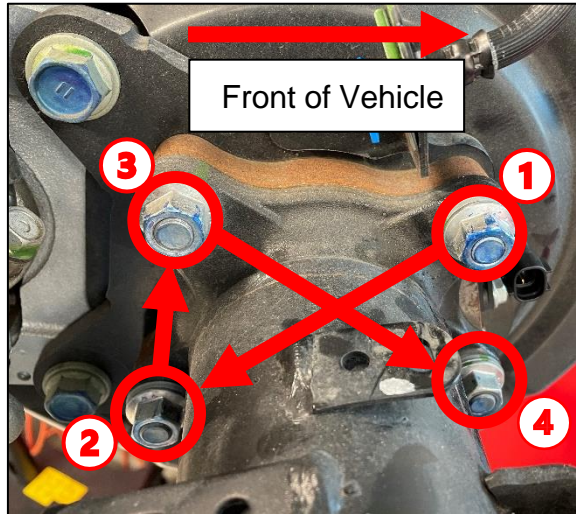
NOTE: Some parts removed for visibility

6. TORQUE STEP 1: CHECK TO SEE IF ALL FOUR (4) NUTS ON LEFT SIDE MOVE AT 20 Nm

- a. Set torque wrench to 20 Nm (204 kgf cm, 177 in. lbf)
- b. Tighten each nut to 20 Nm (204 kgf cm, 177 in. lbf) following the tightening sequence shown in the image to the left.

- Only move the brake line enough to create clearance for a torque wrench. Excessive movement could result in permanent damage to the brake line or losing of the joint.
- Be careful not to scratch or cause other damage to the brake line.
- Do NOT use extensions with the torque wrench.

- c. Check the matchmarks to see if the nuts moved. If **ALL FOUR (4)** moved, this side has failed inspection.

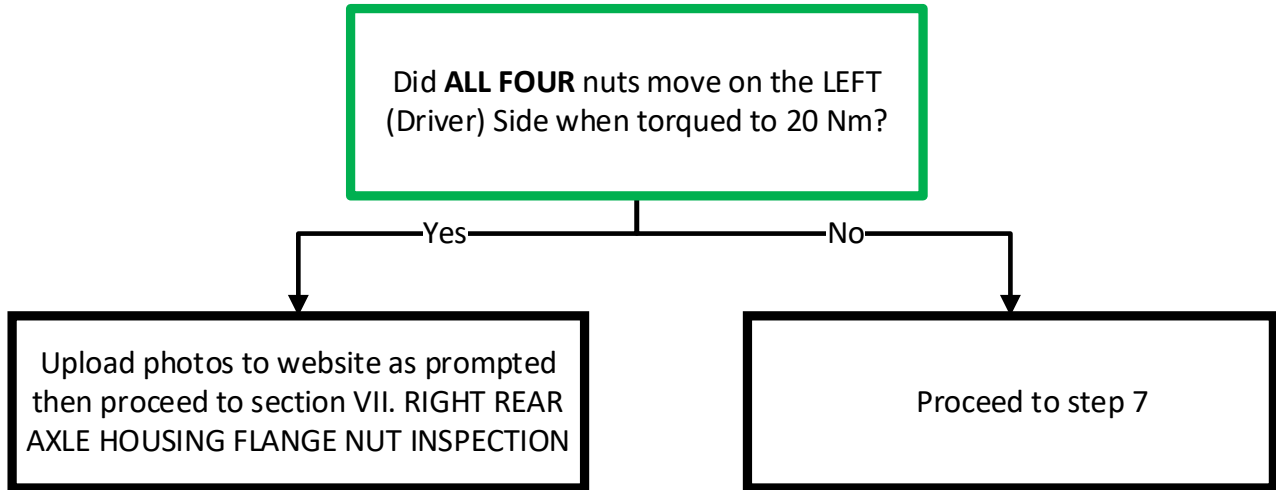
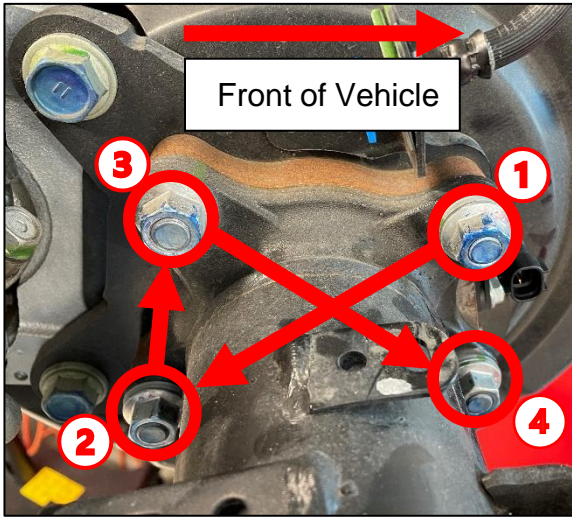
NOTE: Some parts removed for visibility

7. TORQUE STEP 2: INCREASE TORQUE TO 95 Nm
- Set torque wrench to 95 Nm (969 kgf cm, 70 ft. lbf)
 - Tighten each nut to 95 Nm (969 kgf cm, 70 ft. lbf) following the tightening sequence shown to the left.

- Only move the brake line enough to create clearance for a torque wrench. Excessive movement could result in permanent damage to the brake line or losing of the joint.
- Be careful not to scratch or cause other damage to the brake line.
- Torque nuts to 95 Nm (969 kgf cm, 70 ft. lbf). DO NOT use torque specification listed in Repair Manual.
- When torquing the nut apply torque in a smooth slow rotation. DO NOT quickly apply torque.
- Do NOT use extensions with the torque wrench.

- c. Photograph the matchmark positions post-torque and upload 2 photos to website (front and rear of axle; 2 nuts per photo).

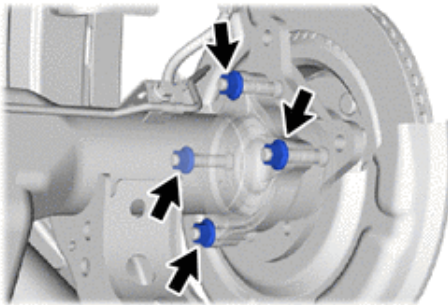
1. CHECK FOR MISSING AXLE SHAFT FLANGE NUTS
 - a. Remove the right (passenger) rear tire.
 - b. Check to see if all 4 nuts are present on the axle housing flange. If one or more nuts are missing, this side has failed inspection.

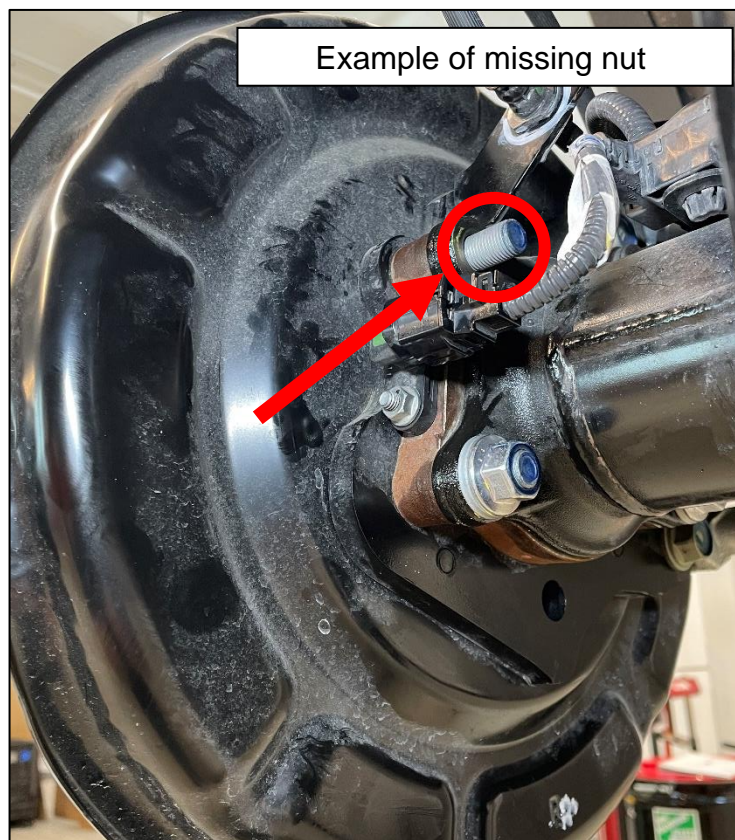
Is there **at least one** nut missing on the
RIGHT (Passenger) Side?

Upload photo to website as prompted
then proceed to section VIII. **INSTALL
BRAKE HARDWARE AND REAR WHEELS**

Proceed to step 2

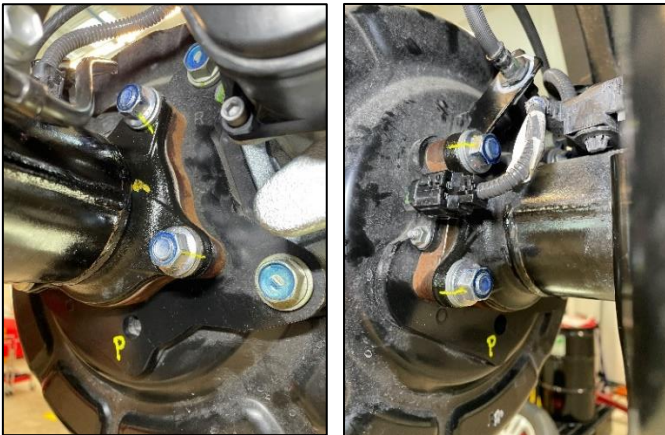
2. MATCHMARK NUTS ON RIGHT SIDE

- a. Using a fine tip paint marker, matchmark all 4 nuts, washers, and the axle housing flange.
- b. Mark "P" for "Passenger" close to the axle shaft flange so it will be visible while taking photos of the nuts/studs.

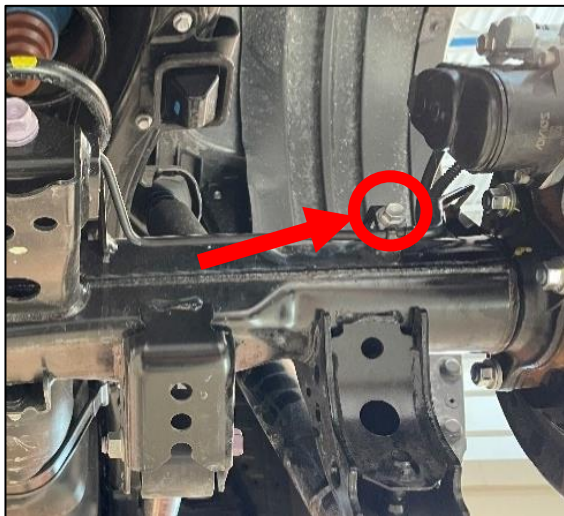
3. TEMPORARILY REMOVE BRAKE LINE HARDWARE TO ALLOW ACCESS TO UPPER RIGHT NUT

- a. Remove the outermost bolt that secures the hard brake line to the axle housing.

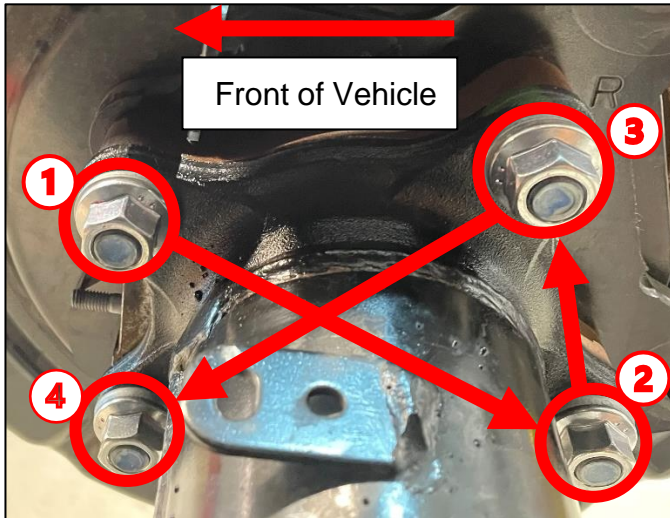
NOTE: Some parts removed for visibility

4. TORQUE STEP 1: CHECK TO SEE IF ALL FOUR (4) NUTS ON RIGHT SIDE MOVE AT 20 Nm
- Set torque wrench to 20 Nm (204 kgf cm, 177 in. lbf).
 - Tighten each nut to 20 Nm (204 kgf cm, 177 in. lbf) following the tightening sequence shown in the image to the left.

- Only move the brake line enough to create clearance for a torque wrench. Excessive movement could result in permanent damage to the brake line.
- Be careful not to scratch or cause other damage to the brake line.
- Do NOT use extensions with the torque wrench.

- Check the matchmarks to see if the nuts moved. If **ALL FOUR (4)** moved, this side has failed inspection.

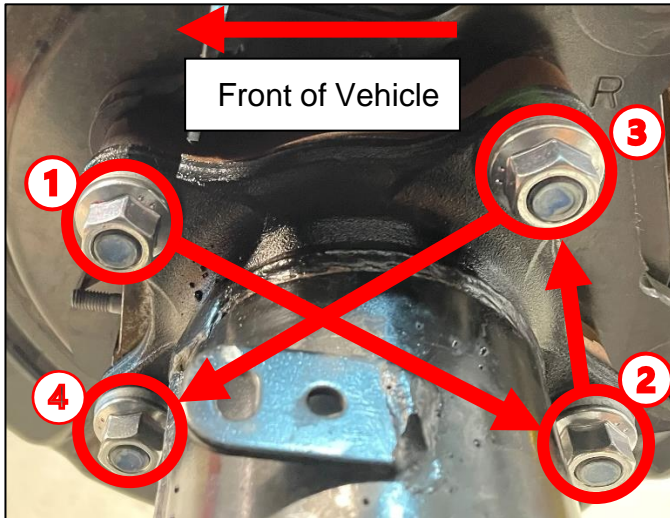
NOTE: Some parts removed for visibility

5. TORQUE STEP 2: INCREASE TORQUE TO 95 Nm
 - a. Set the torque wrench to 95 Nm (969 kgf cm, 70 ft. lbf)
 - b. Tighten each nut to 95 Nm (969 kgf cm, 70 ft. lbf) following the tightening sequence shown to the left.

- Only move the brake line enough to create clearance for a torque wrench. Excessive movement could result in permanent damage to the brake line.
- Be careful not to scratch or cause other damage to the brake line.
- Torque nuts to 95 Nm (969 kgf cm, 70 ft. lbf). DO NOT use torque specification listed in Repair Manual.
- When torquing the nut apply torque in a smooth slow rotation. DO NOT quickly apply torque.
- Do NOT use extensions with the torque wrench.

- c. Photograph the matchmark positions post-torque and upload 2 photos to website (front and rear of axle; 2 nuts per photo).

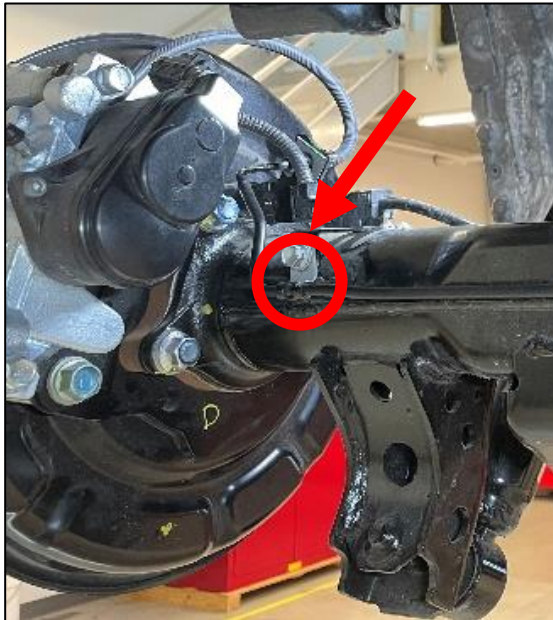
Left (Driver) Side

- a. Reinstall the bolts that secure the hard brake line to the axle housing.

Torque Specification: 19.5 Nm (199 kgf cm, 173 in. lbf)

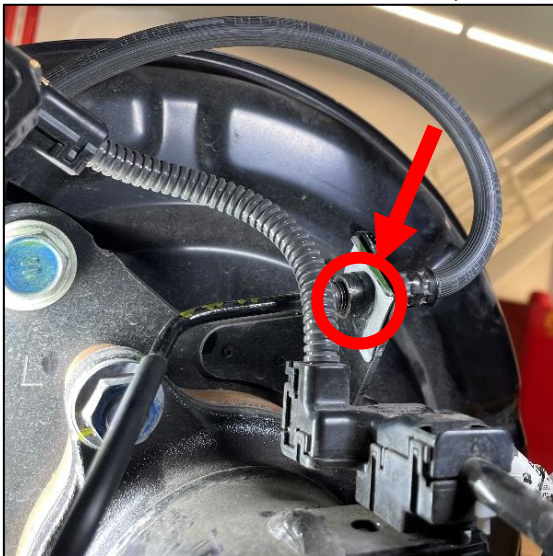
Left (Driver) Side

- a. Inspect both brake line joints for leaks where the hard brake tube connects to the flexible hose. If leaks are found, refer to Repair Manual for tightening procedure and torque.

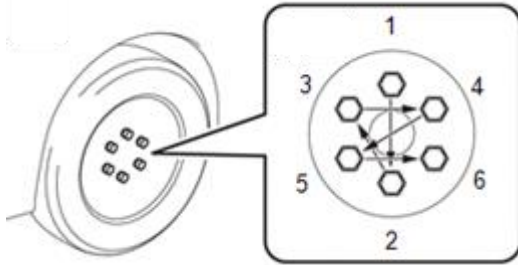
Torque Pattern:

a. Reinstall Rear Wheels and torque according to the sequence and specification below.

- Steel Wheel: 209 Nm (2131 kgf-cm, 154 ft.·lbf)
- Aluminum Wheel: 131 Nm (1336 kgf-cm, 97 ft.·lbf)
