RECALL 22V488 / 2022-370 REMEDY INSTRUCTIONS

Make(s): CATALINA Model(s): SEE BELOW Model Year(s): 2022	Repair Code: RC-036-22-00-004213 Allotted Time: .30 HRS. Inspection Code: RC-036-05-00-004212 Allotted Time: .10 HRS.
	Concern: The breakaway switch wire may be connected to an incorrect circuit. The breakaway switch should be connected to the brake circuit.	Photo(s) Required: NO Prior Authorization Required: NO Part(s) Kit Number: N/A Part(s) Return: N/A

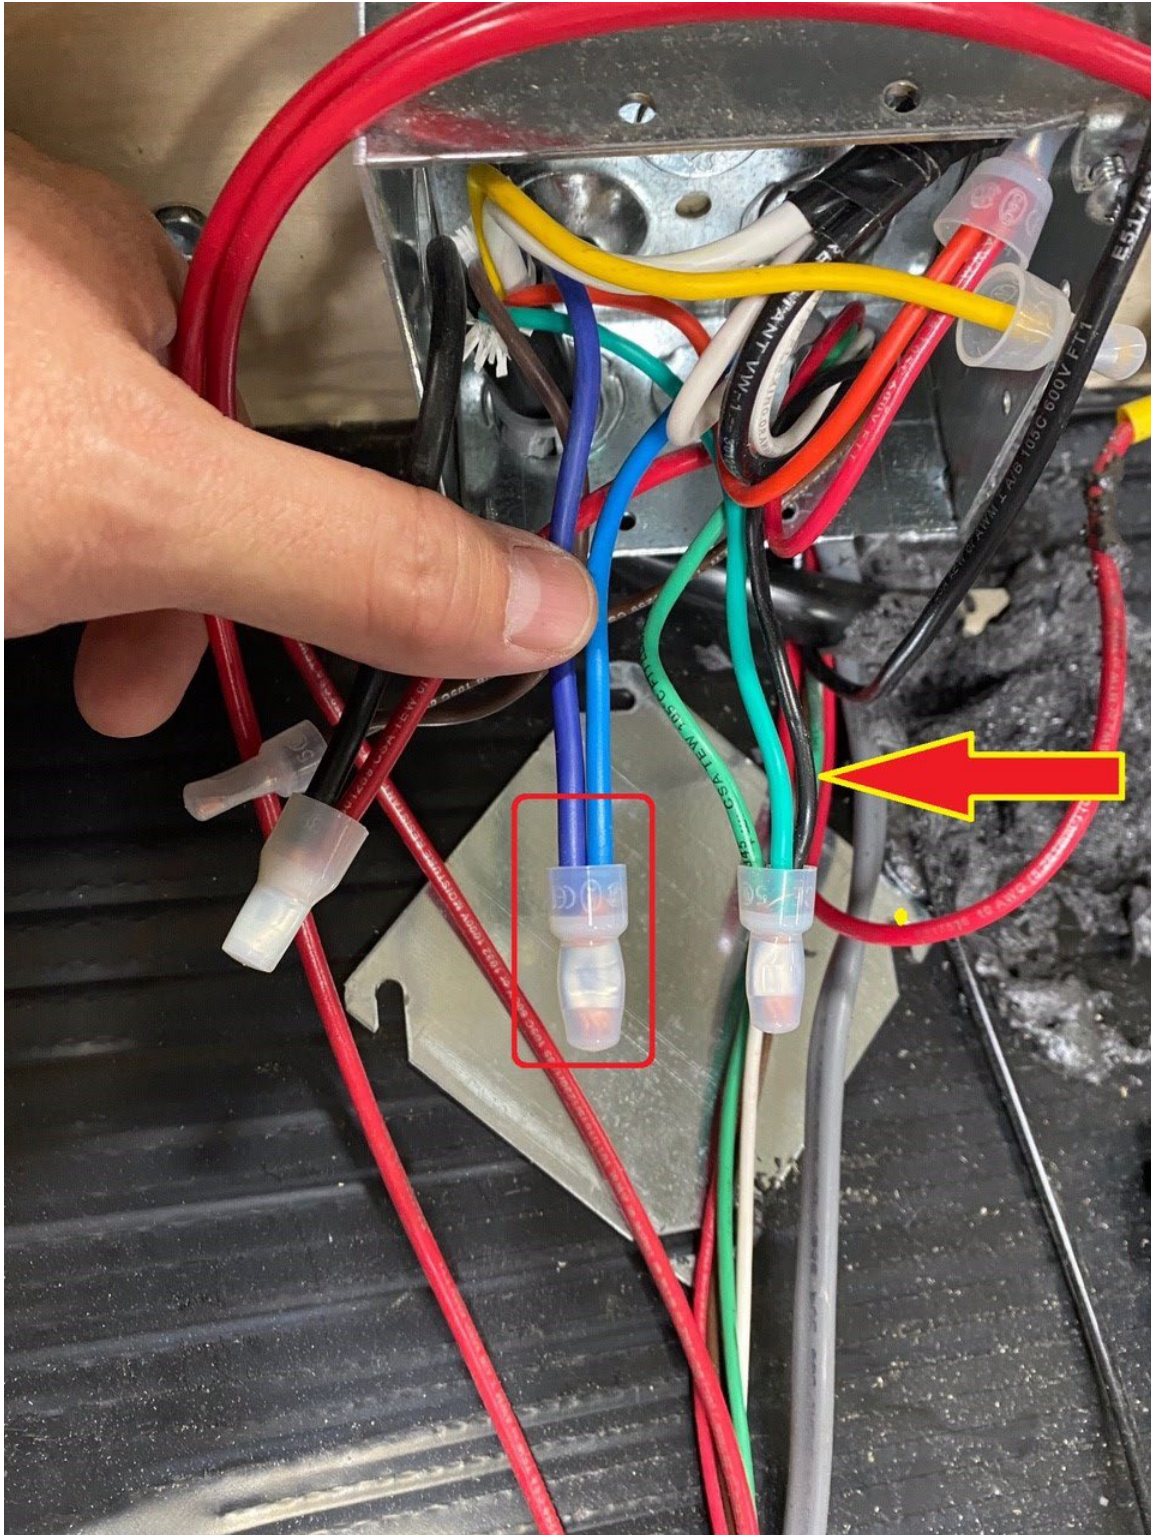
FIGURE 1:

STEP 4: FIND THE CIRCUIT THAT HAS TWO (2) GREEN WIRES AND A SINGLE (1) BLACK WIRE (FROM THE BREAKAWAY SWITCH) (FIGURE 1);

STEP 7: FIND THE CIRCUIT THAT HAS ONE (1) PURPLE AND ONE (1) BLUE WIRE (FIGURE 1);

STEP 5: CUT THE BELL CAP OFF THESE THREE WIRES (FIGURE 1);

STEP 6: STRIP THE TWO (2) GREEN WIRES BACK AGAIN, TWIST THE WIRE STRANDS TOGETHER, THEN PLACE A NEW BELL CAP ON THEM AND CRIMP THE BELL CAP;

STEP 8: STEP 5: CUT THE BELL CAP OFF THESE THREE WIRES (FIGURE 1);

STEP 9: STRIP THE PURPLE, BLUE AND BLACK (FROM THE BREAKAWAY) WIRES BACK AGAIN, TWIST THE WIRE STRANDS TOGETHER, THEN PLACE A NEW BELL CAP ON THEM AND CRIMP THE BELL CAP (FIGURE 1);
