PREVOST

**SAFETY
RECALL**

SR22-310

DATE :	August 2022	SECTION :	18 CHASSIS
SUBJECT:	USSC REAR BENCH SEAT BOLT MISSING

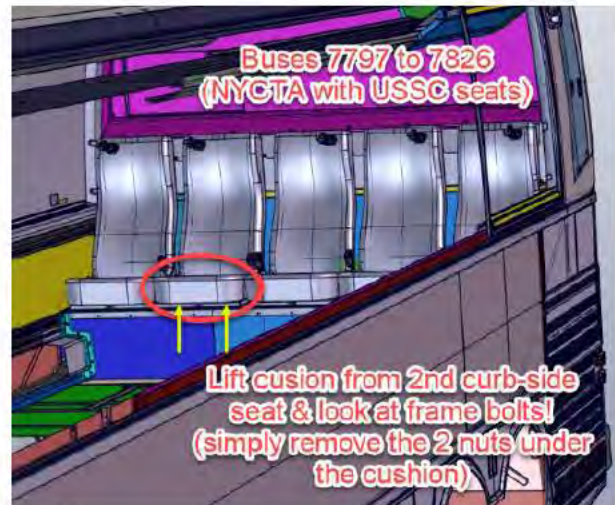
Figure1

1. Remove the seat base from the 2nd curb side rear bench seat (red circle Figure1).

- Unscrew the two screws retaining the seat base to the frame (arrows Figure1).
- Lift to remove the base and expose the frame structure.

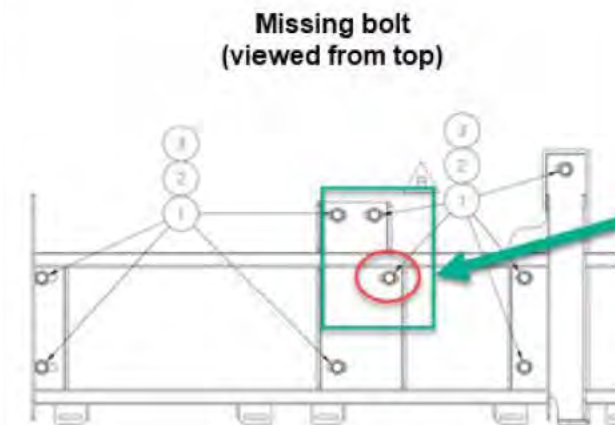
Figure2

On vehicles affected by this recall, one bolt that secures the rear bench seat frame to the vehicle's body was not installed during the manufacturing process because a hole required for the installation of the bolt was missing on the lower back panel.

2. Locate the slot with a missing bolt in the rear seat base structure (red circle in Figure2).

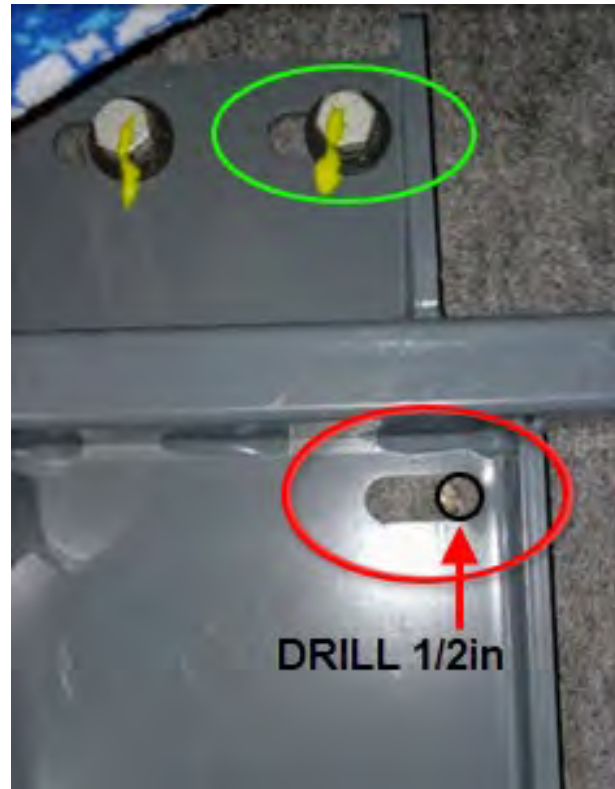
Figure3

3. Drill the missing 1/2in hole in the plywood base using the slot as a guide (Figure3).

- Using a cordless drill (or equivalent) and a 1/2 in drill bit, drill through the carpet and the plywood inside the slot to expose the welded nut behind it.

IMPORTANT: Compare with the two top bolts and drill the hole at the same position (left, center or right) in the slot (right position is shown in Figure3).

The use of a drill stopper installed at 3/4 in from the drill tip is recommended.

- Remove wood chips and frayed carpet from the hole as necessary.

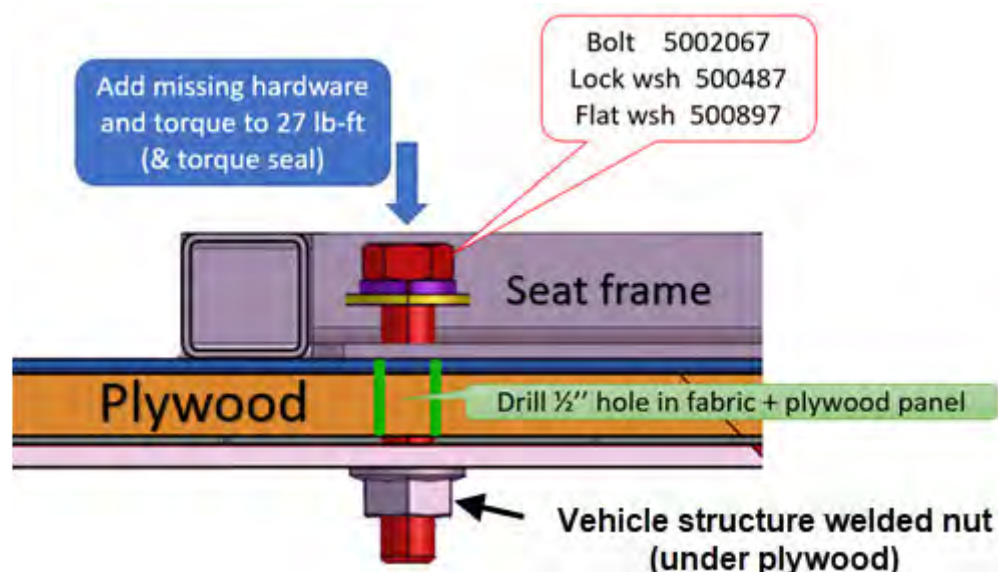
Figure4

4. Install the missing bolt and hardware (Figure4).

- Install the supplied **5002067** Bolt, the **500487** lock washer and the **500897** flat washer.
- Torque the bolt to **27 lb-ft.**
- Add a strip of yellow Torque Seal indicator to the bolt head.
- Reinstall the seat base (Torque to **27 lb-ft**) to complete the procedure.
