Safety Recall

Code: 20DR

Subject	Fuel Pump																												
Release Date	December 22, 2022																												
Affected Vehicles

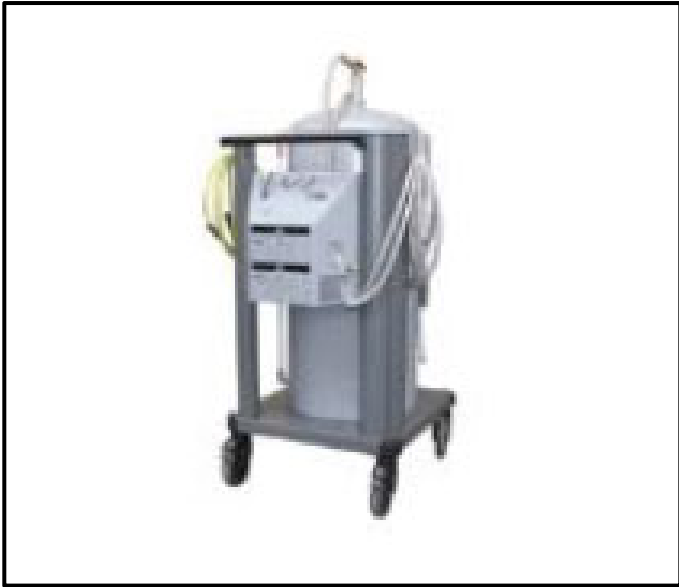
Drain fuel tank:

- Check the vehicle fuel level displayed on the instrument cluster.
- Record the vehicle fuel level on the repair order.
- See ELSA Repair Manual: *Repair Manual > Engine > 20 Fuel Supply > Fuel Tank > Fuel Tank, Draining*

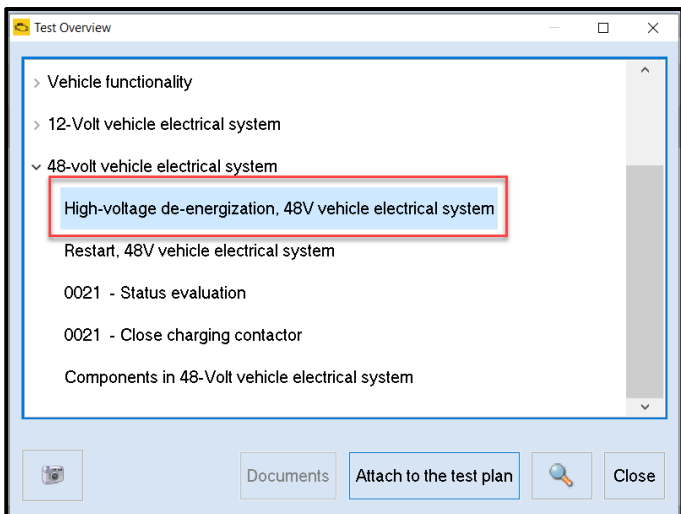
De-energize 48V system (if equipped):

- Select test plan “*High-voltage de-energization, 48V vehicle electrical system.*”
- Follow the ODIS test plan steps.

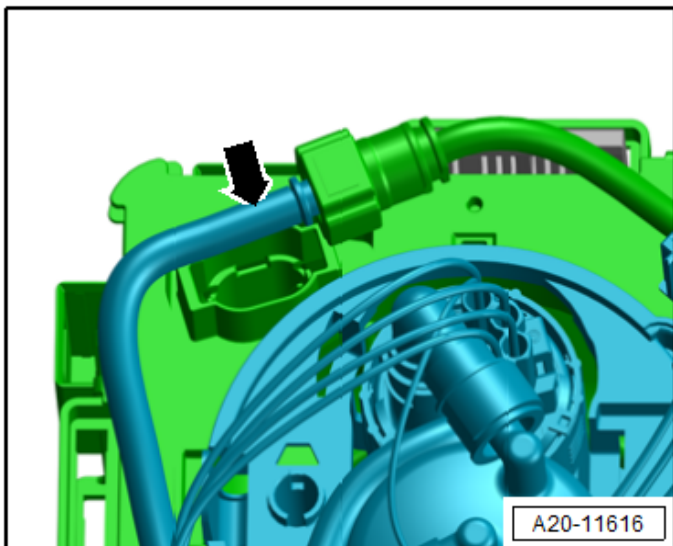
Disconnect suction jet line (version 1):

- Reach through the opening in the fuel tank and disconnect the suction jet line <arrow>.

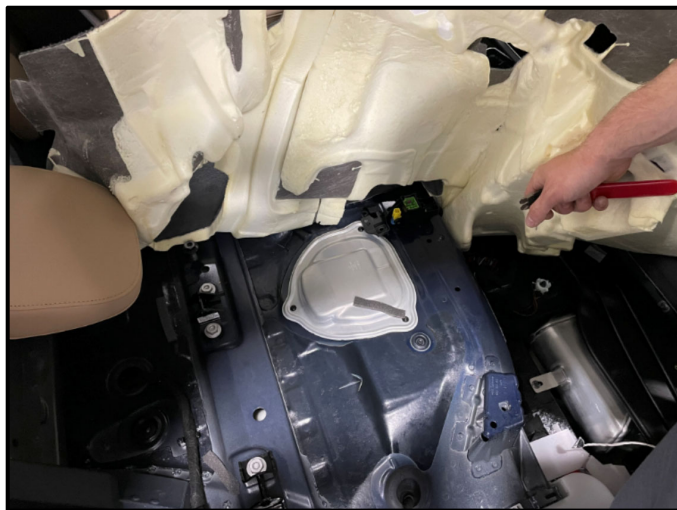
Position carpet:

- Position carpet as shown to access fuel delivery unit cover.
