# SAFETY RELATED RECALL

Global Recall Action  
Number: N720

<b>Subject:</b>  <b>Autoliv Seatbelt Retractor Functionality</b>	Publication No.: N720
	Model: Defender (LE)
	Model Year: 2022 - 2023
	Model: Discovery (LR)
	Model Year: 2022 - 2023
	Model: Discovery Sport (LC)
	Model Year: 2022 - 2023
	Model: Range Rover Sport (LW)
	Model Year: 2022
	Model: Range Rover Velar (LY)
	Model Year: 2022 - 2023
Date of Issue: 19 August 2022

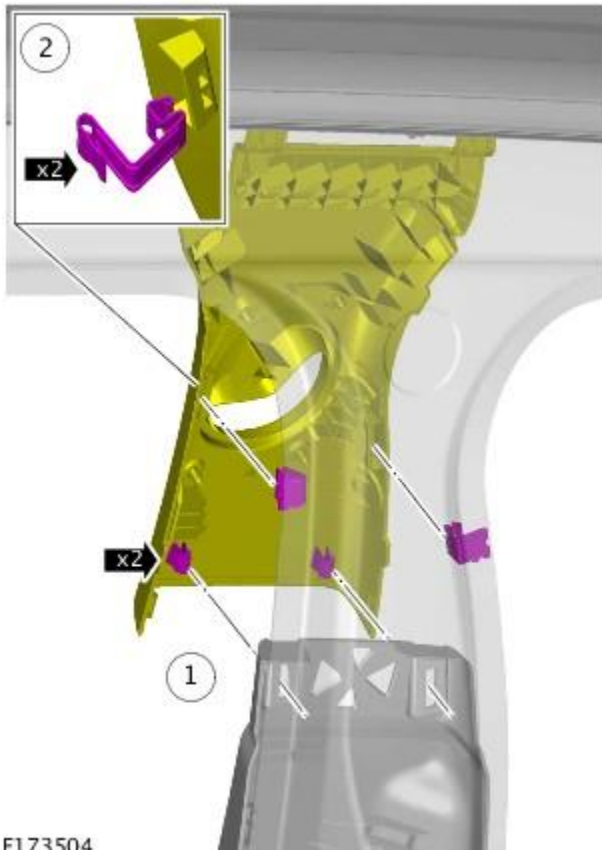
3. Release, but do not fully remove the b-pillar upper trim panel.

1. Release the 2 lower trim clips.

2. Release the 2 center clips.

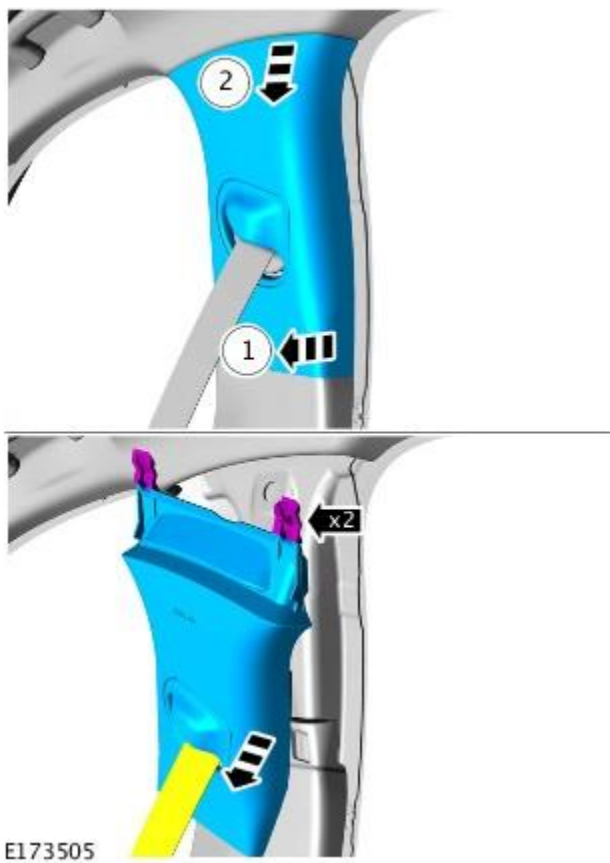
4. Remove the b-pillar upper trim panel.

1. Release the b-pillar upper trim panel from the b-pillar.

2. Release the 2 upper locating arms.

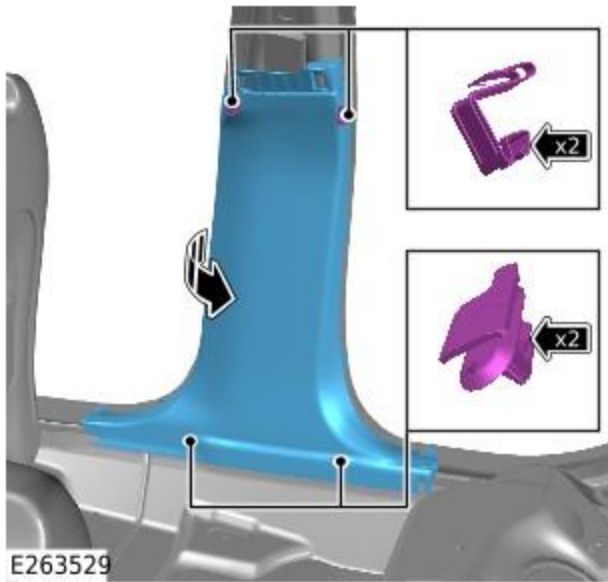
8. Remove the b-pillar lower trim panel.

- Release the 4 trim clips.

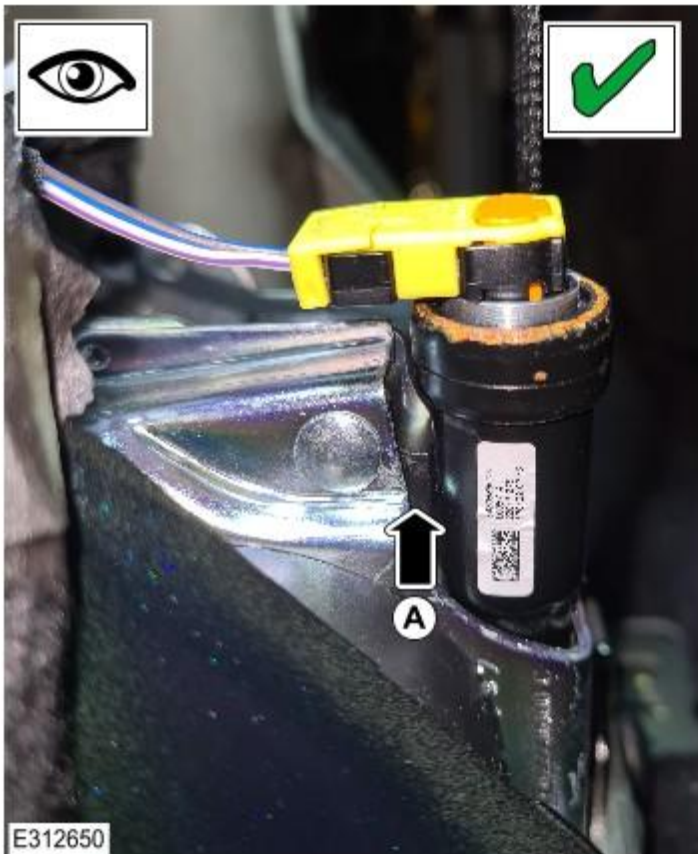
E312651

Inspect both front safety belt retractors for damage shown in the area marked 'A' in the illustrations.

- Any front safety belt retractors which **are** damaged, as shown in the illustration marked with a RED 'X', must be renewed. Continue to step 11 to renew any damaged front safety belt retractors.
- If both front safety belt retractors **are not** damaged, as shown in the illustration marked with a GREEN '✓', reverse steps 1 to 9 above.

11. Renew the damaged front safety belt retractor(s), (see TOPIx Workshop Manual section 501-20: Seatbelt System - Removal and Installation - Front Safety Belt Retractor).

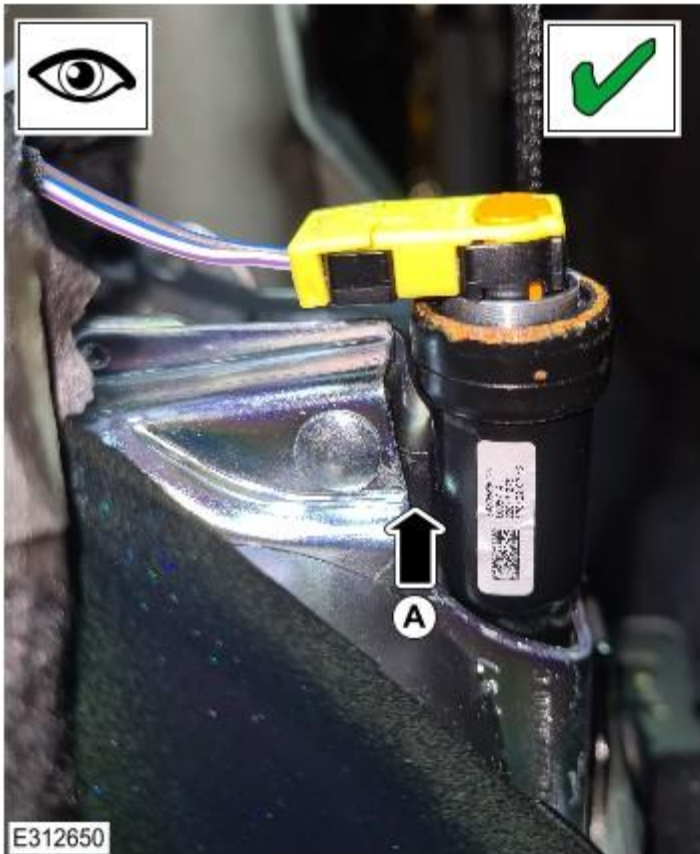
E312651

6. Inspect both front safety belt retractors for damage shown in the area marked 'A' in the illustrations.

- Any front safety belt retractors which **are** damaged, as shown in the illustration marked with a RED 'X', must be renewed. Continue to step 7 to renew any damaged front safety belt retractors.
- If both front safety belt retractors **are not** damaged, as shown in the illustration marked with a GREEN '✓', reverse steps 1 to 5 above.

7. Renew the damaged front safety belt retractor(s), (see TOPIx Workshop Manual section 501-20: Seatbelt System - Removal and Installation - Front Safety Belt Retractor).

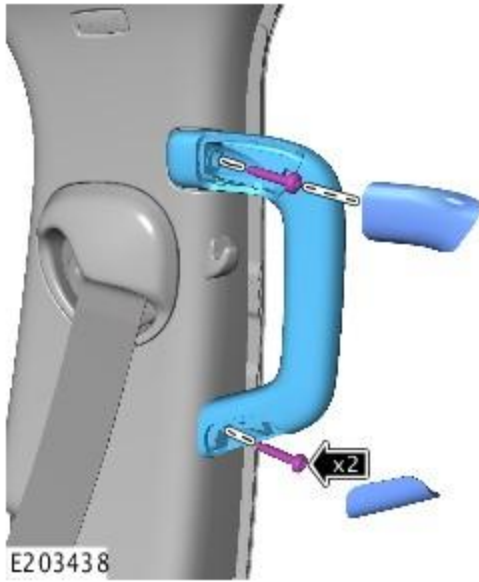
3. Remove the grab handle.

- Remove the 2 bolt covers.
- Remove the 2 bolts.
  - **Torque:** 6 Nm

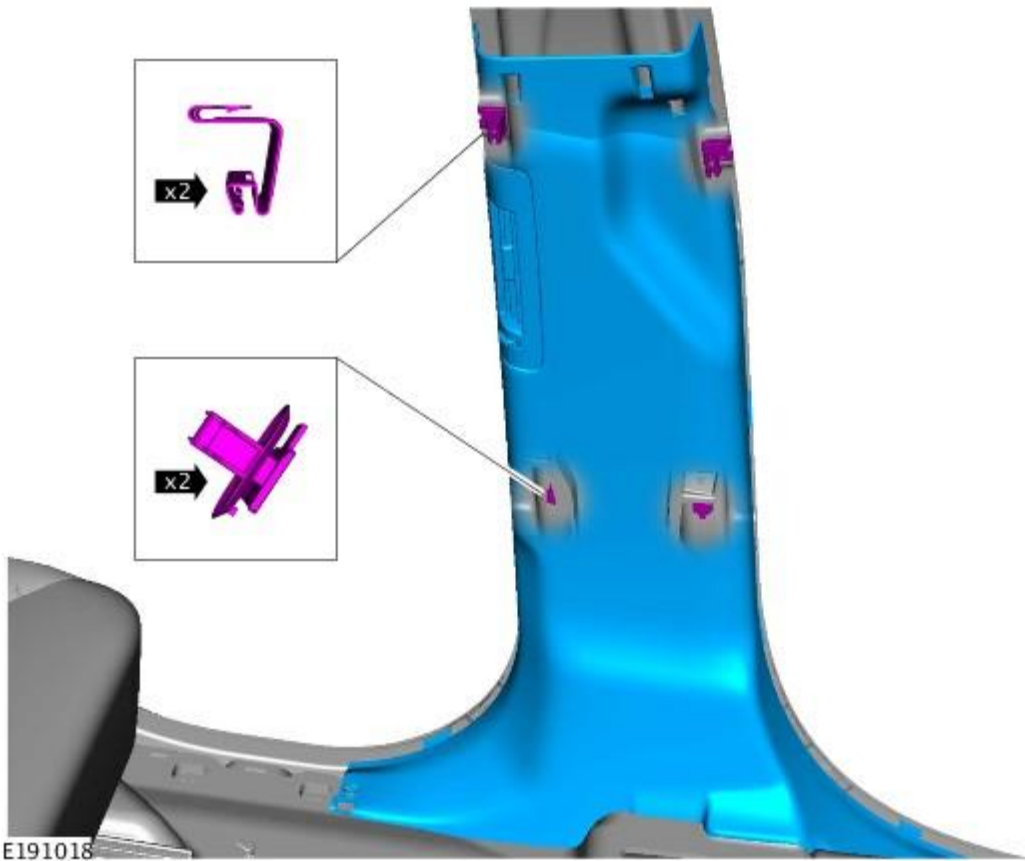
9. Remove the b-pillar lower trim panel.

- Release the 4 trim clips.

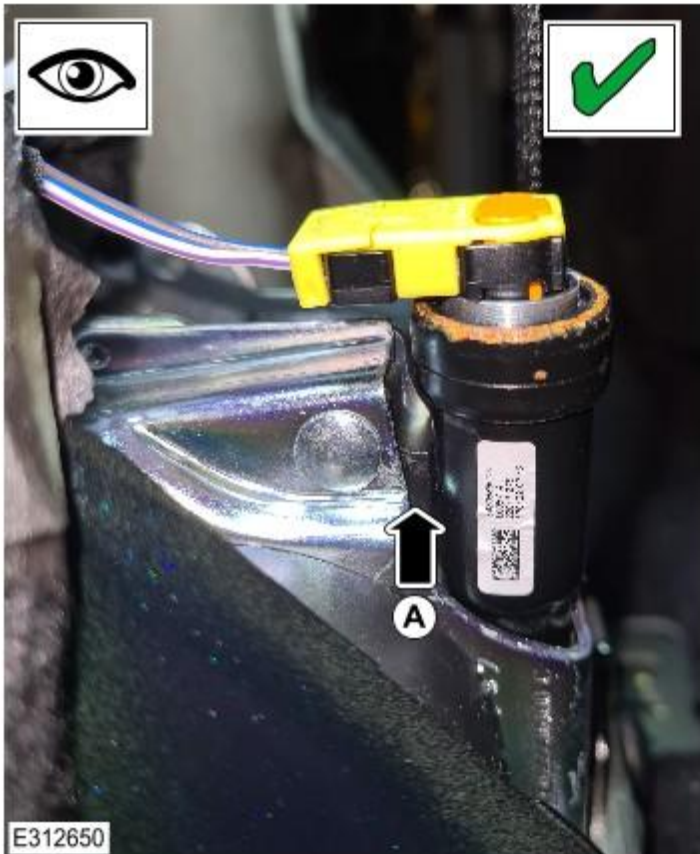
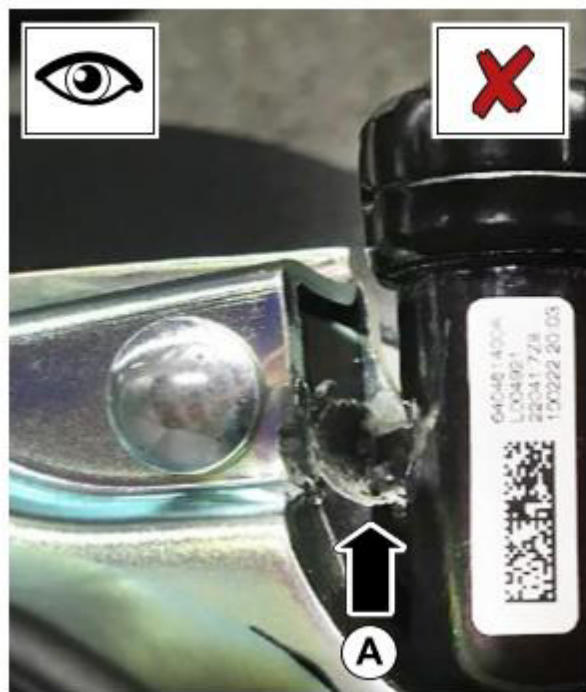
E312651

11. Inspect both front safety belt retractors for damage shown in the area marked 'A' in the illustrations.

- Any front safety belt retractors which **are** damaged, as shown in the illustration marked with a RED 'X', must be renewed. Continue to step 12 to renew any damaged front safety belt retractors.
- If both front safety belt retractors **are not** damaged, as shown in the illustration marked with a GREEN '✓', reverse steps 1 to 10 above.

12. Renew the damaged front safety belt retractor(s), (see TOPIx Workshop Manual section 501-20: Seatbelt System - Removal and Installation - Front Safety Belt Retractor).

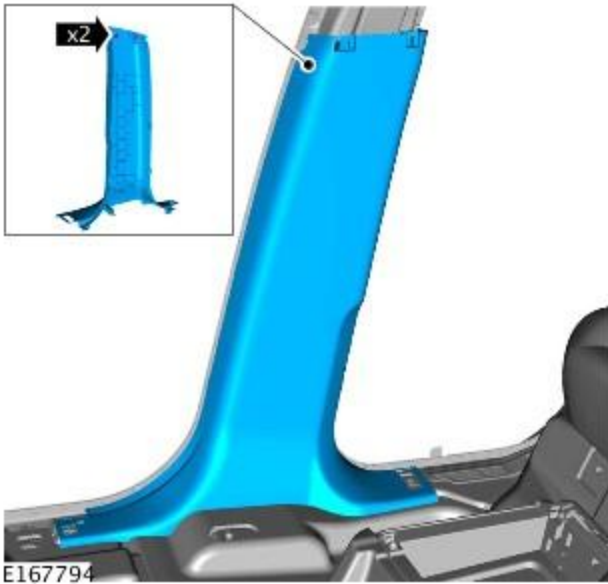
7. Remove the b-pillar lower trim panel.

- Release the 2 trim clips.

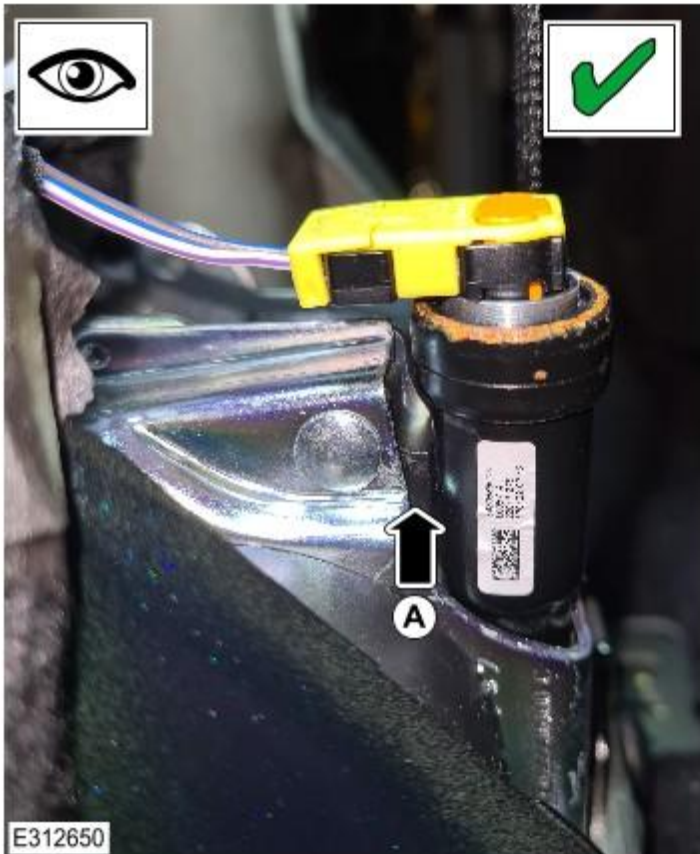
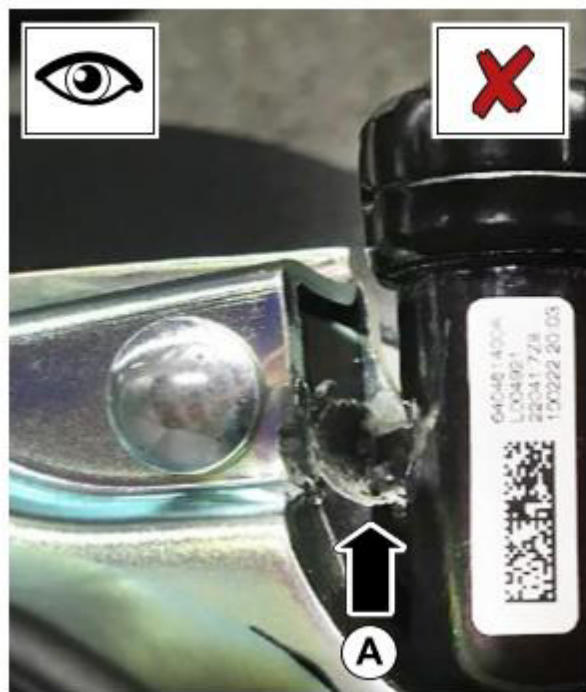
E312651

9. Inspect both front safety belt retractors for damage shown in the area marked 'A' in the illustrations.

- Any front safety belt retractors which **are** damaged, as shown in the illustration marked with a RED 'X', must be renewed. Continue to step 10 to renew any damaged front safety belt retractors.
- If both front safety belt retractors **are not** damaged, as shown in the illustration marked with a GREEN '✓', reverse steps 1 to 8 above.

10. Renew the damaged front safety belt retractor(s), (see TOPIx Workshop Manual section 501-20: Seatbelt System - Removal and Installation - Front Safety Belt Retractor).

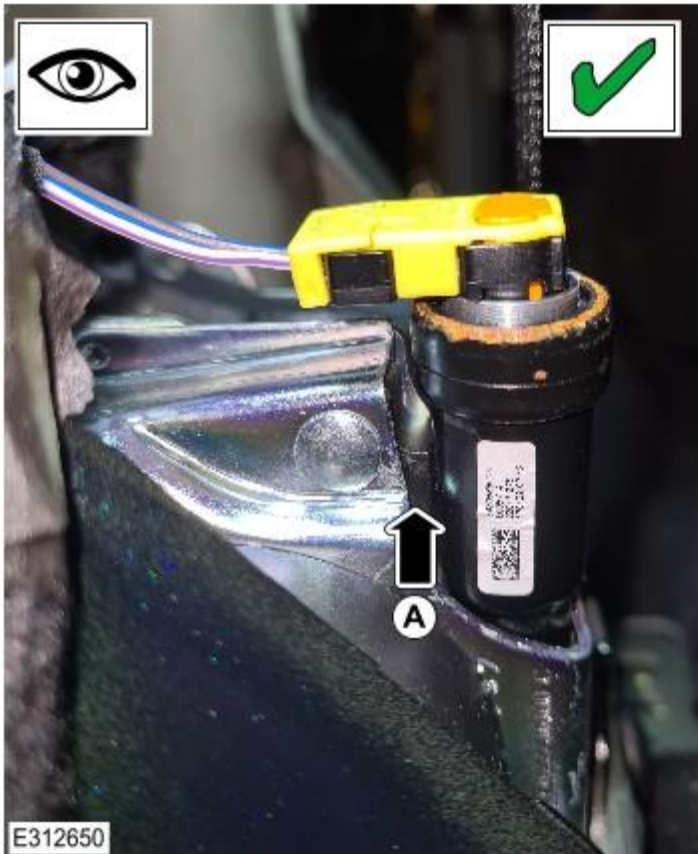
E312651

2. Inspect both front safety belt retractors for damage shown in the area marked 'A' in the illustrations.

- Any front safety belt retractors which **are** damaged, as shown in the illustration marked with a RED 'X', must be renewed. Continue to step 3 to renew any damaged front safety belt retractors.
- If both front safety belt retractors **are not** damaged, as shown in the illustration marked with a GREEN '✓', reverse step 1 above.

3. Renew the damaged front safety belt retractor(s), (see TOPIx Workshop Manual section 501-20: Seatbelt System - Removal and Installation - Front Safety Belt Retractor).

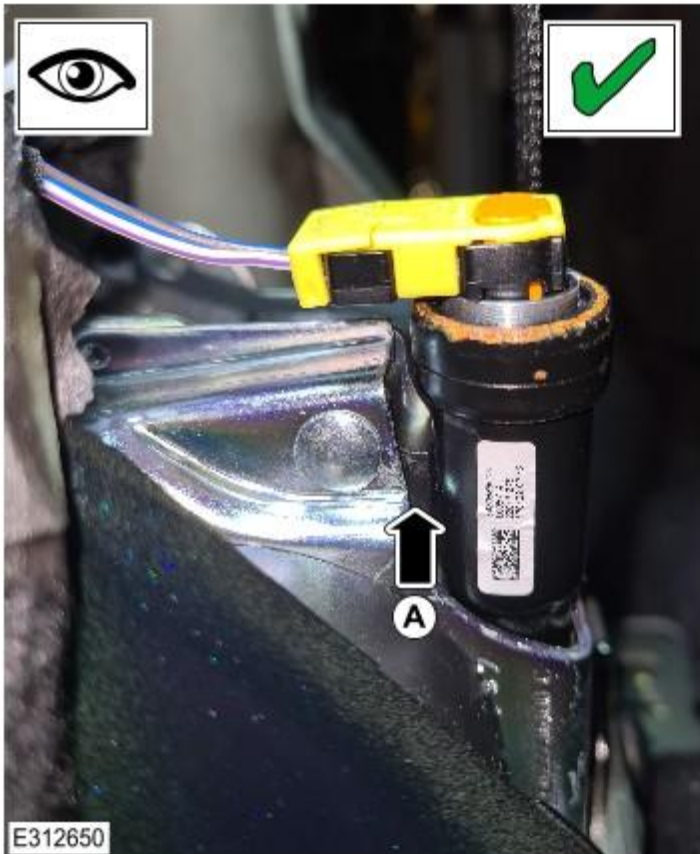
E312651

5. Inspect both front safety belt retractors for damage shown in the area marked 'A' in the illustrations.

- Any front safety belt retractors which **are** damaged, as shown in the illustration marked with a RED 'X', must be renewed. Continue to step 3 to renew any damaged front safety belt retractors.
- If both front safety belt retractors **are not** damaged, as shown in the illustration marked with a GREEN '✓', reverse step 1 above.

6. Renew the damaged front safety belt retractor(s), (see TOPIx Workshop Manual section 501-20: Seatbelt System - Removal and Installation - Front Safety Belt Retractor).
