# SAFETY RELATED RECALL

Global Recall Action  
Number: H412

<b>Subject:</b>  <b>Autoliv Seatbelt Retractor Functionality</b>	Publication No.: H412
	Model: F-PACE (X761)
	Model Year: 2022 - 2023
	Model: F-TYPE (X152)
	Model Year: 2022
	Model: XF (X260)
	Model Year: 2022
	Date of Issue: 19 August 2022

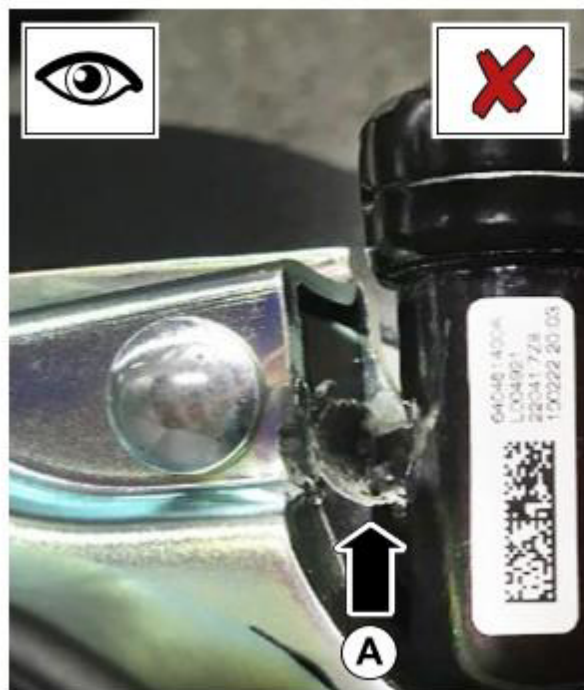
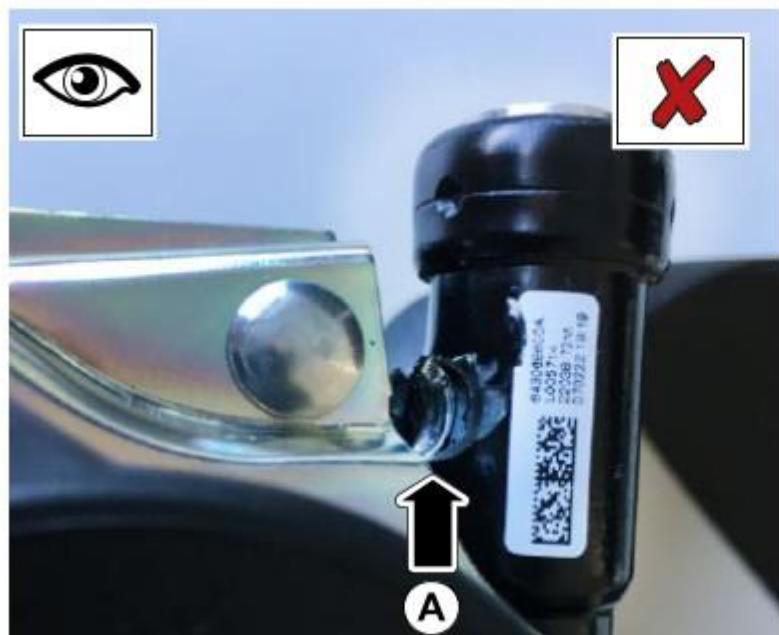
E312651

9. Inspect both front safety belt retractors for damage shown in the area marked 'A' in the illustrations.

- Any front safety belt retractors which **are** damaged, as shown in the illustration marked with a RED 'X', must be renewed. Continue to step 10 to renew any damaged front safety belt retractors.
- If both front safety belt retractors **are not** damaged, as shown in the illustration marked with a GREEN '✓', reverse steps 1 to 8 above.

10. Renew the damaged front safety belt retractor(s), (see TOPIx Workshop Manual section 501-20: Seatbelt System - Removal and Installation - Front Safety Belt Retractor).

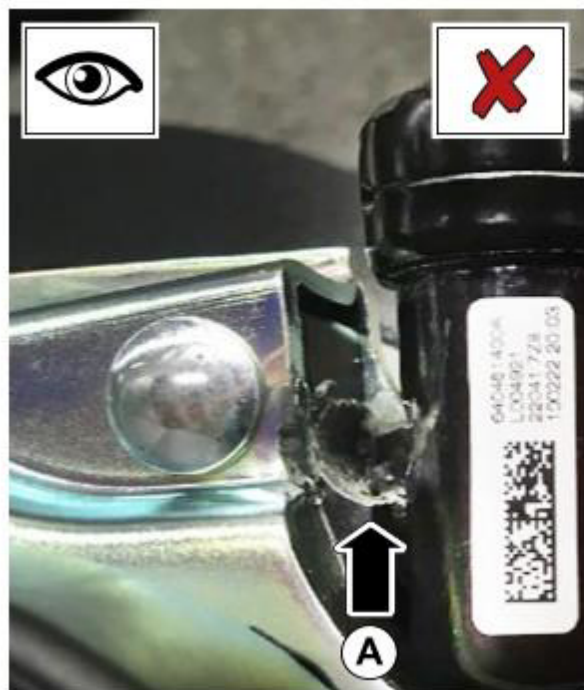
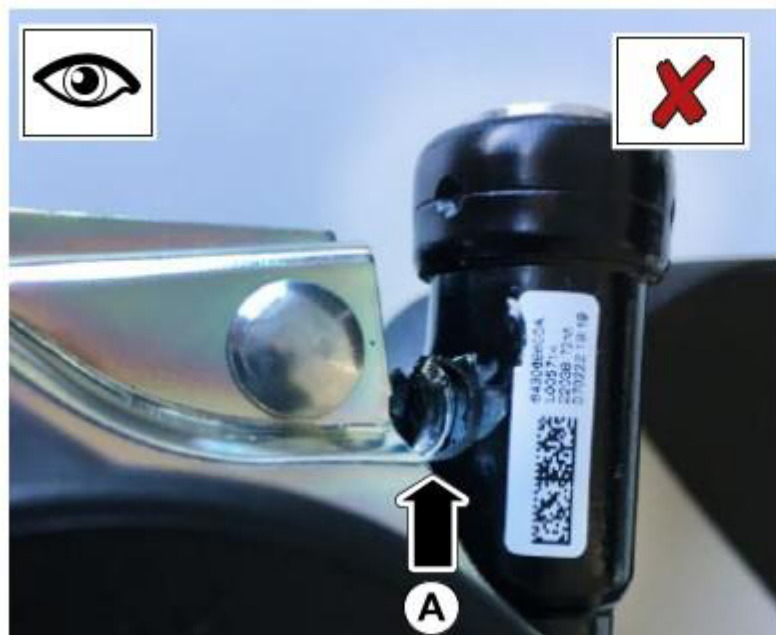
E312651

10. Inspect both front safety belt retractors for damage shown in the area marked 'A' in the illustrations.

- Any front safety belt retractors which **are** damaged, as shown in the illustration marked with a RED 'X', must be renewed. Continue to step 11 to renew any damaged front safety belt retractors.
- If both front safety belt retractors **are not** damaged, as shown in the illustration marked with a GREEN '✓', reverse steps 1 to 9 above.

11. Renew the damaged front safety belt retractor(s), (see TOPIx Workshop Manual section 501-20: Seatbelt System - Removal and Installation - Front Safety Belt Retractor).

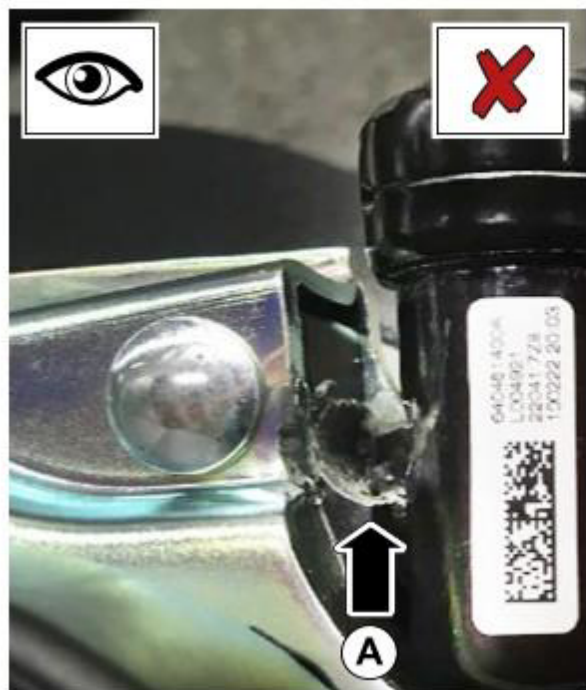
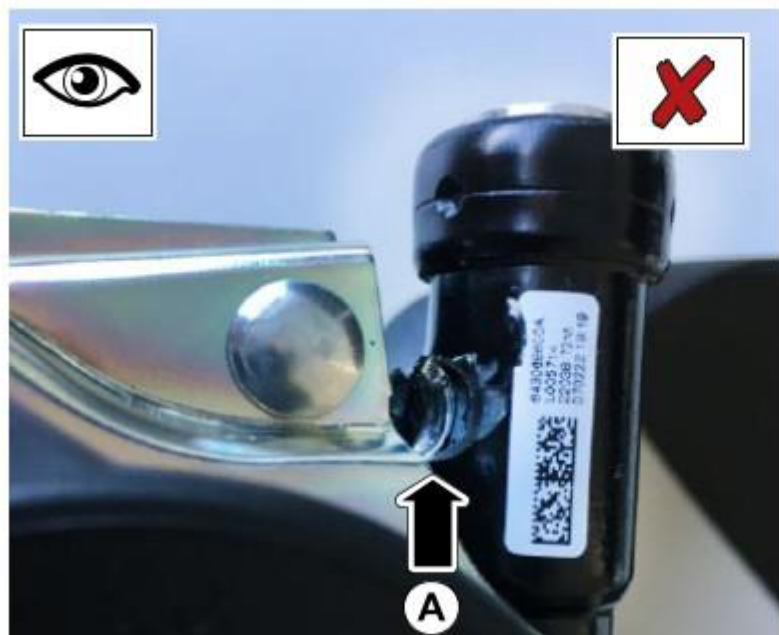
E312651

Inspect both front safety belt retractors for damage shown in the area marked 'A' in the illustrations.

- Any front safety belt retractors which **are** damaged, as shown in the illustration marked with a RED 'X', must be renewed. Continue to step 11 to renew any damaged front safety belt retractors.
- If both front safety belt retractors **are not** damaged, as shown in the illustration marked with a GREEN '✓', reverse steps 1 to 9 above.

11. Renew the damaged front safety belt retractor(s), (see TOPIx Workshop Manual section 501-20: Seatbelt System - Removal and Installation - Front Safety Belt Retractor).

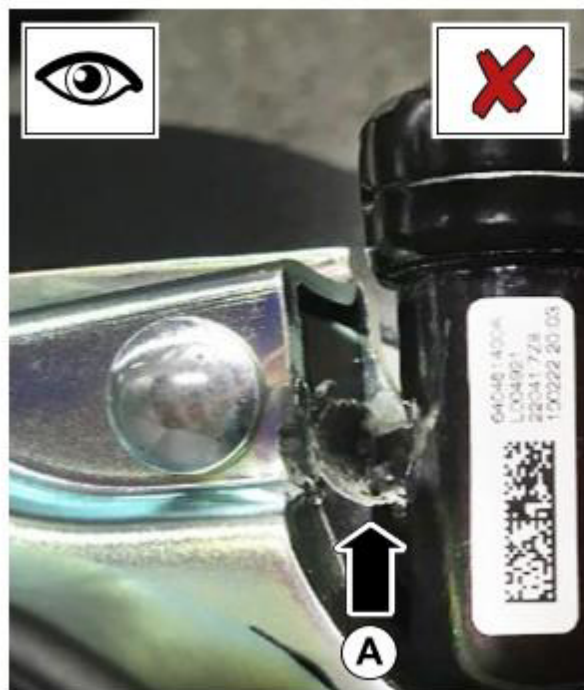
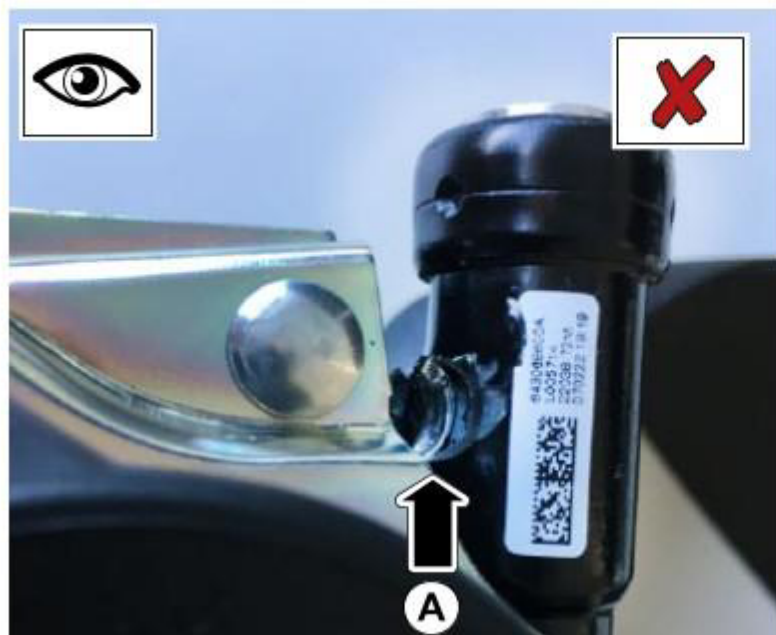
E312651

8. Inspect both front safety belt retractors for damage shown in the area marked 'A' in the illustrations.

- Any front safety belt retractors which **are** damaged, as shown in the illustration marked with a RED 'X', must be renewed. Continue to step 9 to renew any damaged front safety belt retractors.
- If both front safety belt retractors **are not** damaged, as shown in the illustration marked with a GREEN '✓', reverse steps 1 to 7 above.

9. Renew the damaged front safety belt retractor(s), (see TOPIx Workshop Manual section 501-20: Seatbelt System - Removal and Installation - Front Safety Belt Retractor).

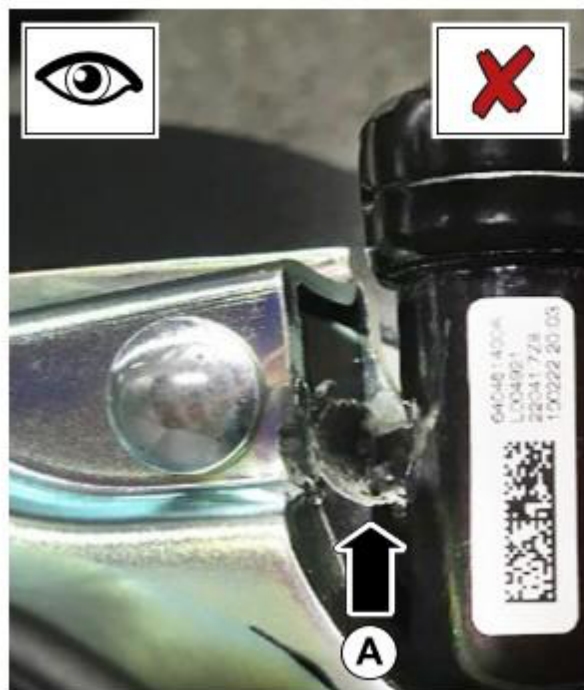
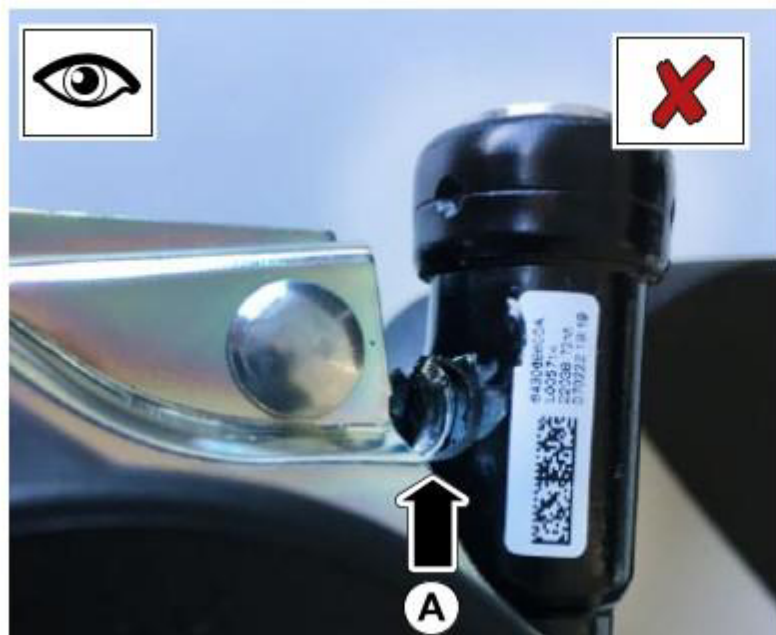
E312651

20. Inspect both front safety belt retractors for damage shown in the area marked 'A' in the illustrations.

- Any front safety belt retractors which **are** damaged, as shown in the illustration marked with a RED 'X', must be renewed. Continue to step 21 to renew any damaged front safety belt retractors.
- If both front safety belt retractors **are not** damaged, as shown in the illustration marked with a GREEN '✓', reverse steps 10 to 19 above.

21. Renew the damaged front safety belt retractor(s), (see TOPIx Workshop Manual section 501-20: Seatbelt System - Removal and Installation - Front Safety Belt Retractor).
