Keystone RV Company

SAFETY ADVISORY # 22-434

Lippert Awnings

AWNING INSPECTION AND WELD/SEAM REPAIR

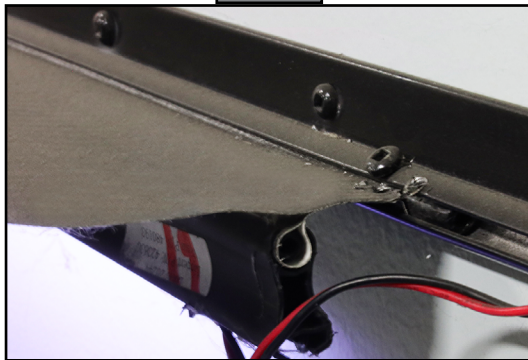
Fig. 1

The purpose of this document is to provide guidance, as well as visual aides, to dealers performing inspection on units that may have insufficient awning weld(s). The inspection point is at the awning fabric seam at the awning rail at the wall of the unit (Fig. 1). This only affects awnings manufactured January 17, 2022 – June 14, 2022. The date of manufacture can be located on the variant code label (Fig. 2) located on the awning.

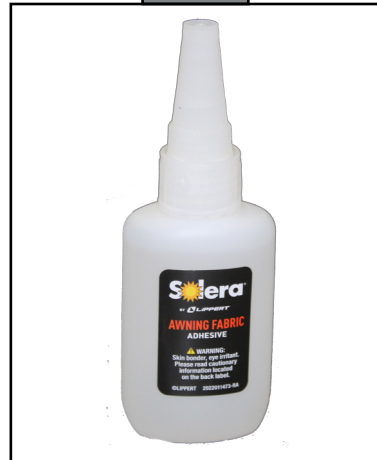
Fig. 1

This document outlines the repair of awning fabric that has separated at the seam using Awning Seam Repair Adhesive PN 2022107896 (Fig. 1).

PN 2022107896

- Awning Seam Repair Adhesive PN 2022107896 (Fig. 1)
- Mild soap and water
- Ladder, if needed, to reach the awning rail or roll tube

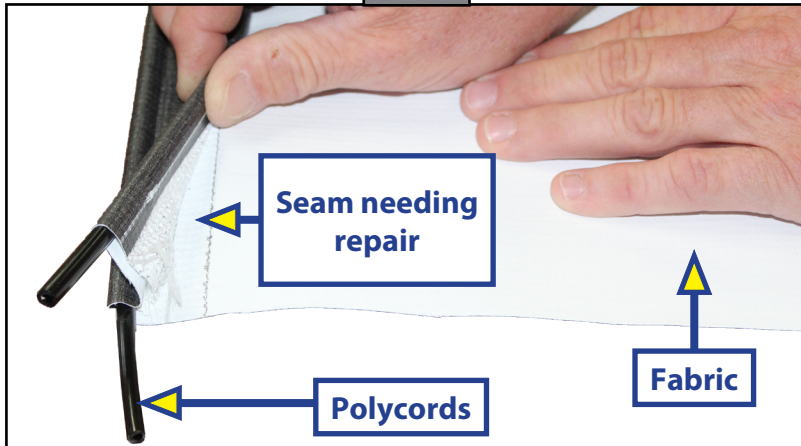
Fig. 2

NOTE: The repair procedure is optimal for 6 to 8" seam separations or less (Fig. 2).

1. Extend the awning:
 - A. For a seam fix at the awning rail, extend the awning a few feet.
 - B. For a seam fix at the roll tube, extend the awning completely.
2. Tie both awning arms slightly back to gain some slack in the fabric.
3. Clean the area to be repaired with mild soap and water. Allow to dry completely.
4. Spread open the seam area needed repair and apply a continuous bead of Awning Seam Repair Adhesive PN 2022107896 along the entire separation (Fig. 3).
5. Press down firmly and hold for several minutes.
6. Allow to dry for at least four hours.

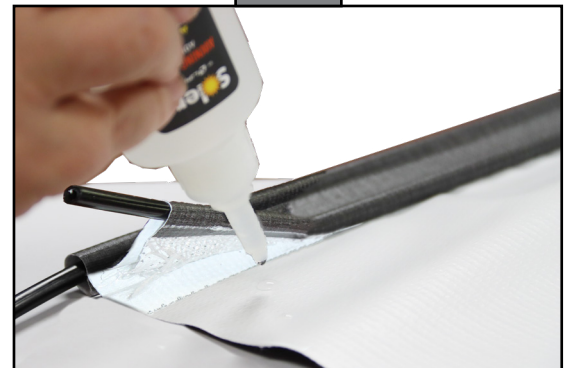
Fig. 3

NOTE: Photo shows fabric removed from the awning for clarity and upside down. The repair can be completed with the awning fabric installed.

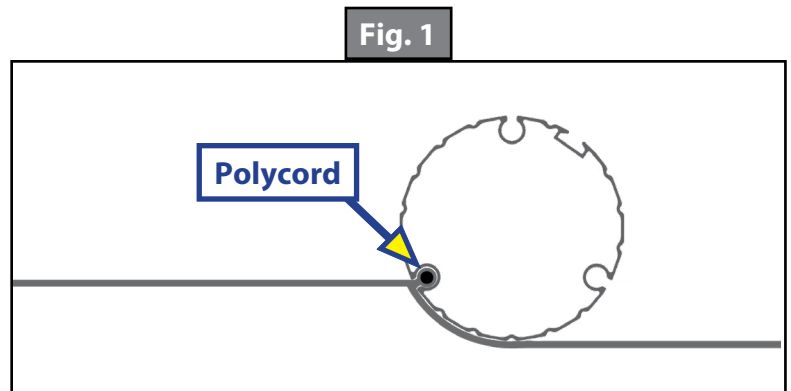
NOTE: Previous awning versions had two (2) polycords and fabric stitching along the hem. The current awning model has one (1) polycord (see Fig. 1) and no fabric stitching. This should not be mistaken as defective.

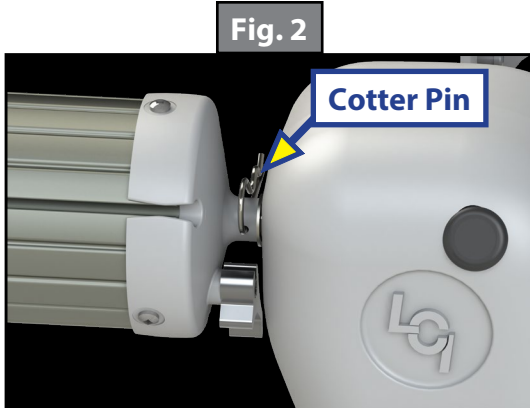
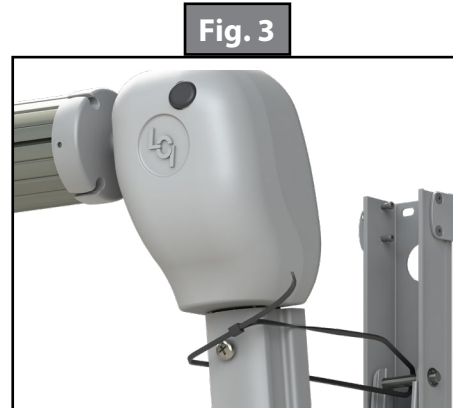
1. Remove the drip cap (if equipped) from the end of the awning from which the fabric will be removed.
2. Extend the awning out approximately 12" and insert cotter pins through both end caps into the shafts on the head assemblies (Fig. 2).

3. Secure both support arm assemblies by running a zip tie around the outer arm and around the pin on the top of the mount arm where the mount arm and inner arm connect (Fig. 3).
4. Remove the screws holding the polycord in place on the awning rail.

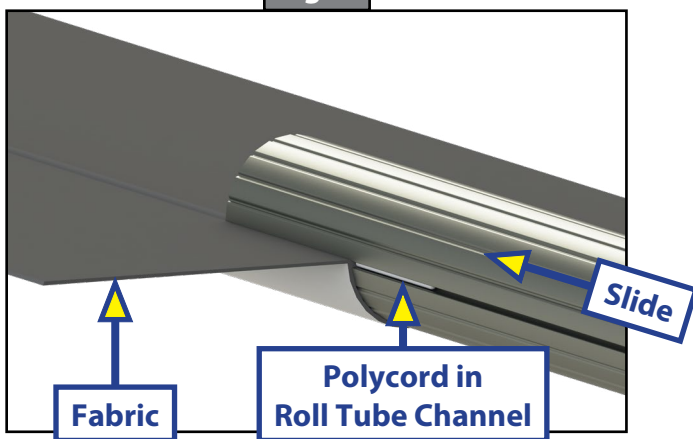
Fig. 4

1. Unroll the replacement fabric printed side down so that the polycord is parallel and away from the roll tube.
2. On a clean, level surface free of any debris able to scratch or damage the roll tube, gently slide the roll tube onto the polycord of the fabric, making sure that the non-printed side is touching the roll tube (Fig. 4).
3. Center the fabric on the roll tube.
4. Apply the screws that were holding the polycord in place on the roll tube. Install the screws no more than 1" from the edge of the fabric.

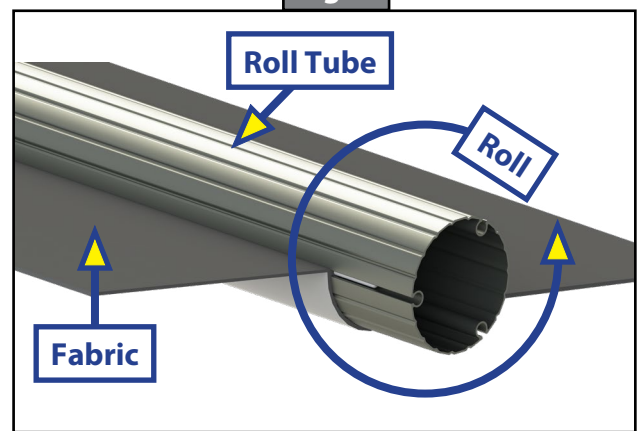
Fig. 5

5. Roll the fabric onto the roll tube (Fig. 5). Make sure the fabric stays snug and flat to the roll tube with the printed side facing away.
6. Using the three screws previously removed from the drive head assembly end cap, attach the drive head to the roll tube, making sure the orientation is the same.

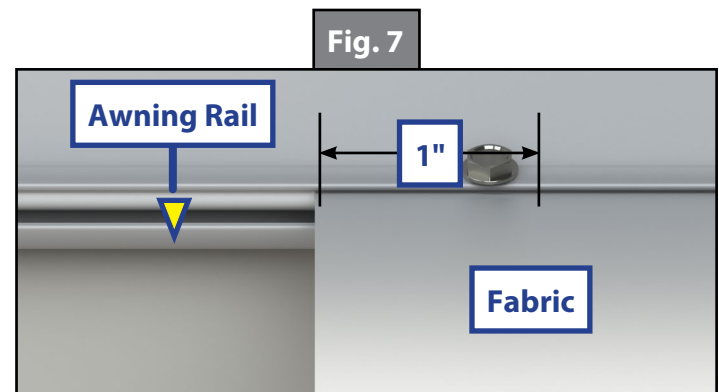
9. Working together, install the roll tube assembly (which includes the drive/idler head assemblies) to the awning rail and support arms by sliding the assembly along the awning rail. Make sure the awning will unroll with the printed side of the fabric up.
10. Install the previously removed drive/idler head assembly retaining bolts into the outer arms to secure.
11. Remove the cotter pins from both end caps and cut the zip ties from the support arm assemblies.
12. Extend and retract the awning several times to ensure that the fabric is square on the roll tube.
13. Secure the fabric in the awning rail 1" inside the edge of the fabric on both ends using a #6 x 1/2" hex head screw. Install the screw down through the awning rail into the fabric and the polycord (Fig 7).
14. Reinstall the drip cap (if previously equipped).

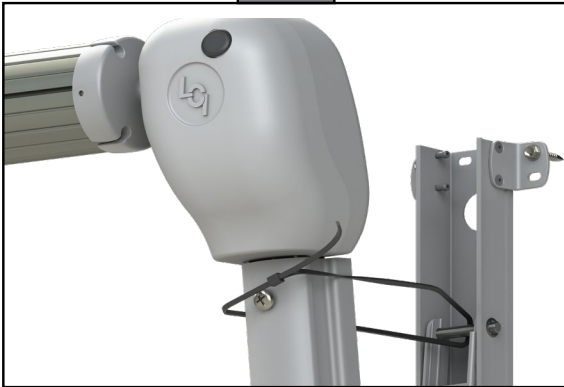
Fig. 8

1. Remove the drip cap (if equipped) from the end from which the fabric will be removed.
2. Fully extend the awning.
3. Disconnect any fabric LED lights in the support arm assembly or remove the fabric LED light strip from the polycord of the fabric.
4. Retract the awning until approximately 12" remain visible.
5. Secure both support arm assemblies by running a zip tie around the outer arm and around the pin on the top of the mount arm where the mount arm and inner arm connect (Fig. 8).
6. Remove the screws holding the polycord in place on the awning rail.
7. Remove the wax screws holding the end caps onto the drive and idler head shafts (Fig. 9).
8. Working together, remove the roll tube and fabric from the awning rail and support arm assemblies.
9. Place the roll tube and fabric on a clean, level surface that is free of any debris able to scratch or damage the roll tube and/or fabric.

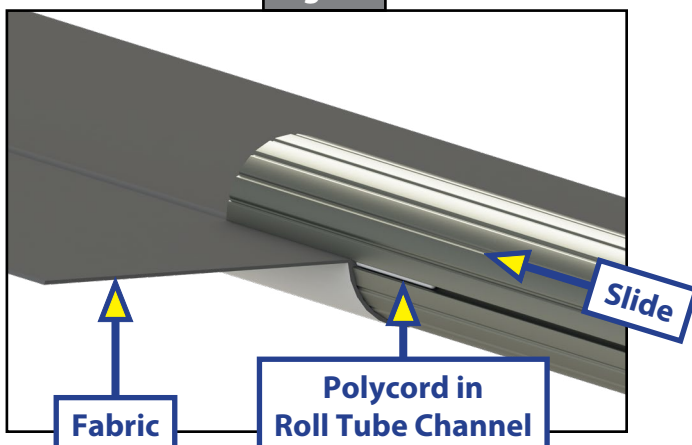
Fig. 10

1. Unroll the replacement fabric so that the cords are parallel with the roll tube.
2. On a clean, level surface free of any debris able to scratch or damage the roll tube, gently slide the roll tube onto the polycord of the fabric, making sure that the non-printed side is touching the roll tube (Fig. 10).
3. Center the fabric on the roll tube.
4. Install the screws that were holding the polycord in place on the roll tube. Install the screws no more than 1" from the edge of the fabric.
5. Roll the fabric onto the roll tube (Fig. 11). Make sure the fabric stays snug and flat to the roll tube with the printed side facing away.

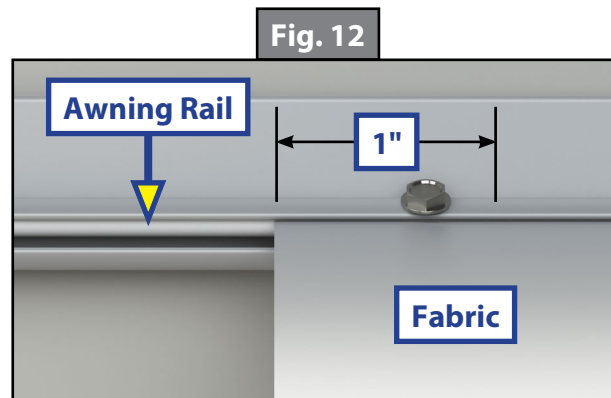
9. Extend and retract the awning several times to ensure that the fabric is square on the roll tube.
10. Secure the fabric in the awning rail no more than 1" inside the edge of the fabric on both ends using a #6 x $\frac{1}{2}$ " hex head screw. Install the screw down through the awning rail into the fabric and the polycord (Fig. 12).
