GROUP	MODEL
Safety Recall Campaign	2020-2022MY Telluride (ON)
NUMBER	DATE
SC247 (Rev 2, 04/11/2023)	October 2022

TRAILER TOW HITCH HARNESS REPAIR AND FUSE/LABEL REPLACEMENT (SC247)

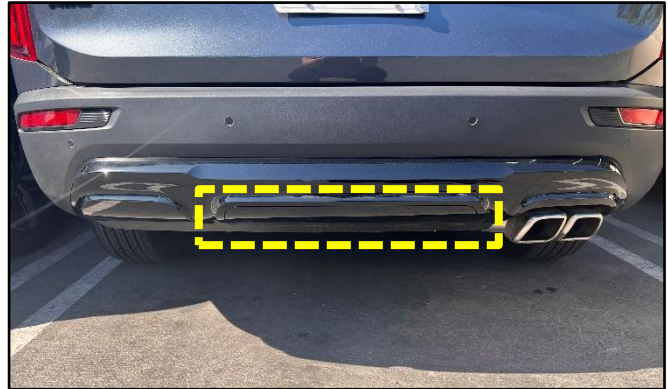
- Vehicle is **not equipped** with a tow hitch harness. No further action is required.

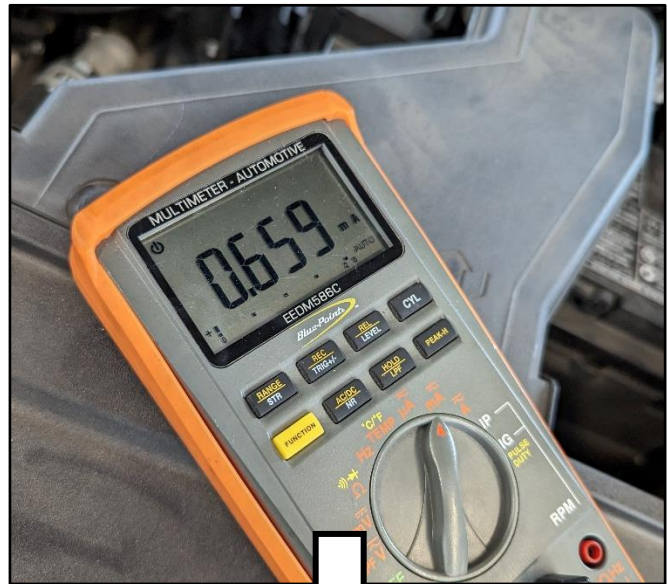
5. Upon touching the two (2) fuse insert pin contacts, the DMM will display between 0 and 20mA and then start to decrease towards 0mA as the circuit goes back to sleep.

- If the DMM displays 13mA or less, proceed to **repair** the trailer hitch harness 'extension'. Continue to step 6.
- If the DMM displays 13mA or more, then **replace** the trailer hitch harness 'assembly' by referring to: "Service Materials → Accessory Information → Body (Interior and Exterior) → 2020 - Telluride (ON) Tow Hitch Harness (S9F67 AC001) Isheet" on KGIS **and then** skip to step 16.

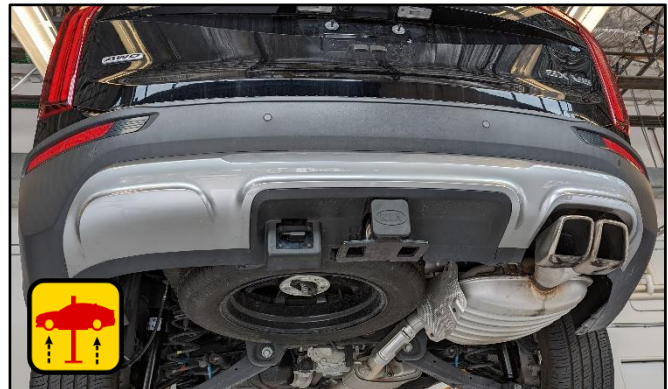
6. Raise the vehicle on a lift to gain access to the trailer hitch harness at the rear of the vehicle.

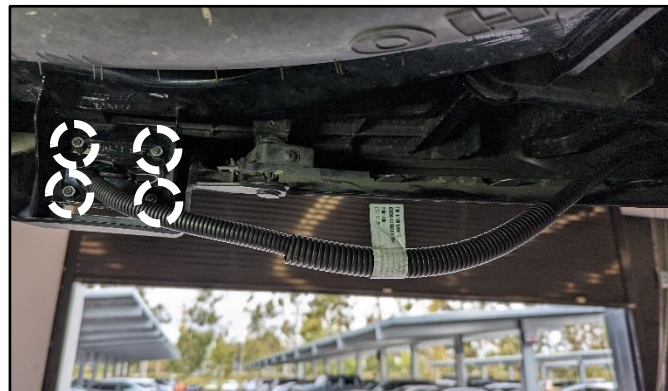
- 7a. Cut the one (1) or two (2) cable ties securing the trailer hitch harness to the vehicle.

- 7b. Loosen the four (4) trailer hitch harness bracket retaining bolts.

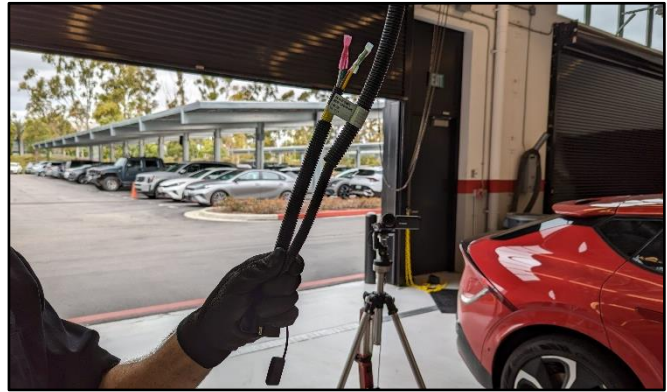
- 8a. Detach the 4-pin trailer hitch harness from the trailer hitch and allow to hang down freely.
- 8b. Align the 'new' 4-pin trailer hitch harness extension against the existing 4-pin trailer harness on the vehicle.

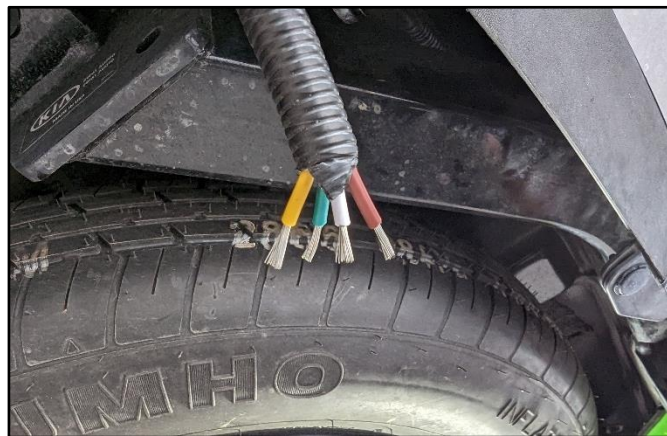
10. Strip 12mm (0.5" in.) off each of the four (4) wires and then twist the loose wire strands together.

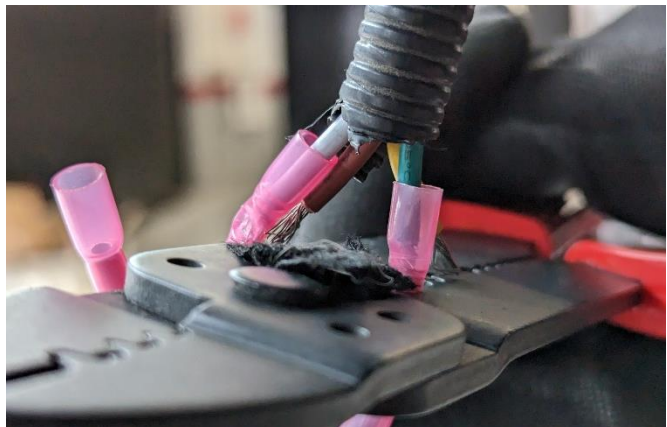
11. Take the new 4-pin wire harness extension, match the corresponding colors and crimp each of the four (4) wires butt-connectors to the vehicle harness.

Note: Crimp each butt-connector individually and gently pull on each wire after crimping to ensure it is secured.

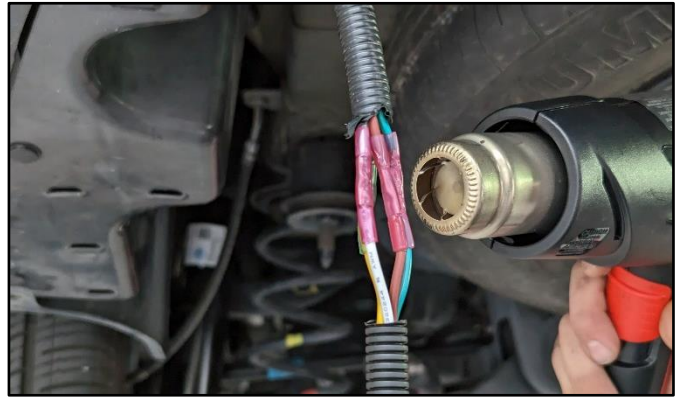
12. Using a heat gun, direct hot air to the butt-connectors to allow them to shrink tight for a water-proof seal.

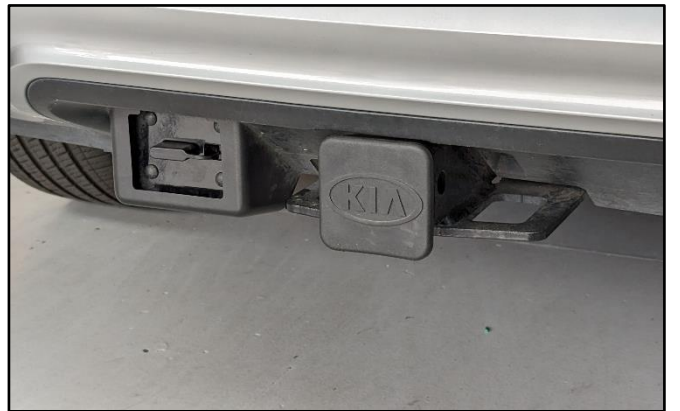
14. Using electrical tape, wrap the loose wire harness corrugated/insulation tubing around both corrugated/insulation tube ends.

15. Reinstall the trailer hitch 4-pin connector to the tow hitch on the vehicle in the reverse order of removal.

Note: Be sure to secure the harness to the same location of the previously removed cable ties from step 7a. (Refer to iSheet)

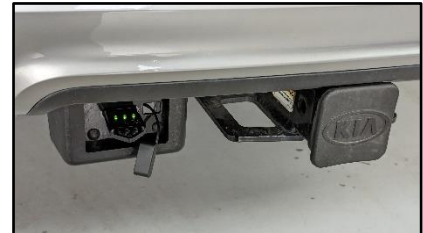
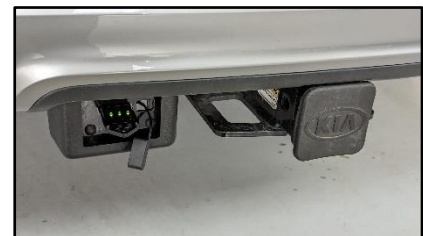
19. Perform the trailer lighting Function Check List below and confirm normal operation.
