Recall 234: Driver Airbag Emblem – Remedy Available - Dealer Best Practice

November 04, 2022

Description of Campaign:

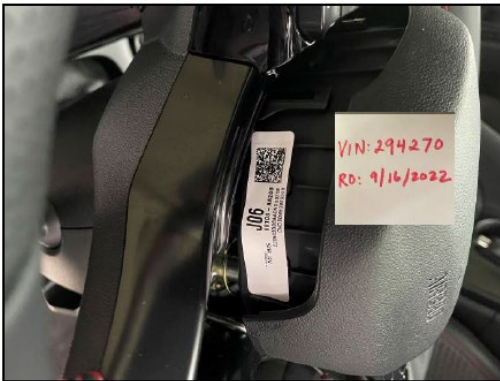
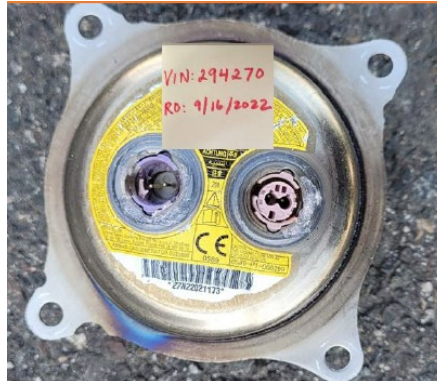
Ensure a STUI photo of the driver's airbag label with the last 6 digits of the VIN and the date of repair is included & uploaded.
Refer to TSB 22-01-079H-1.

- Picture must be taken prior to the new driver airbag being inserted into the steering wheel
- Picture must be taken of original air bag module deployed.

Acceptable STUI photos of new driver airbag inserted and deployed airbag module below:

NOTE 4: Two STUI pictures, one of the new air bag label (before inserted into the steering wheel) and one of the deployed inflator module along with a piece of paper displaying the last 6 digits of the VIN and the date of the repair must be included and uploaded to STUI. If not included, claim will be subject to debit.

STUI pictures that do not have the last 6 digits of the VIN, date of repair, driver's airbag label and deployed inflator module are not acceptable.
