<b>HYUNDAI</b> <b>Technical Service Bulletin</b>	GROUP <b>RECALL</b>	NUMBER <b>23-01-044H</b>
	DATE <b>MAY 2023</b>	MODEL(S) <b>PALISADE (LX2)</b>
<b>SUBJECT:</b> TRAILER TOW HITCH HARNESS INSPECTION AND 4 PINS PIGTAIL EXTENSION WIRE & HARNESS/FUSE REPLACEMENT (RECALL 235)

**Applicable Vehicles:** Certain 2020 - 2022MY Palisade (LX2) produced 04/10/2019 – 05/30/2022

**SUBJECT: TRAILER TOW HITCH HARNESS INSPECTION AND 4 PINS PIGTAIL HARNESS/FUSE REPLACEMENT (RECALL 235)**

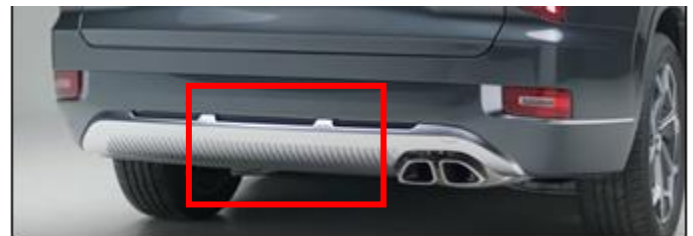
1. Visually inspect the center rear lower bumper for the following:

- Genuine Hyundai Accessory trailer tow hitch and wire harness installed.
- Genuine Hyundai Accessory trailer tow hitch installed, but no visible harness connection installed.
- No trailer tow hitch installed

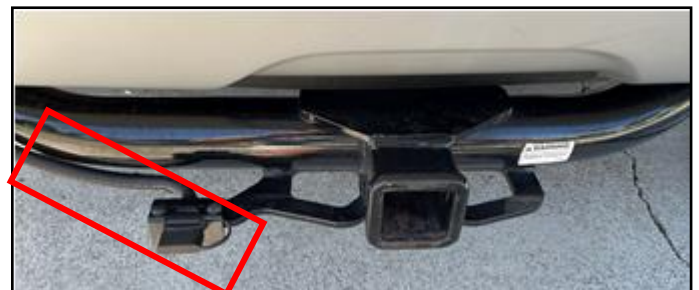
1A. If the vehicle is equipped with a Genuine Hyundai Accessory trailer tow hitch and wire harness, please refer to "MULTIMETER READING TO DETERMINE HARNESS REPAIR" on page 7.

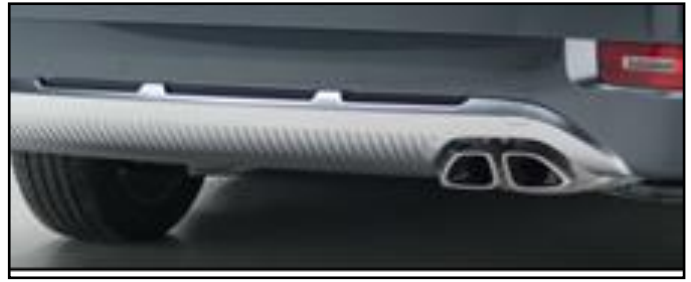
- 1B. If the vehicle is not equipped with a Genuine Hyundai Accessory trailer tow hitch, then proceed to Step 2 below to complete the procedure.

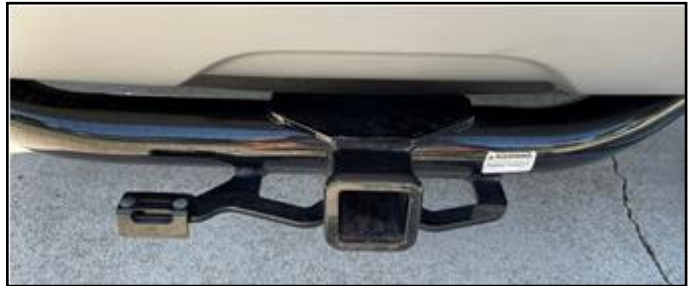
- 1C. If the vehicle is equipped with a Genuine Hyundai Accessory trailer tow hitch, but there is no visible wire harness installed, then proceed to Step 2 to complete the procedure.

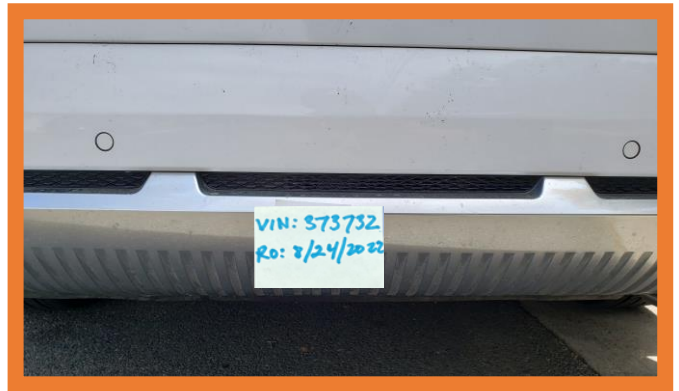
Example to the right is a picture of a vehicle not equipped with the Genuine Hyundai Accessory trailer tow hitch.

2. Write the last six digits of the VIN and date of repair onto a piece of paper and place it near the center of the rear bumper.

**Using STUI, take a picture of the rear center lower bumper. Upload the photo to STUI.**

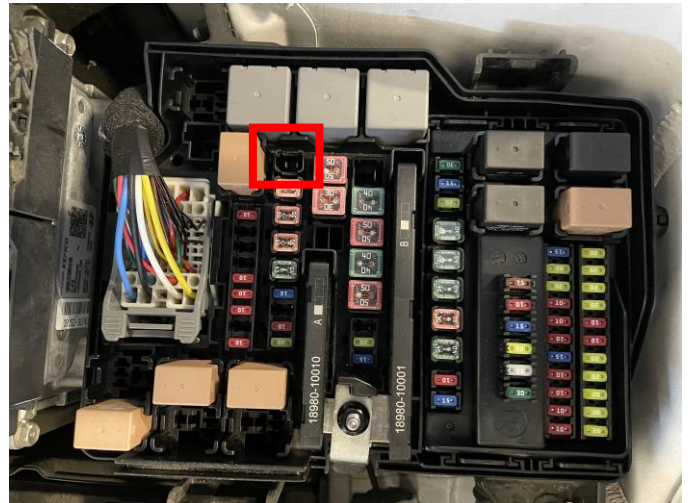
1. Align the vehicle to the vehicle lift position. Do not lift the vehicle.
2. Open the hood and remove the 40A trailer fuse inside the junction box.

If there is no 40A trailer fuse, it was previously removed during the campaign P31.

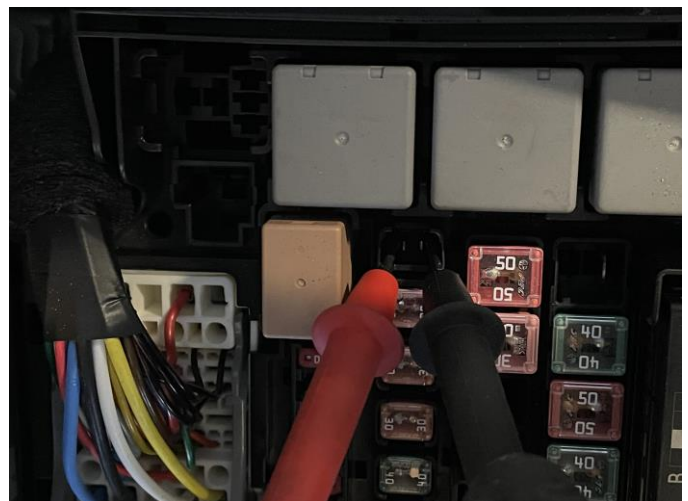
3. Measure both terminals where the fuse was with a multimeter probe.

Vehicle should be OFF, with key removed.

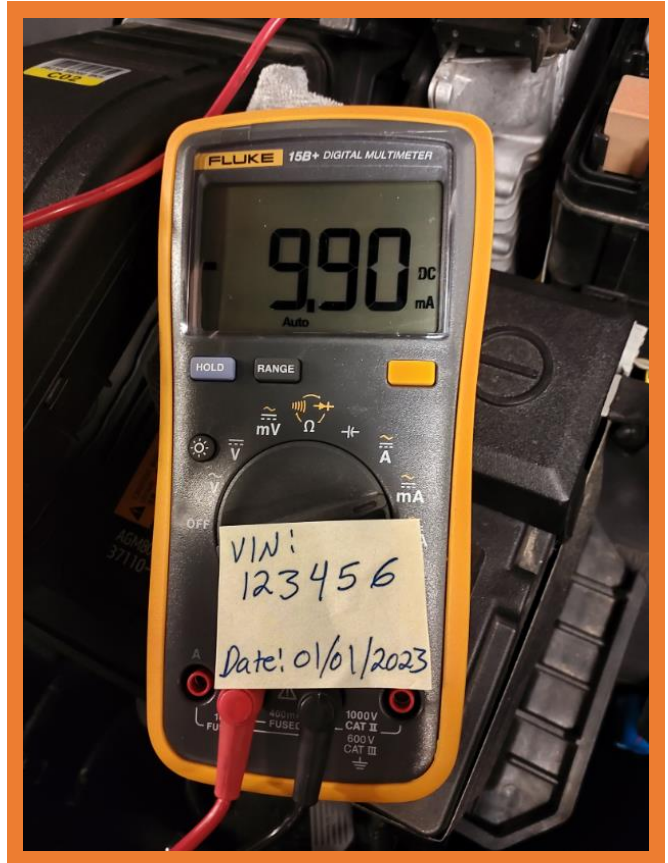
4. Check whether the multimeter is reading above or below 13mA.

**Using STUI, take a picture of the multimeter reading with the last 6 digits of the VIN and date of the repair on a piece of paper. Ensure picture is clear before taking. Upload the photo to STUI.**

If reading is **below 13mA**, proceed to step 5 to perform wire harness repair with extension wire kit, install an updated fuse, and fuse label.

If reading is **equal to or above 13mA**, the accessory harness assembly must be removed and replaced. An updated fuse must also be installed with a new fuse label.

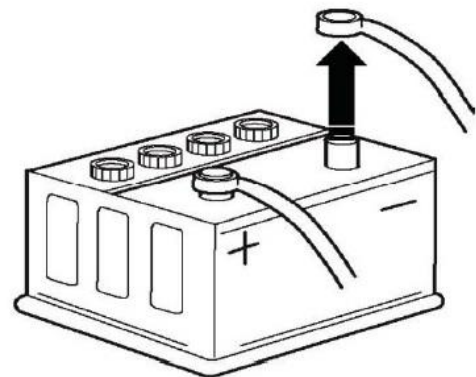
5. A) Record any pre-set radio stations, if applicable.
- B) Open the vehicle's hood.
- C) Remove the cap from the negative (-) battery cable, if applicable.
- D) Disconnect and isolate the vehicle's negative (-) battery cable.

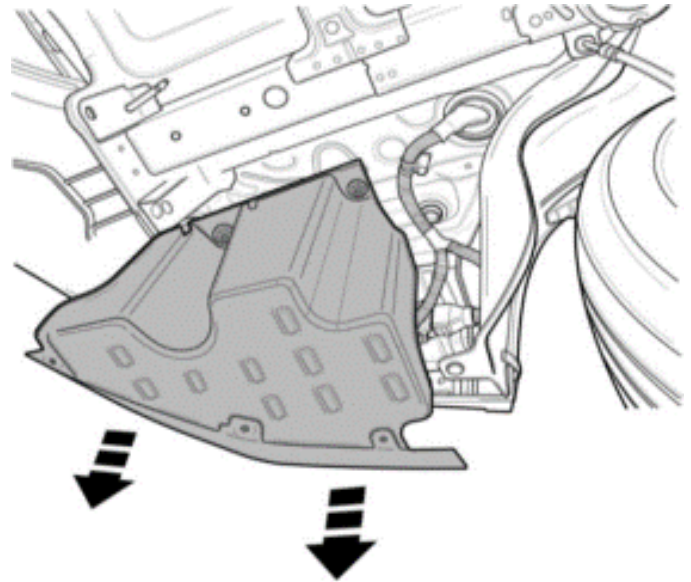
7. Remove rear bumper under cover.

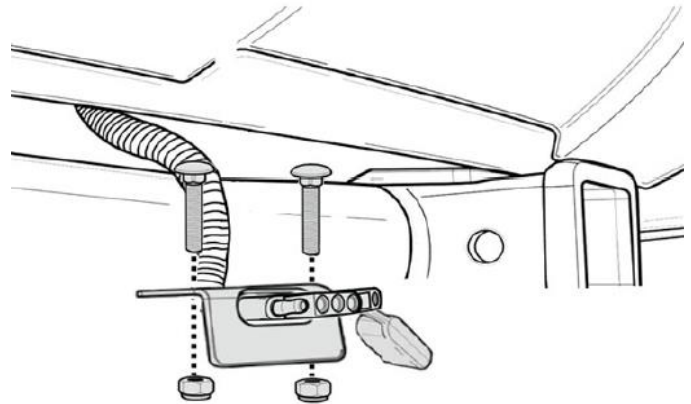
8. Release the 4-Pin connector fixing bolt.

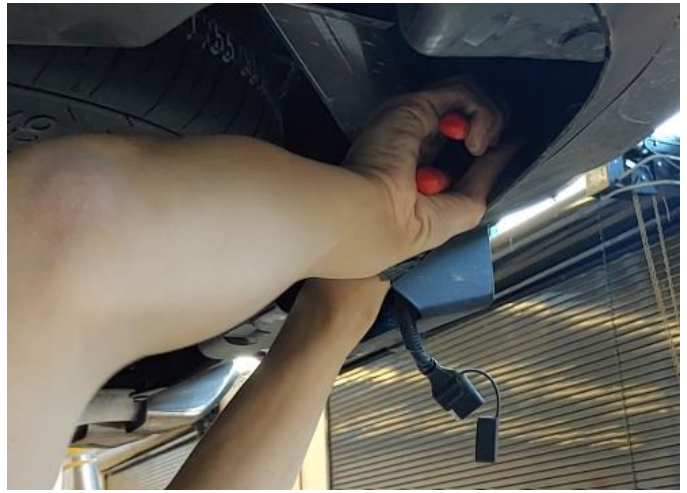
9. Cut one cable tie and separate the 4-Pin connector.

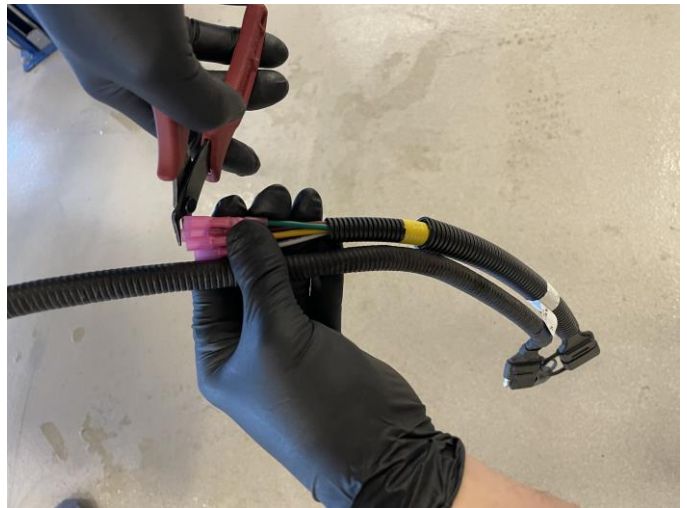
10. Pull out the 4-Pin connector to mark where to cut.

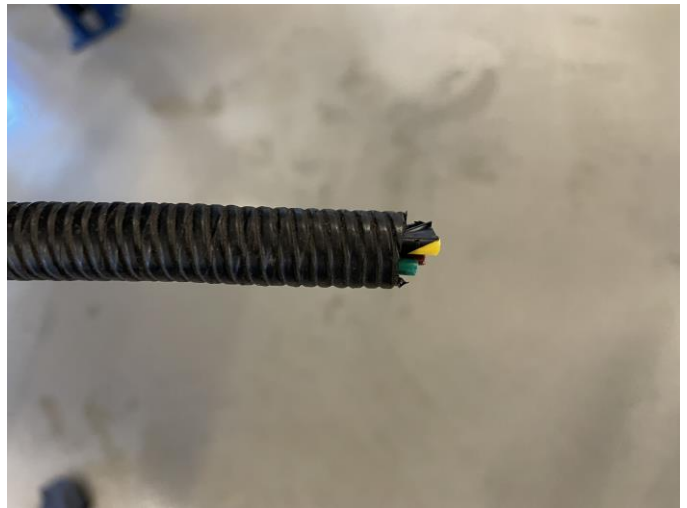
11. Cut the harness to match the length of the extension wire.

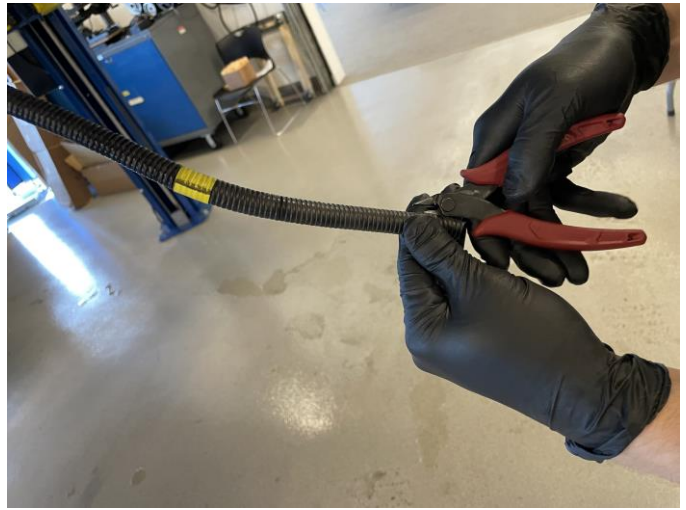
12. Cut off about 10 cm of the corrugated tube and pull out the wires.

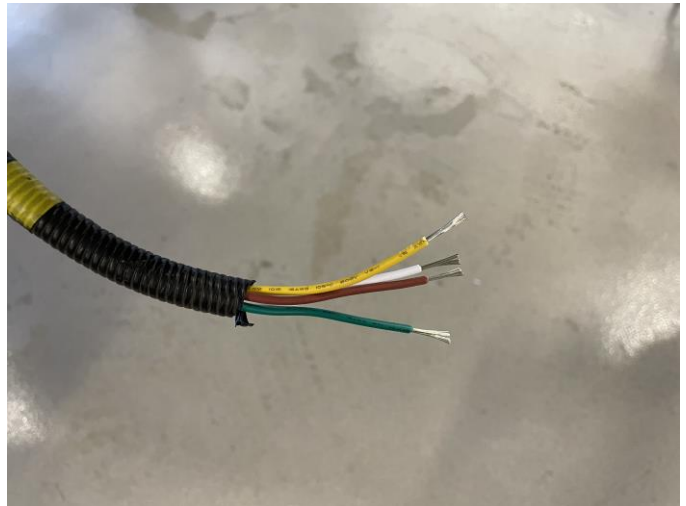
13. Strip the sheath of the wires. Expose 8-10mm of the wiring.

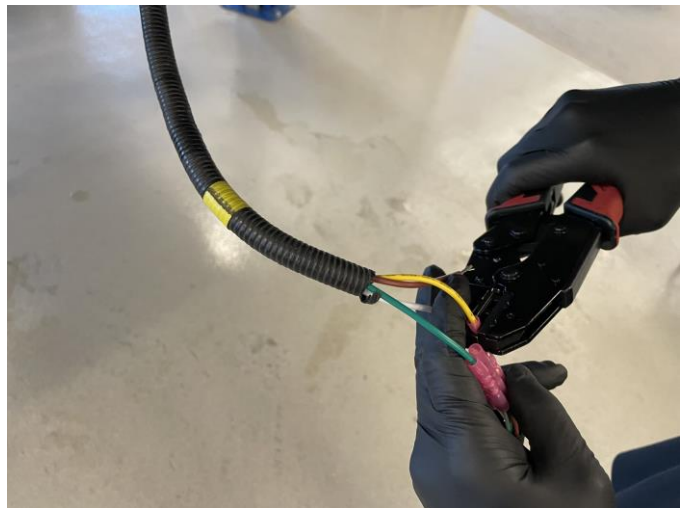
14. Match the wires by color and crimp them.

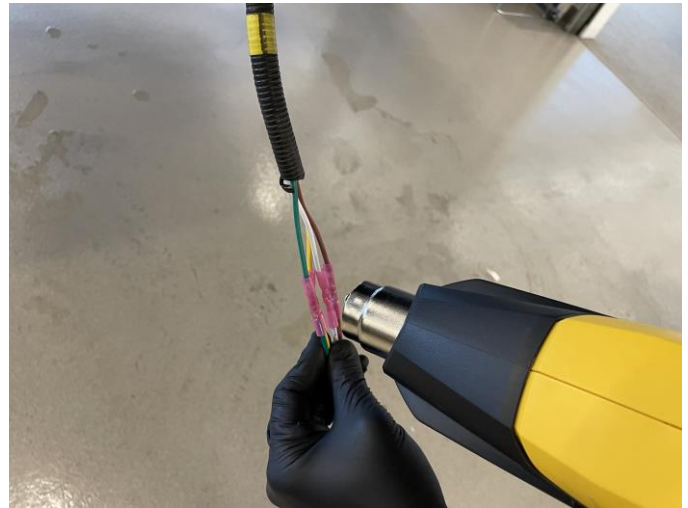
15. Blow hot air onto the butt splice / quick connector until it shrinks. (350°C/650°F).

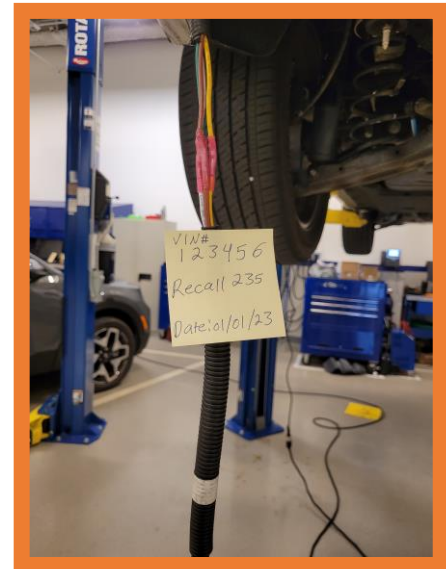
Using STUI, take a picture of the wire spliced with the last 6 digits of the VIN and date of the repair on a piece of paper. Upload the photo to STUI.

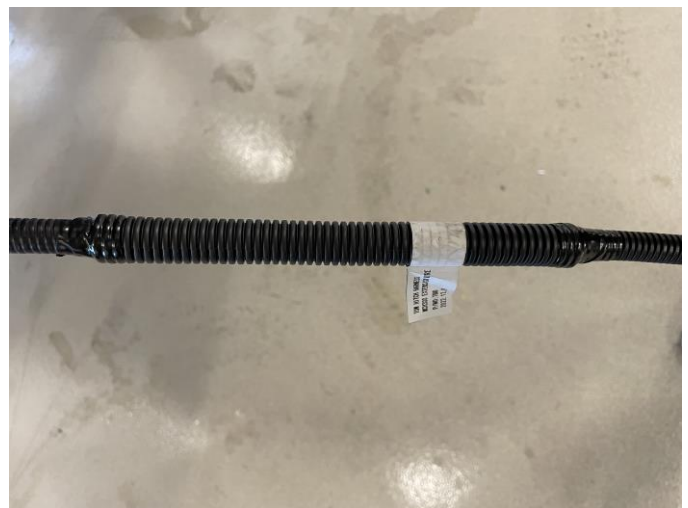
17. Raise the corrugated tube up to the mark and seal both ends with electrical tape.

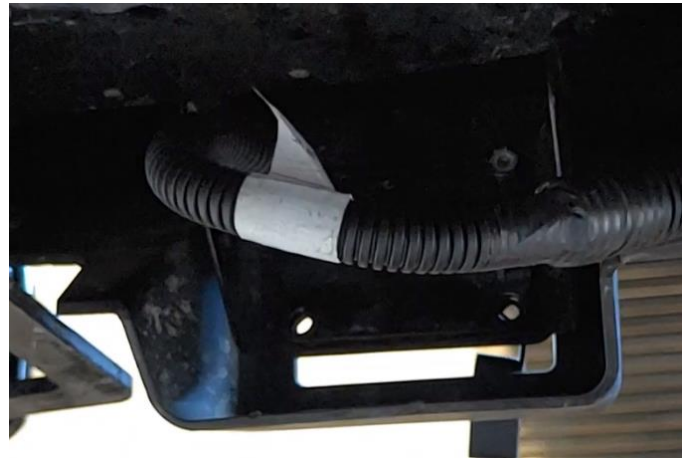
18. Insert the 4-Pin connector into the bracket and tighten the bracket bolts.

**4-Pin connector tightening nut:**

7.8 – 9.8 Nm (0.8 – 1.0 kgf.m, 5.2 – 8.7 lb-ft)

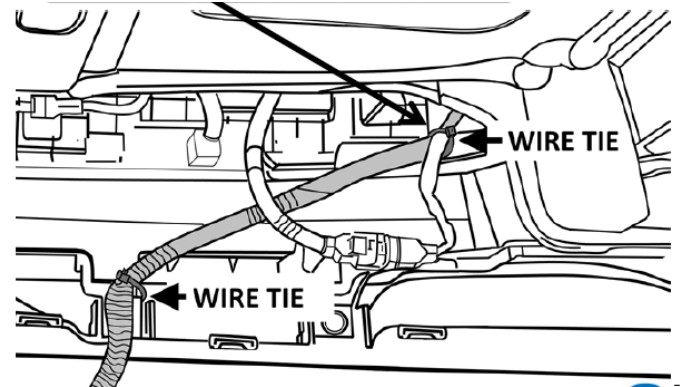
19. Fasten and secure harness with cable ties.

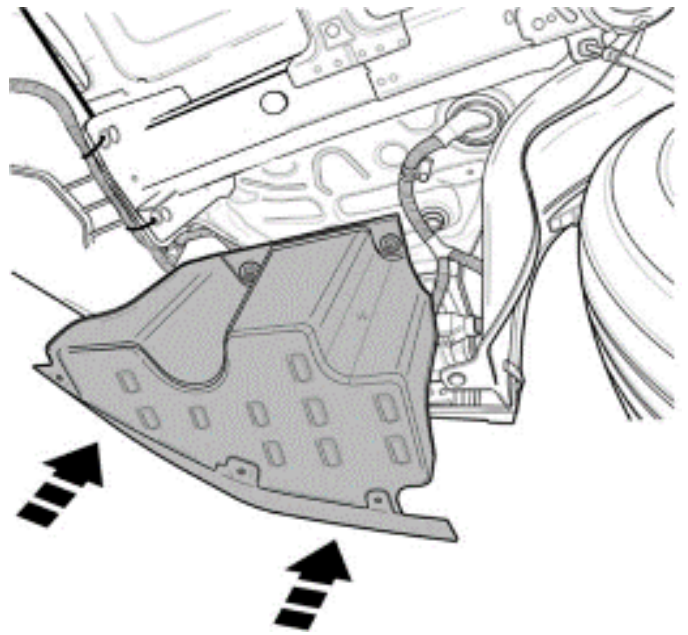
20. Reinstall rear bumper under cover.

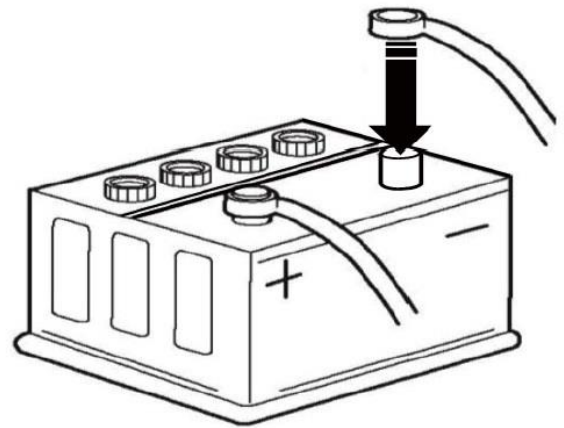
22. A) Reconnect the vehicle's negative (-) battery cable.

**Torque to:**  
**5.0 ~ 6.0 Nm (0.5 ~ 0.6 kgf.m, 45 ~ 52 lb-in).**

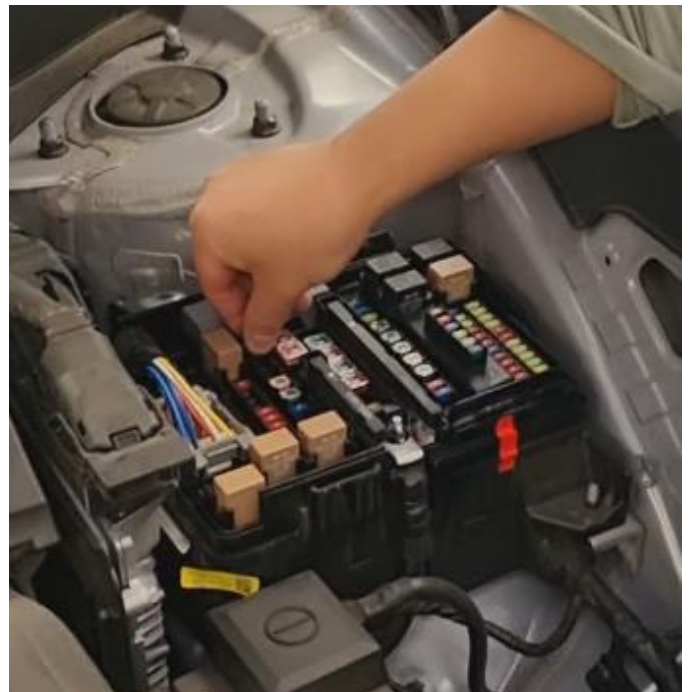
23. Replace the trailer fuse (same as step 2 on page 7) and attach the 15A sticker to the junction box cover.

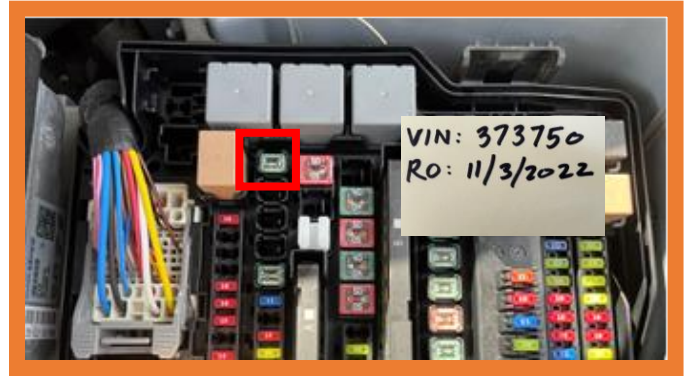
24. Write the last six digits of the VIN and date of repair onto a piece of paper and place it near the replaced 15A fuse in the engine fuse box.

**Using STUI, take a picture of the engine fuse box with the last 6 digits of the VIN and date of the repair on a piece of paper. Ensure picture is clear before taking. Upload the photo to STUI.**

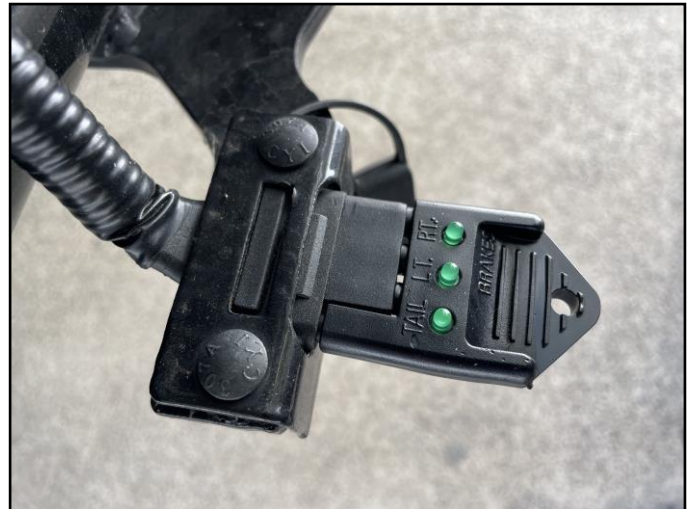
25. Connect the 4 pins mini-tester to the trailer hitch 4 pins connector.

A second person is required to confirm the 4 pins mini-tester validation.

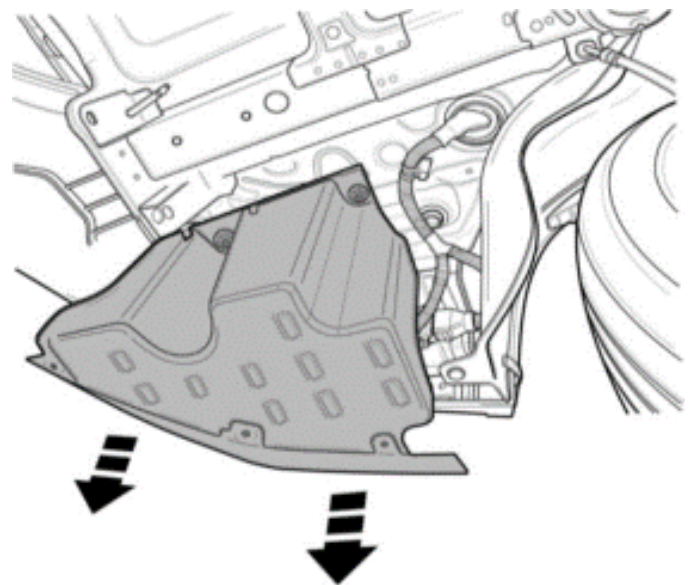
3. Remove rear bumper under cover.

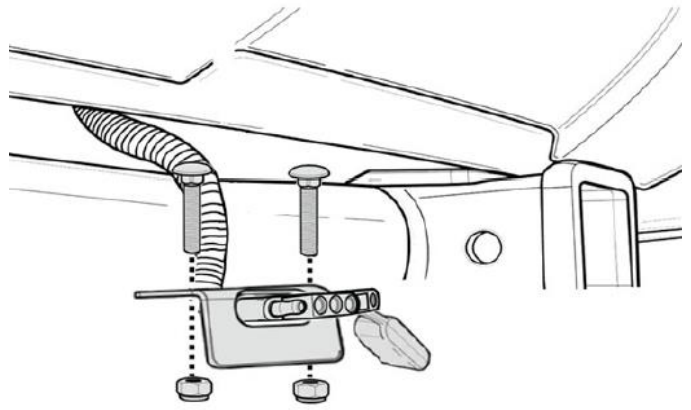
4. Release the 4-pin connector fixing bolt.

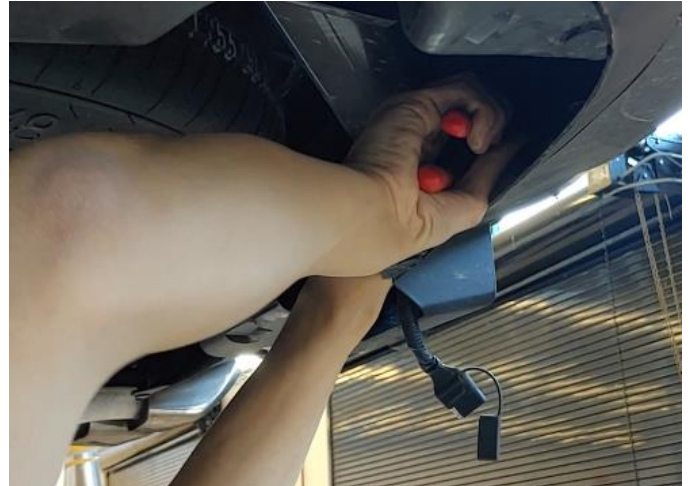
5. Cut one cable tie and separate the 4-Pin connector.

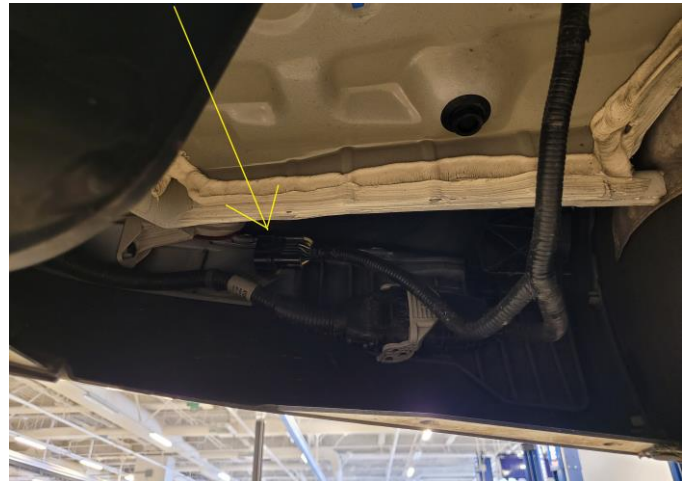
6. Locate the factory 12-Pin harness connector on the driver's side rear quarter panel area.

NOTE: Disconnect and remove the original 12-pin harness with connector from the vehicle factory connector.

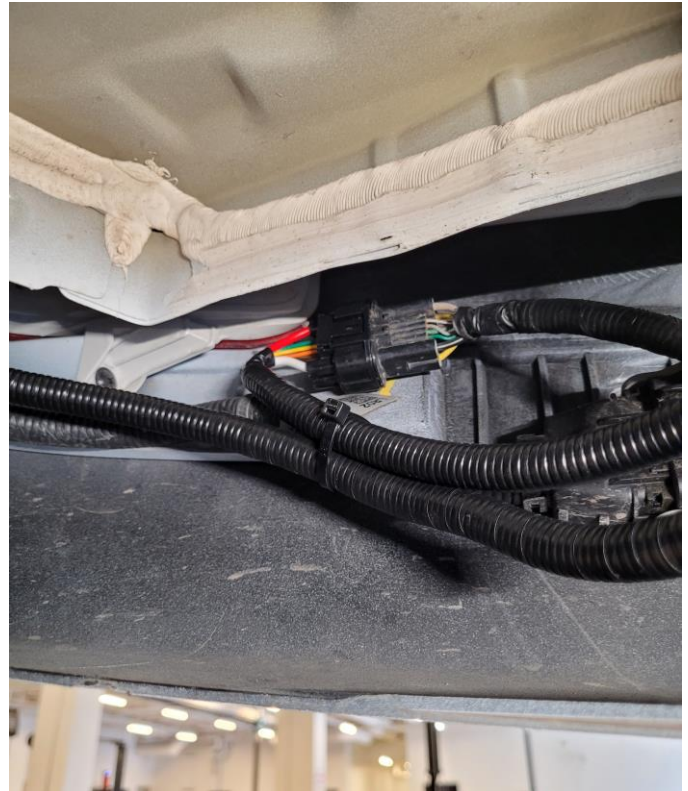
7. Connect the new tow hitch harness 12-Pin connector to the vehicle factory connector.

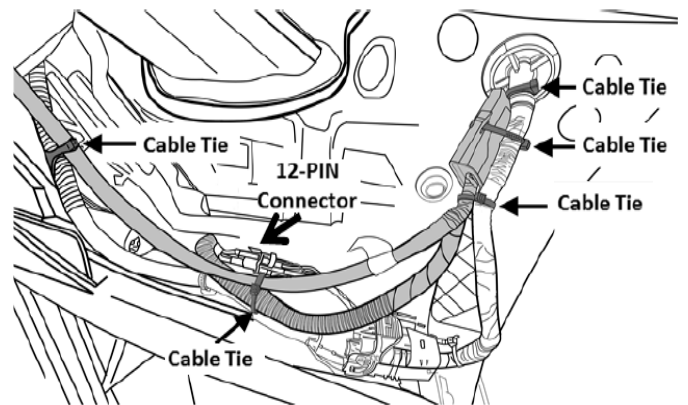
8. Secure the module to the vehicle factory harness, as shown, by passing one (1) cable tie through the side tabs of the module, one (1) cable tie through the hole at the end of the module and one (1) cable tie at the base of the module. Trim excess cable tie material.

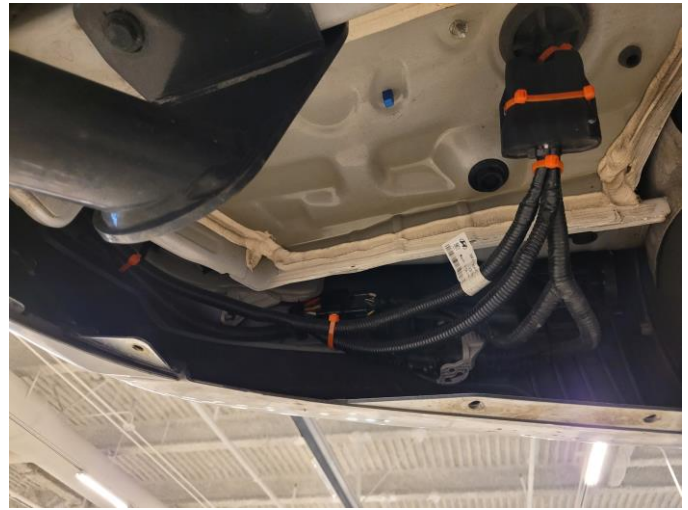
9. Using two (2) cable ties, secure the Tow Hitch Harnesses to the vehicle factory harnesses, but do NOT fully tighten the cable ties at this time.

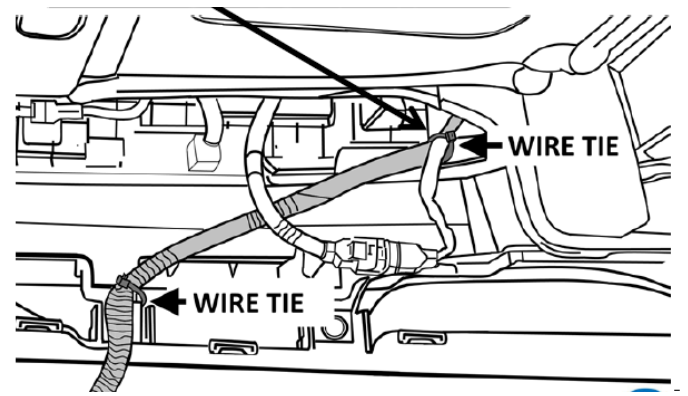
10. Route the Tow Hitch Harness over the bumper beam behind the rear bumper. Fasten and secure harness with (2) cable ties.

Take up any harness slack and tighten the two loose cable ties from step 9. Trim excess cable tie material.

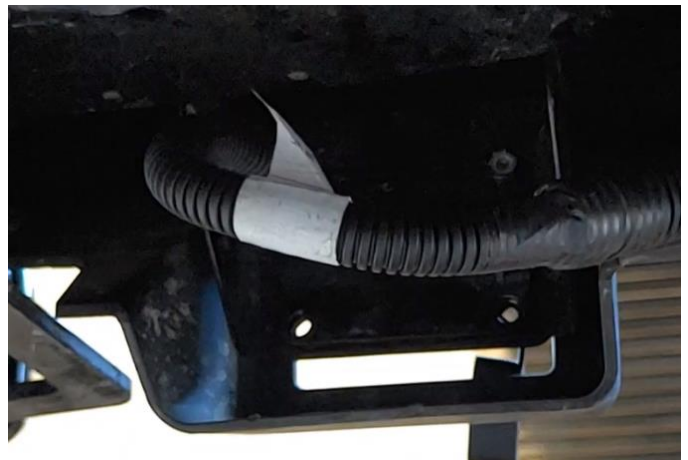
11. Insert the 4-Pin connector into the bracket and tighten the bracket bolts.

**4 pins connector tightening nut:  
7.8 – 9.8 Nm (0.8 – 1.0 kgf.m, 5.2 – 8.7 lb-ft)**

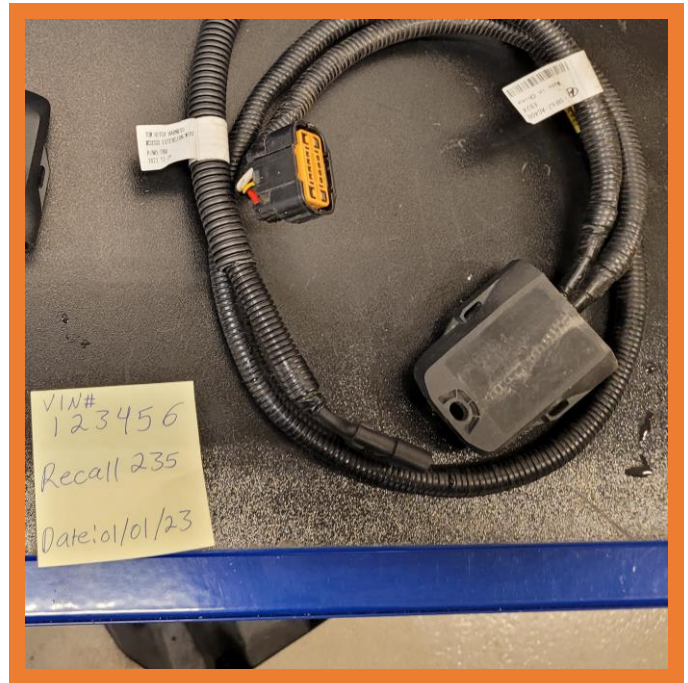
**Using STUI, take a picture of the removed harness with the last 6 digits of the VIN and date of the repair on a piece of paper. Ensure picture is clear before taking. Upload the photo to STUI.**
