# VOLUNTARY RECALL CAMPAIGN

Classification: RS22-011	Reference: NTB22-078	Date: September 7, 2022
-----------------------------	-------------------------	----------------------------

## VOLUNTARY SAFETY RECALL CAMPAIGN 2021-2022 ROGUE; REAR OUTBOARD SEAT BELT INSPECTION

**CAMPAIGN ID #:** PC915  
**APPLIED VEHICLES:** 2021-2022 Rogue (T33)

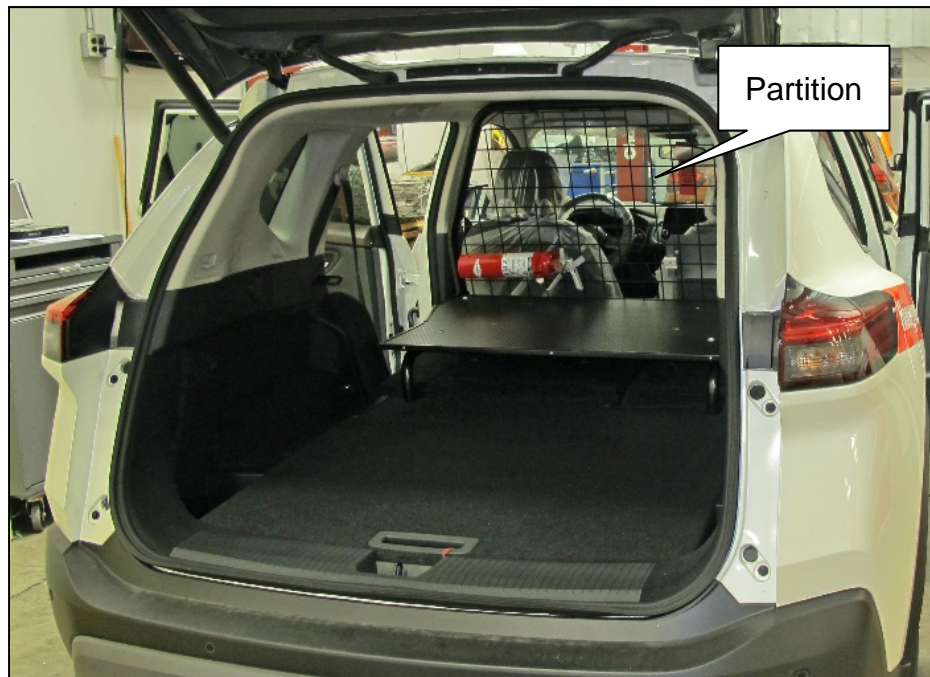
Figure 1

1. If the vehicle is equipped with a partition behind the front seats (Figure 1), skip to step 14 on page 7 to remove the partition. If the vehicle is NOT equipped with a partition, continue to step 2 on page 3

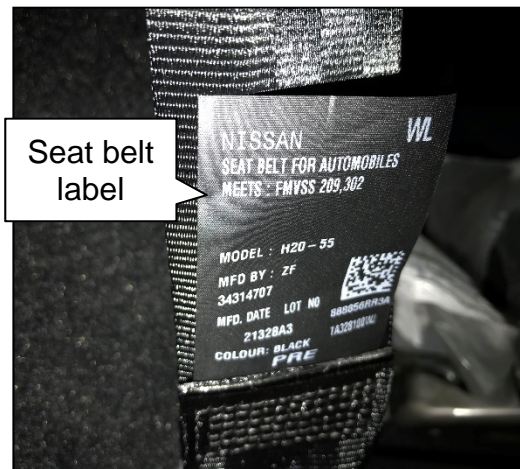
Figure 2

3. Position the Driver (LH) side rear outboard seat belt so that the seat belt label is viewable (Figure 2).

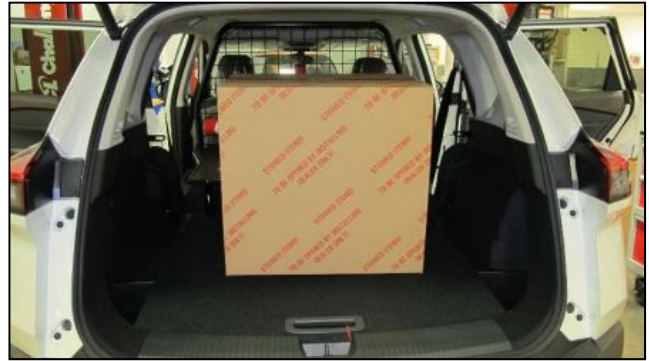
Figure 7

14. Open both rear doors and the back door.

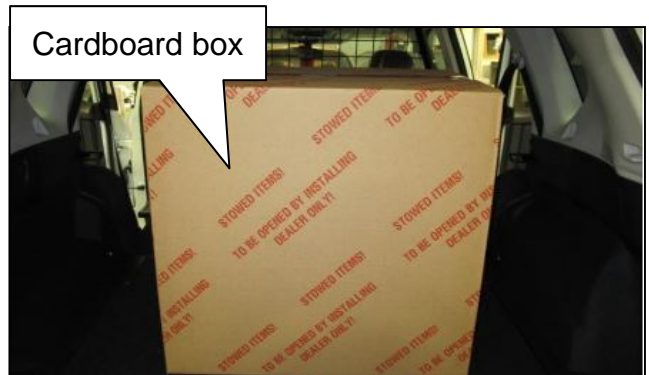
Figure 8

15. If present, remove the cardboard box labeled "STOWED ITEMS" (Figure 8).

**IMPORTANT:** Do not open the cardboard box, it has a tamper proof seal.

- Secure the cardboard box in a safe place, it will be placed back in the vehicle.

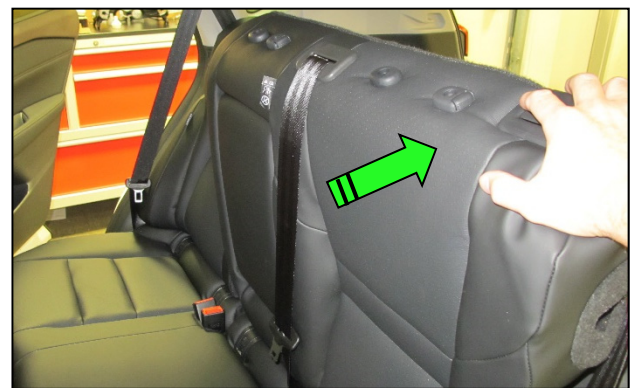
Figure 14

20. Move both second row seat backs to the full upright position.

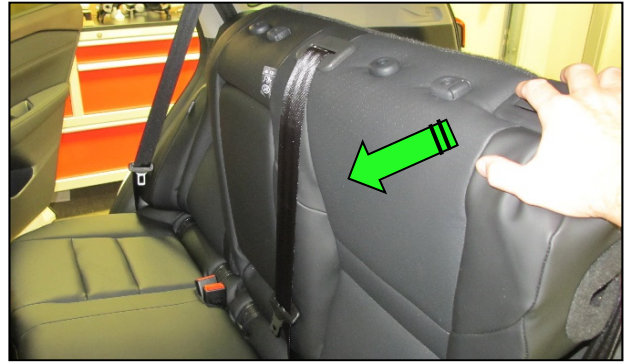
Figure 15

22. Fold both second row seat backs to the fully down position.

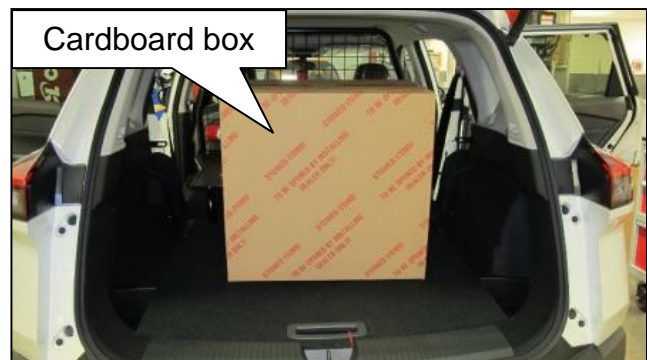
Figure 21

27. If applicable, place the cardboard box labeled "STOWED ITEMS" into the rear cargo area.

**IMPORTANT:** Do not open the cardboard box, it has a tamper proof seal.

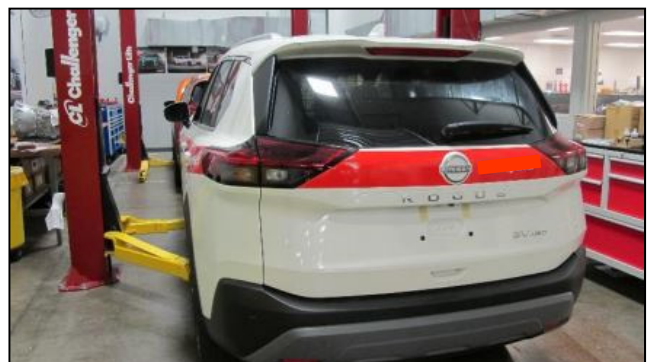
Figure 22

28. Close both rear doors and the back door.
29. Remove the vehicle from the lift.
