AFFECTED MODEL: All Front Hose Reel Mounted Vacall AllJetVac and AllJetVac Recyclers
Manufactured September 10, 2019 through June 30, 2022

SUBJECT: Hose Reel Tilt Cylinder P/N 2130120013

RECALL NUMBER: 22V-669

SERVICE PROCEDURE FOR RECALL 22V-669

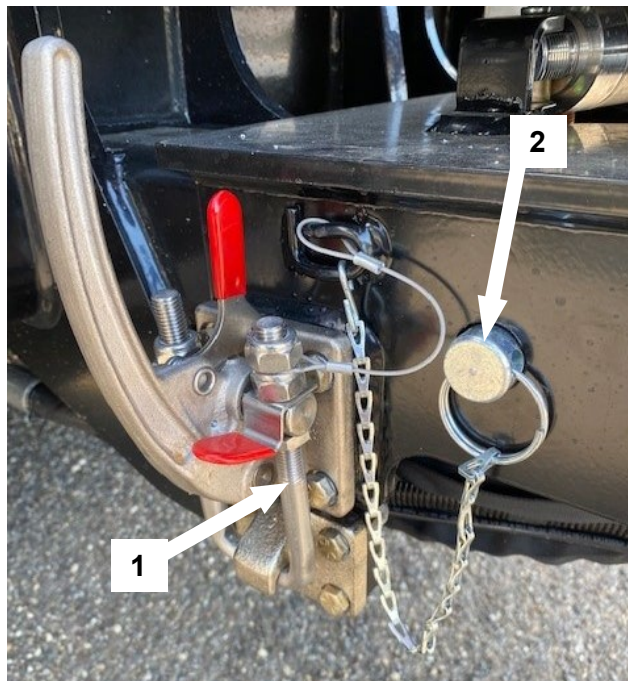
1. Park the vehicle on a flat level surface. Ensure the hose reel clamps (1) are engaged and pins (2) are installed on both sides of the hose reel. If the hose reel clamps are not engaged and the pins are not installed do not attempt to replace the clevis. To latch the hose reel clamps and/or install the pins, the hose reel may need to be raised up using either the engine and hydraulic system or the emergency power pack on the truck.

2. After verifying the hose reel clamps are engaged and pins are installed, chock the wheels, and lock out and tag out the vehicle.
3. Support the front of the hose reel with either a crane, jack stand, or blocks of wood to prevent the hose reel from pivoting downward when removing and replacing the cylinder clevis.
4. After ensuring the hose reel is properly supported, loosen the hydraulic hose on the barrel end of the cylinder to bleed off any pressure. Catch any hydraulic oil that runs out of the connection using an appropriate container. It's not necessary to completely remove the hose from the cylinder.
5. Remove the cotter pin and pin from the rod end of the cylinder.

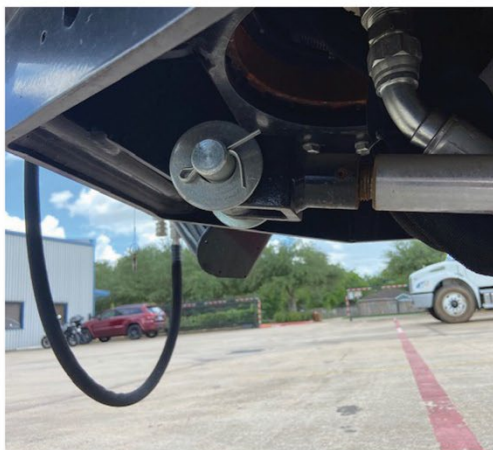
The hose reel tilt cylinder is equipped with a clevis that is threaded onto the rod end of the cylinder for adjustment purposes. On certain vehicles the hose reel tilt cylinder clevis may not have adequate thread engagement onto the cylinder rod. As a result, damage to the clevis and/or cylinder rod threads may occur during travel and normal jetting operations.

Image showing original
clevis installed

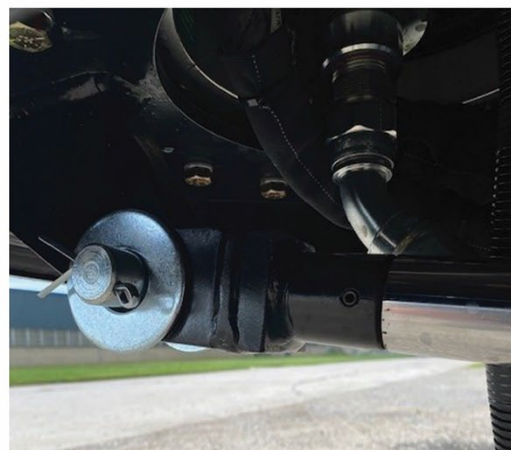
Image showing updated
clevis installed

6. Hinge the cylinder downward. Remove the clevis from the cylinder rod by first removing the set screw on the threaded part of the clevis.
7. Inspect the threads on the rod end of the cylinder for damage. If the threads on the cylinder rod are damaged a new cylinder must be installed. If the threads are not damaged, install an updated clevis (P/N VA0000S6257) by threading the clevis completely onto the cylinder rod and securing the set screw.

8. Reinstall the cylinder. It will be necessary to use a prybar to collapse the cylinder about $\frac{3}{4}$ " before installing the pin, washer, and cotter pin to secure the cylinder.
