**PREVOST**

**SAFETY  
RECALL**

**SR22-13**

| SUBJECT: | DRIVER SEAT REPLACEMENT WITH RECARO 3-POINT BELT DRIVER SEAT | |

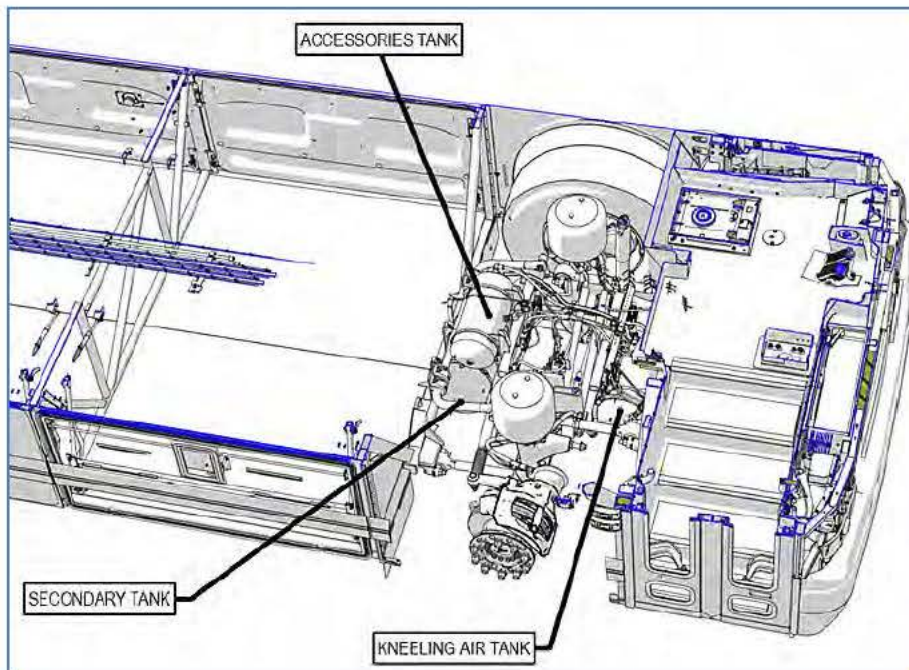
Figure 1

2. Drain the air from the Accessories tank. This tank is found above the secondary air tank. It is provided with a bottom drain valve.

3. Close the drain valve once done.

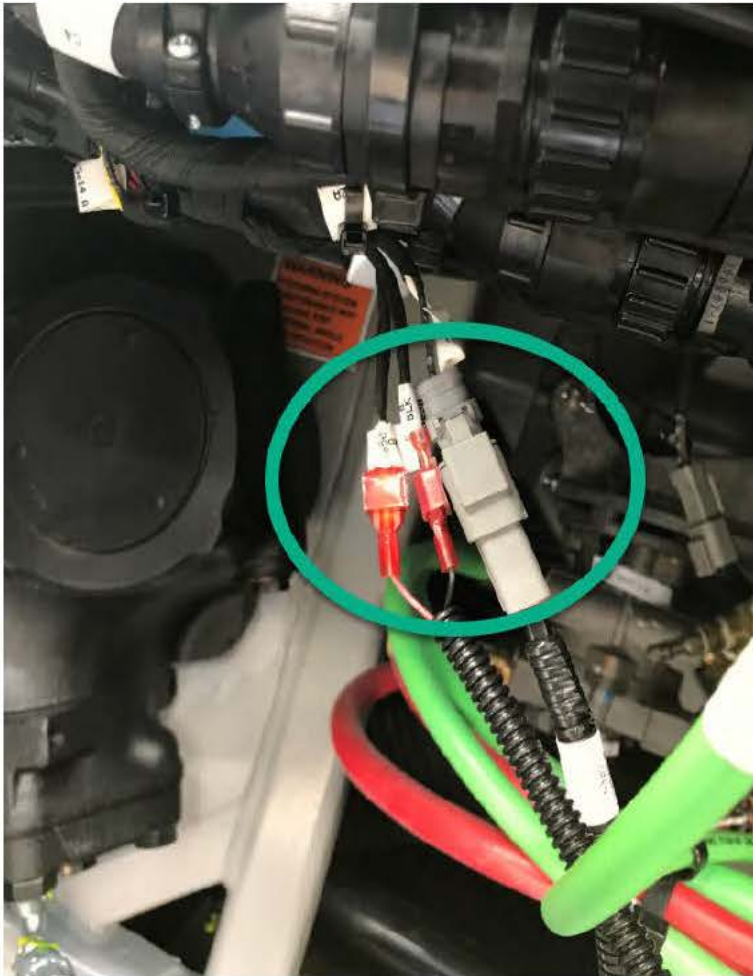
Figure 2

4. In the front service compartment, disconnect the driver seat harness.

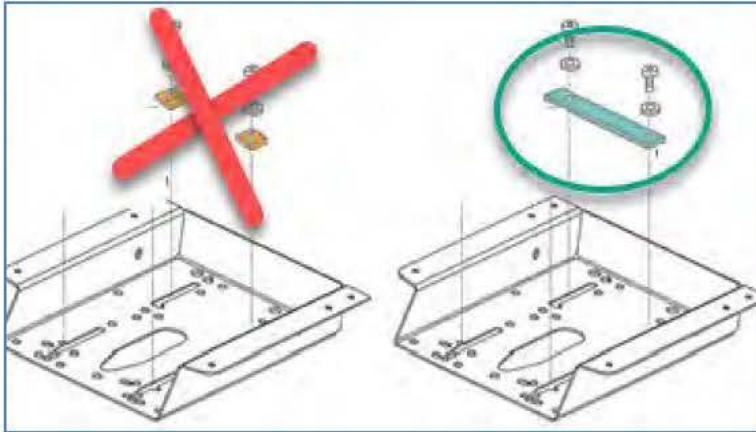
Figure 5

8. Replace the 2 backplates securing the riser with the long bar supplied with the new seat.

***Torque to 38 lb-ft***

***apply torque seal marks***

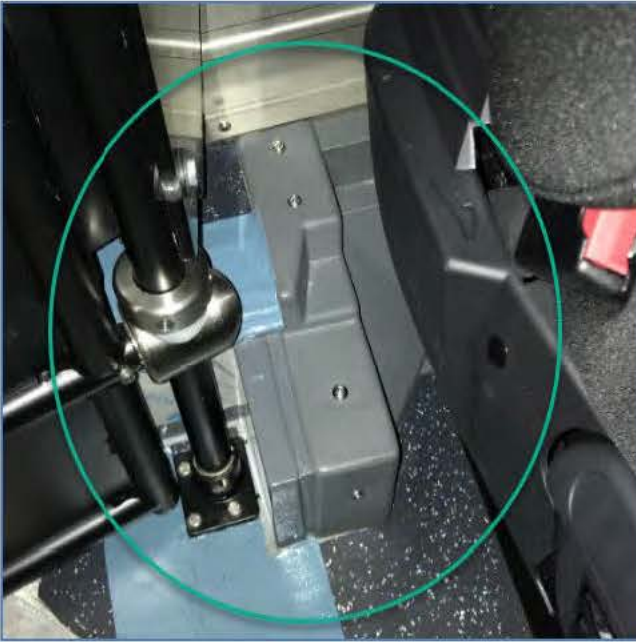
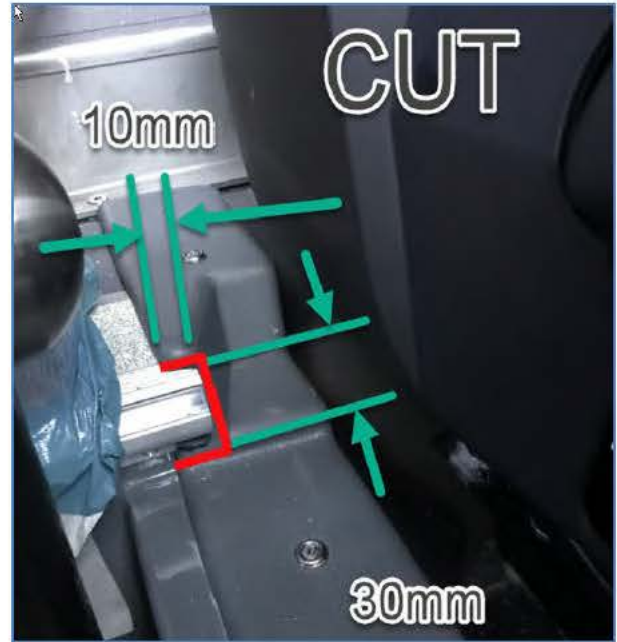
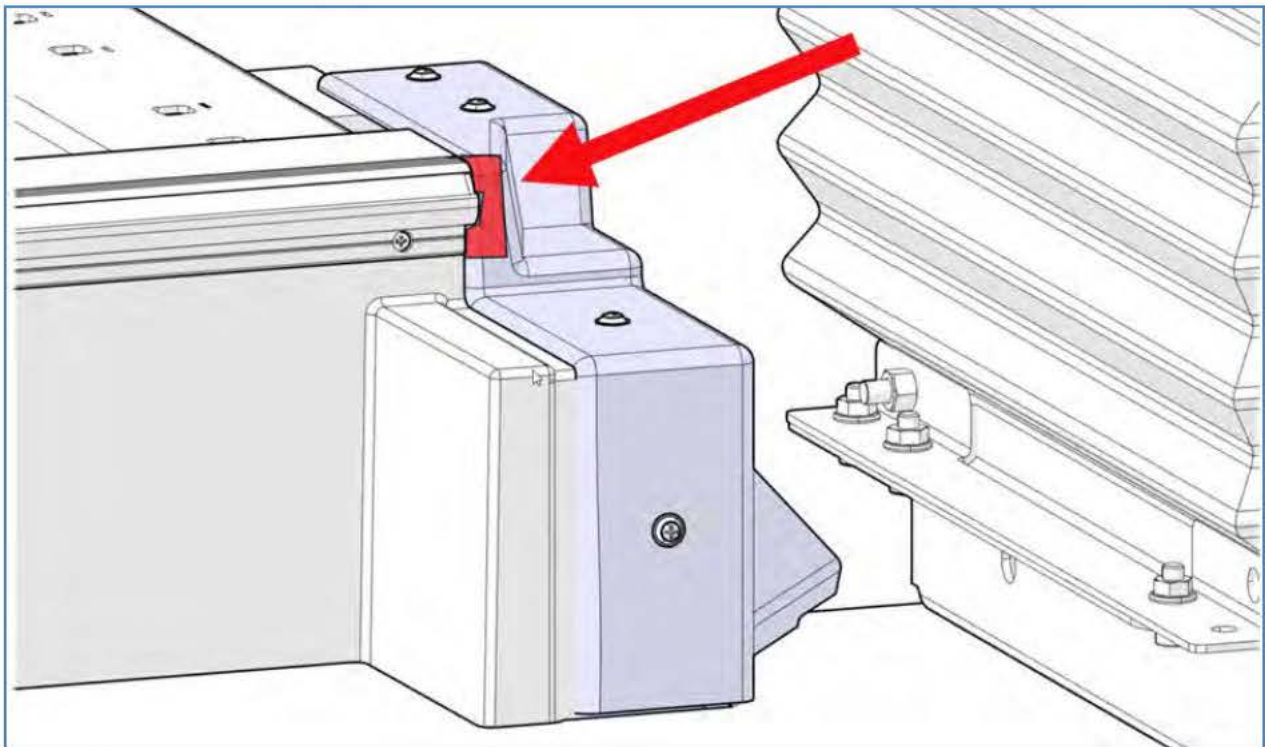
9. Remove the aisle stairs cover and cut a part of it as shown.

Dimensions to cut: about 10 mm X 30 mm

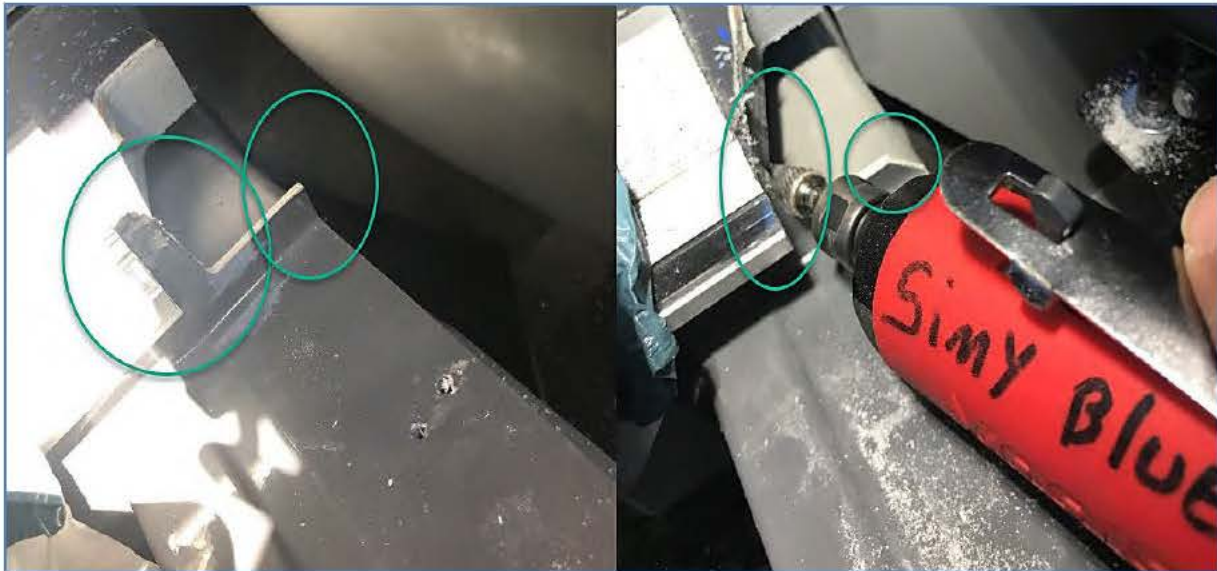
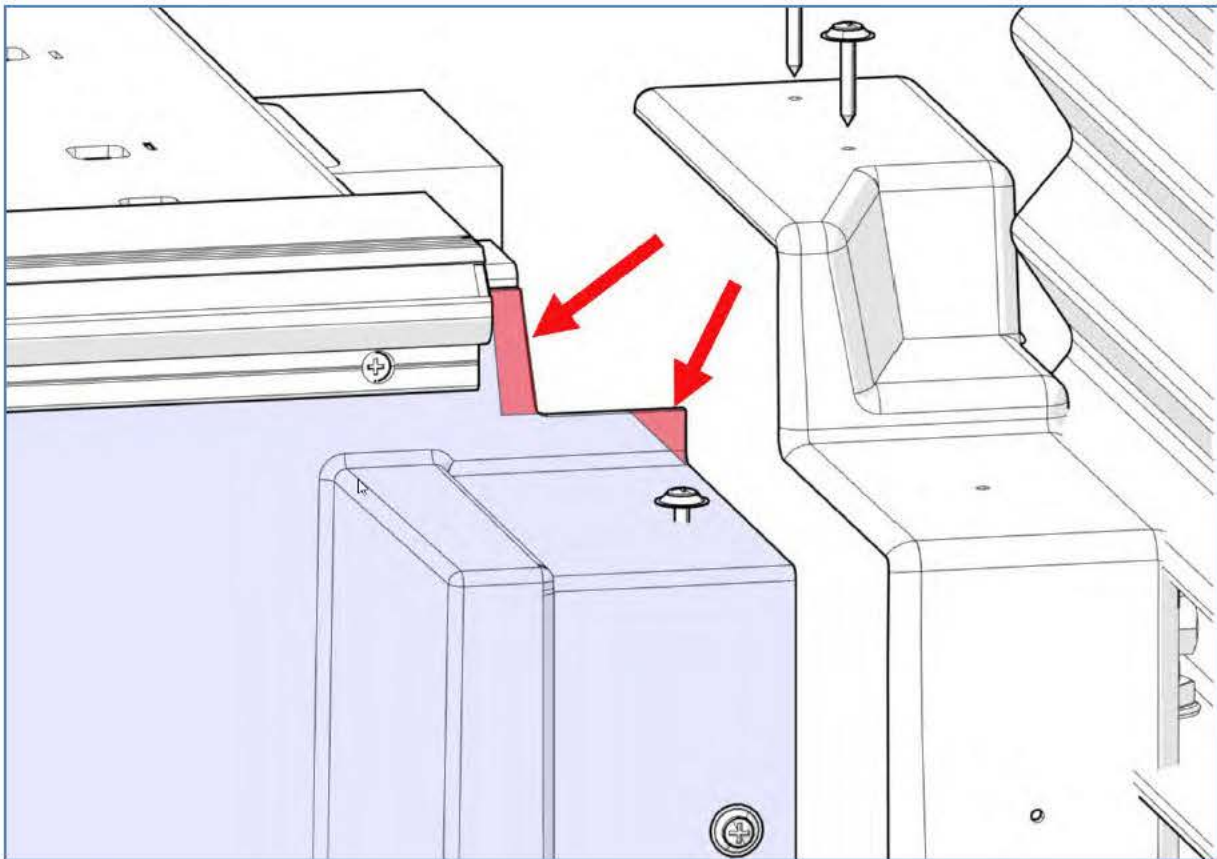
10. Cut fiberglass on the stairs as shown. The goal is to reinstall the cover as far as possible towards the entrance door so to leave a greater clearance between the seat and the cover.

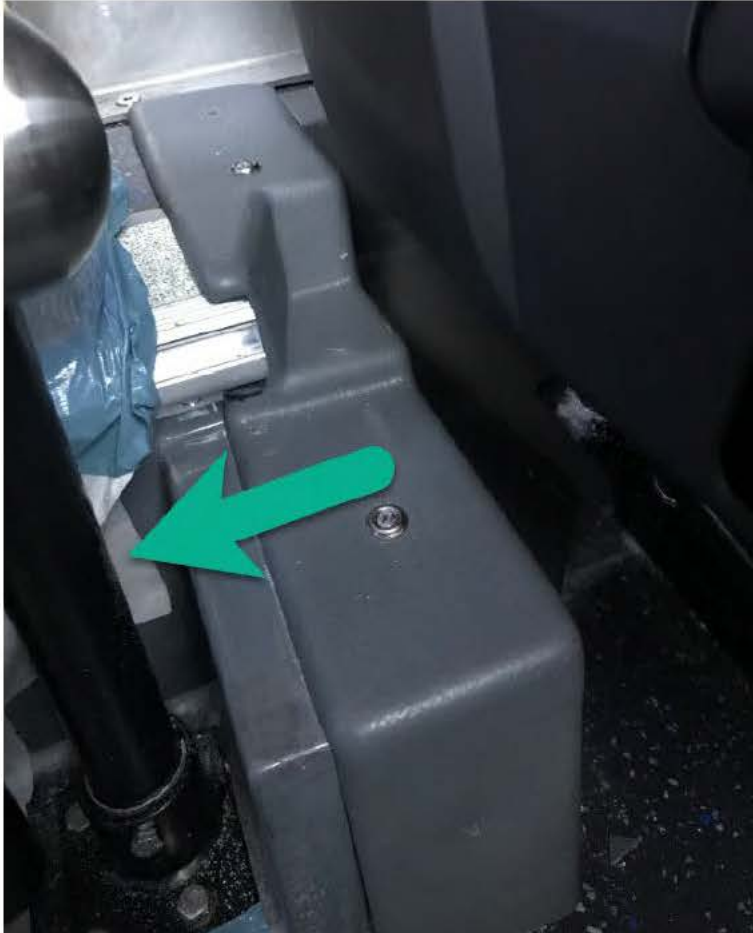
Figure 11

11. Reinstall the cover as far as possible towards the entrance door. Take note that the cover is now over the step and lean on the edge of the aluminum molding.

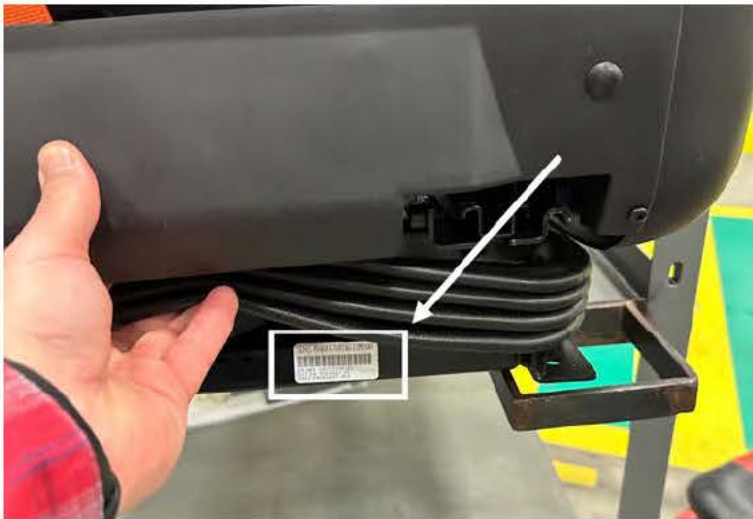
Figure 12: SERIAL NUMBER LOCATION

12. Record the serial number of the new seat and the VIN of the vehicle in which it is installed.

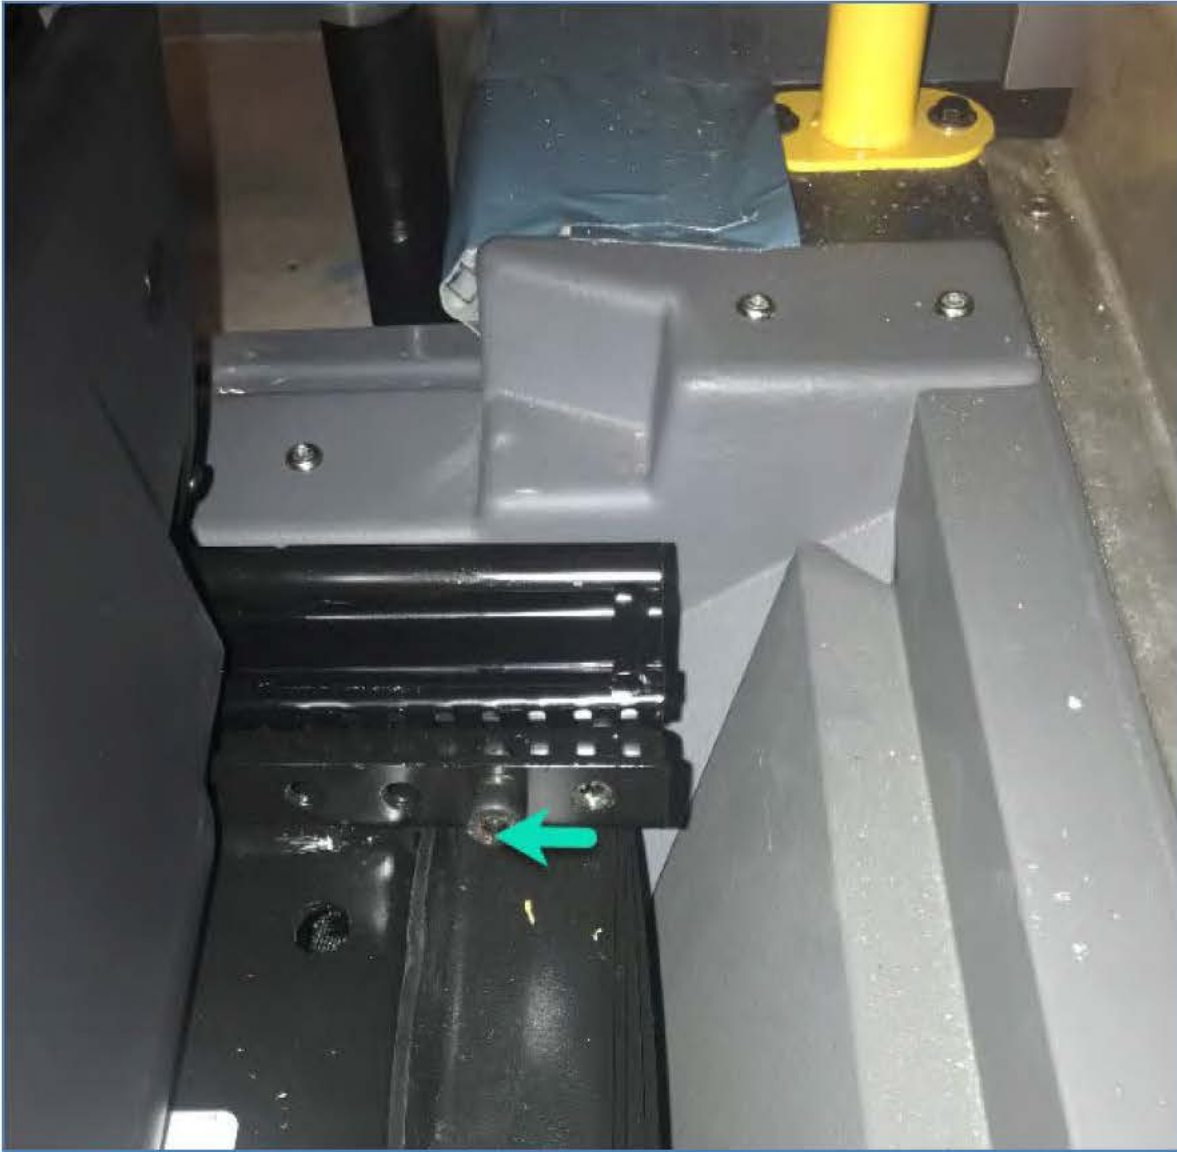
Figure 13

13. Before moving the new seat in the vehicle, relocate the stopper screw to the second hole (right rail, curb side, at the back of the seat).

***Torque to 8 lb-ft***

***Apply torque seal marks if applicable***

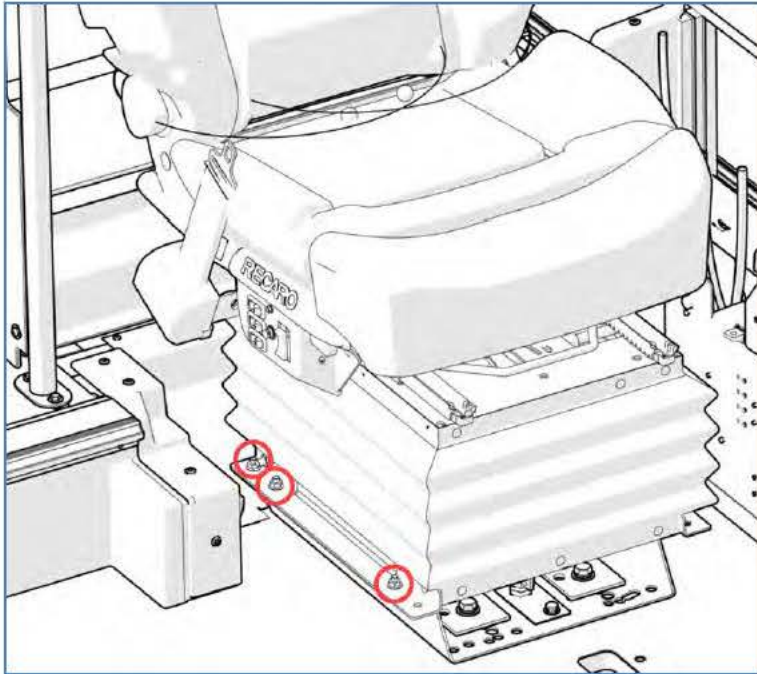
Figure 14

14. With the help of an assistant, install the new seat on the riser with the 6 screws previously removed. For aesthetic consideration, apply torque seal marks only if torque seal marks were present on the previous installation.

***Torque to 16.5 lb-ft***

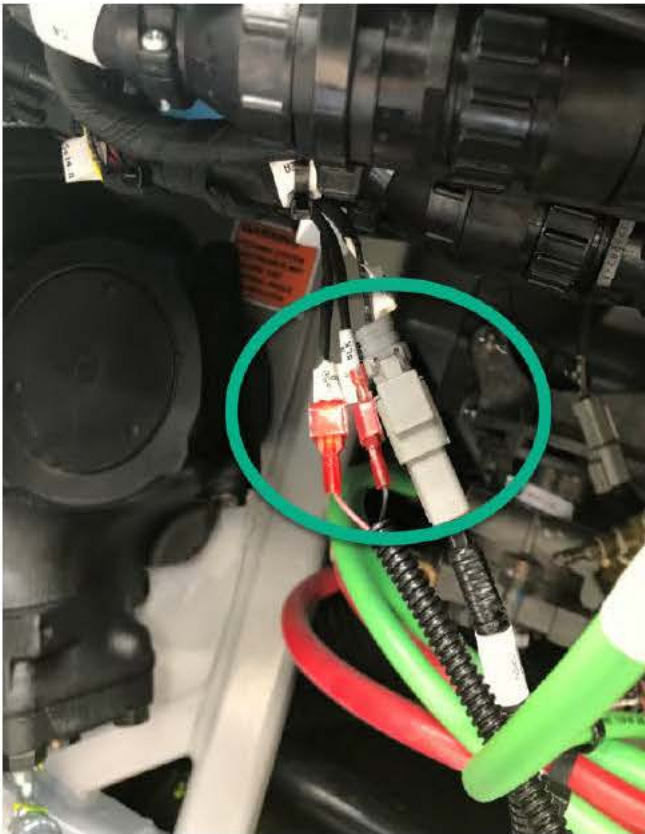
Figure 16

16. In the front service compartment, connect the driver seat harness, red, black and Open.
