Safety Recall

Code: 19Q8

Subject Radiator and Coolant Hose

Release Date November 08, 2022

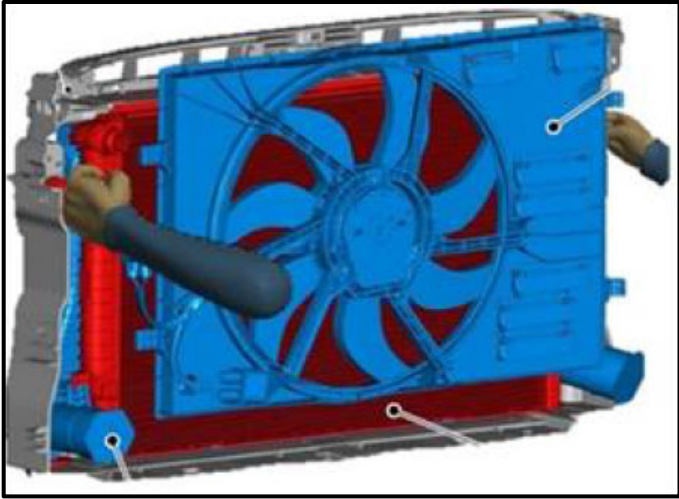
Repair Overview

- Inspect radiator mounting.
- If necessary, inspect lower radiator coolant hose and ribbed belt.

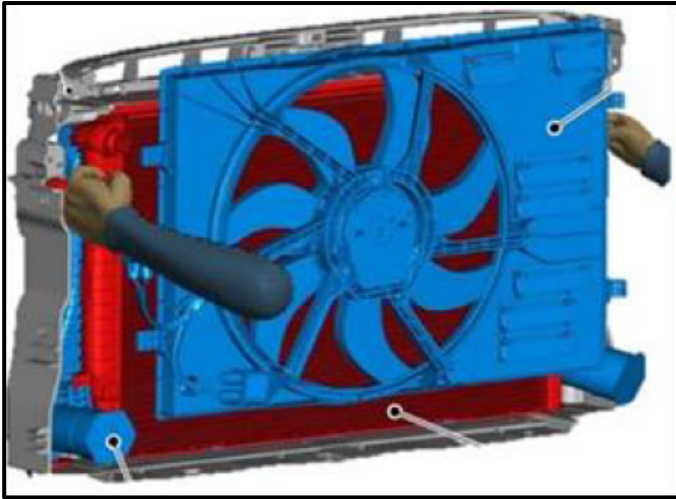
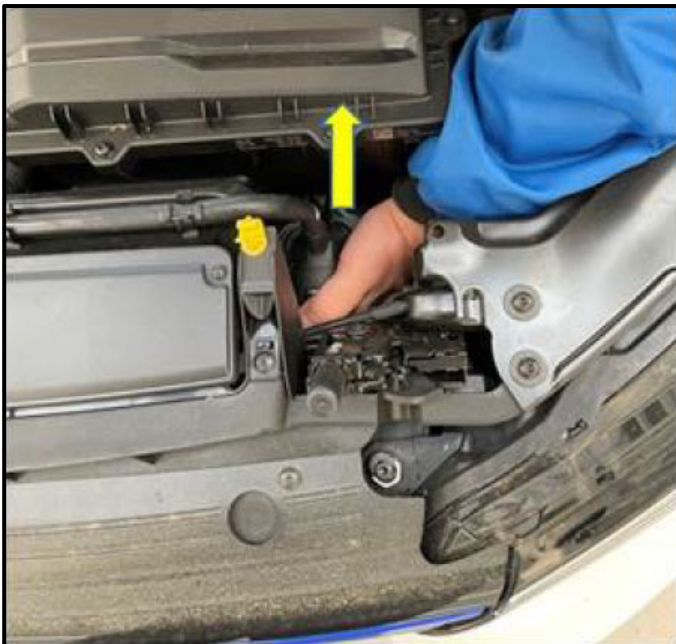
Inspecting radiator mounting:

- Grab behind the radiator by hand in direction of travel. Pull radiator to the rear of the vehicle and then forward again.
- If the radiator is mounted correctly:
 - No further work required.
 - Proceed to Section E.
- If the radiator is not mounted correctly:
 - The radiator must be secured correctly.
 - The lower radiator hose and ribbed belt must be checked for damage.
 - Proceed to Section C.

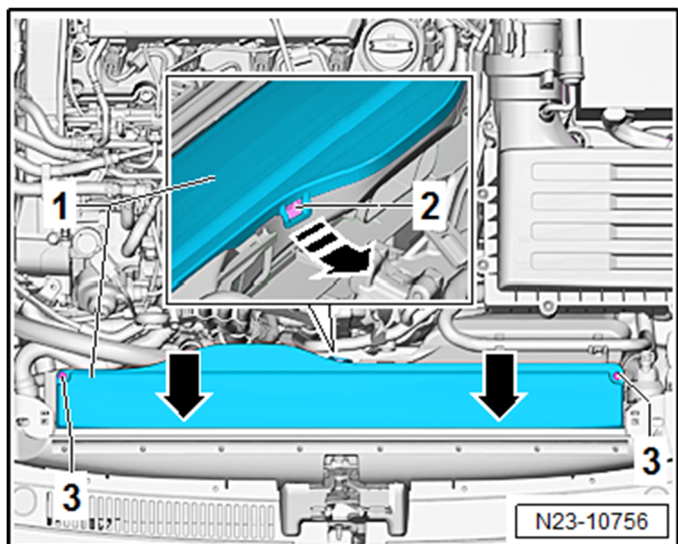
Remove air duct on lock carrier:

- See ELSA Repair Manual: *Repair manual > Engine > 4-Cylinder Direct Injection 2.0L 4V TSI Engine (EA 888evo4) > 24 Multiport Fuel Injection > Air Filter > Air Duct on Lock Carrier, Removing and Installing*

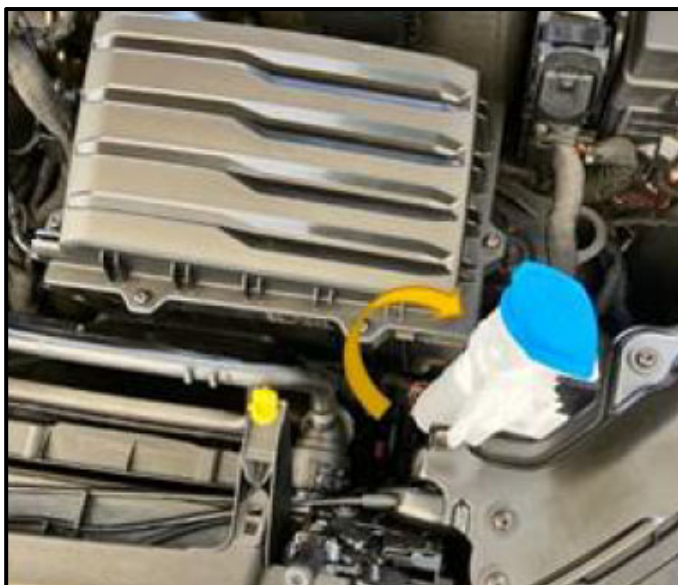
Unclip washer fluid filler neck:

- Unclip washer fluid filler neck and move to the side, as shown.

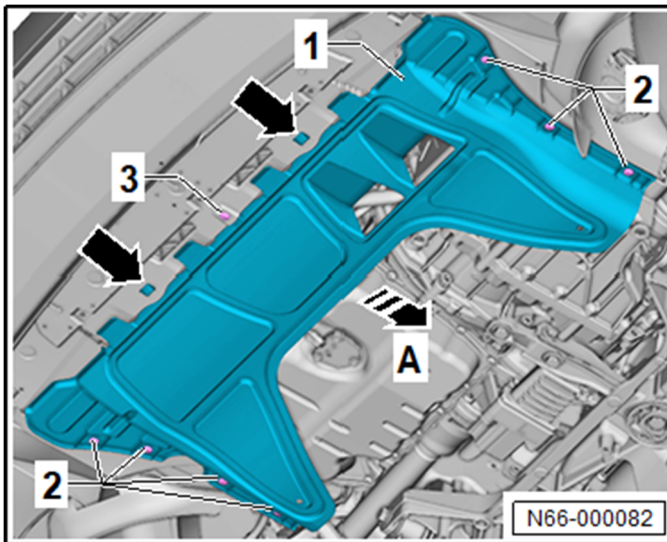
Remove noise insulation:

- Remove the bolts <2 and 3>.
- Release the retainers <arrows>.
- Remove the noise insulation <1> in direction of <arrow A>.

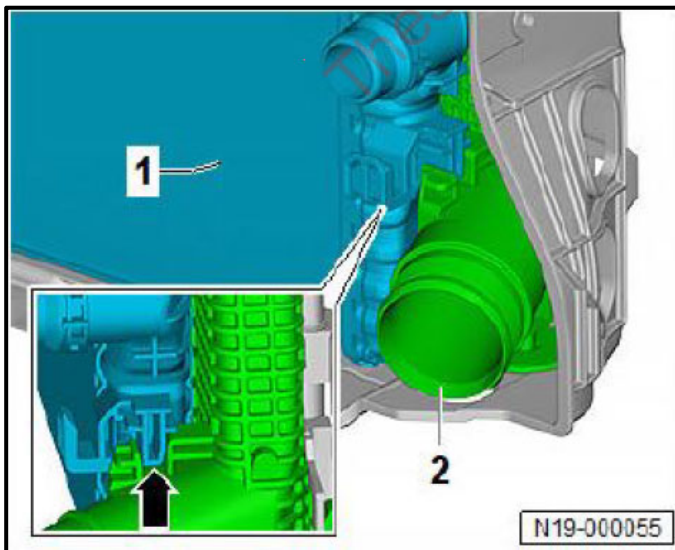
Check installation of radiator:

- Both sides of the radiator must be checked.
- Check installation position of the lower mounting from underneath the vehicle
- If the radiator is not secured in the mount, lift the radiator into the mount.

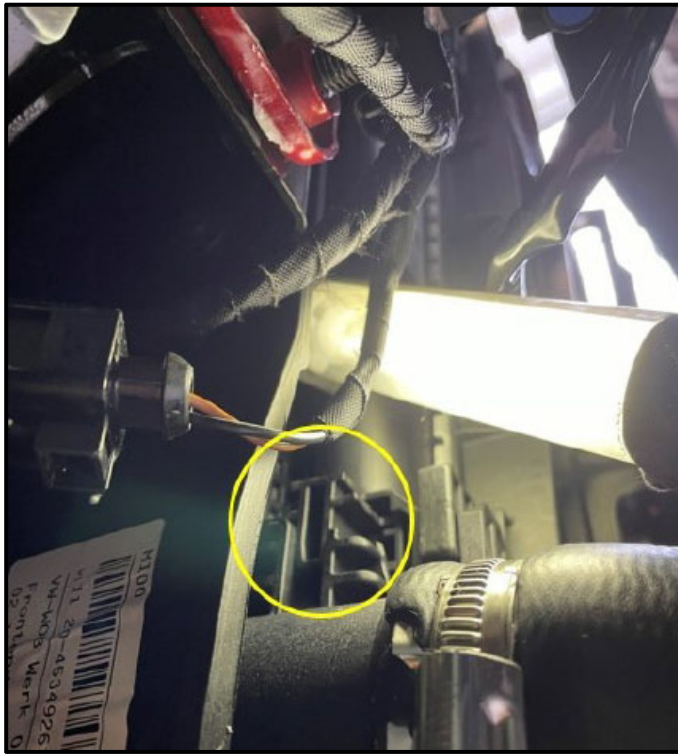
Correct installation of radiator mount shown.

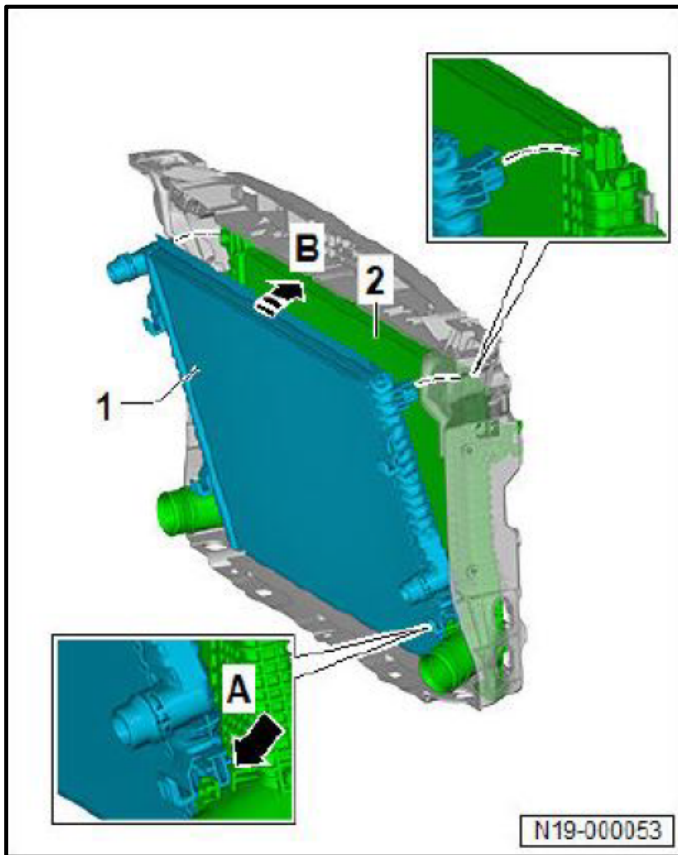
Secure top of radiator:

- Press the top of the radiator into the mounts in direction of <arrow B>.
- The radiator must audibly engage in the mounts.
- Ensure it is secure by pulling on radiator in opposite direction of vehicle travel as previously described.

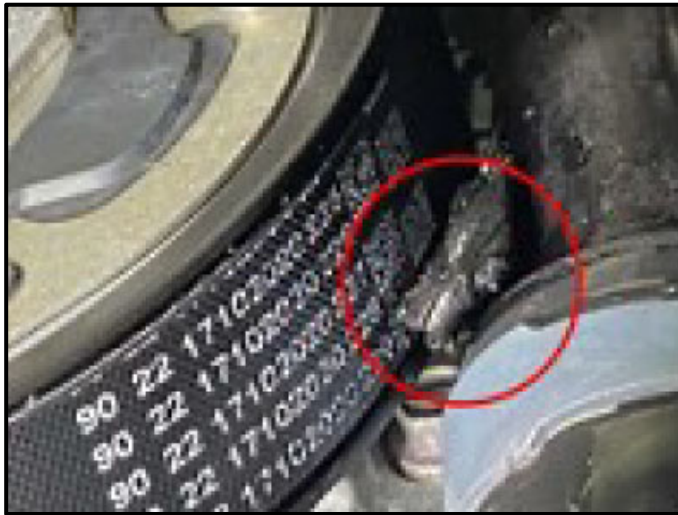
Inspect for contact damage between lower radiator hose and ribbed belt:

If the radiator was mounted incorrectly, it is possible that the radiator can move toward the rear. This can result in contact between the ribbed belt and the lower radiator hose.

- Check for damage to the lower radiator hose due to a loose radiator.
- If there is damage to the lower radiator hose:
 - The coolant hose must be replaced.
 - The ribbed belt must be replaced.
 - Proceed to Section D.
- If there is no damage to the lower radiator hose:
 - No further work is required.
 - Reassemble vehicle in the reverse order of removal.
 - Proceed to Section E.

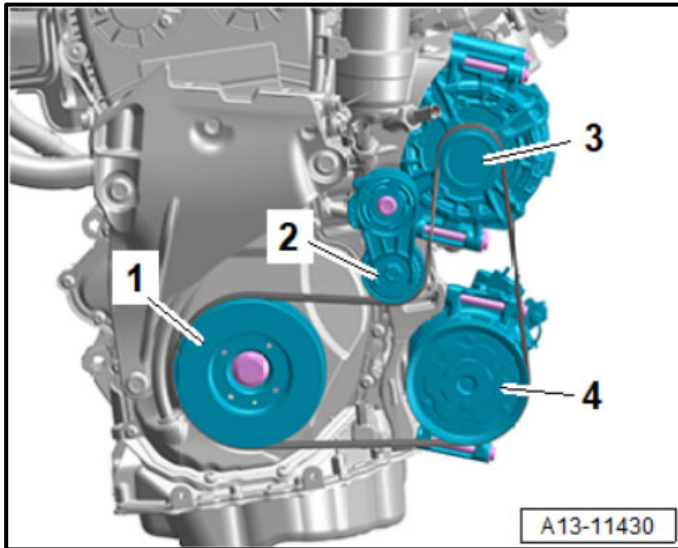
Replace ribbed belt:

- See ELSA Repair Manual: *Repair manual > Engine > 4-Cylinder Direct Injection 2.0L 4V TSI Engine (EA 888evo4) > 13 Crankshaft, Cylinder Block > Cylinder Block, Belt Pulley Side > Ribbed Belt, Removing and Installing*

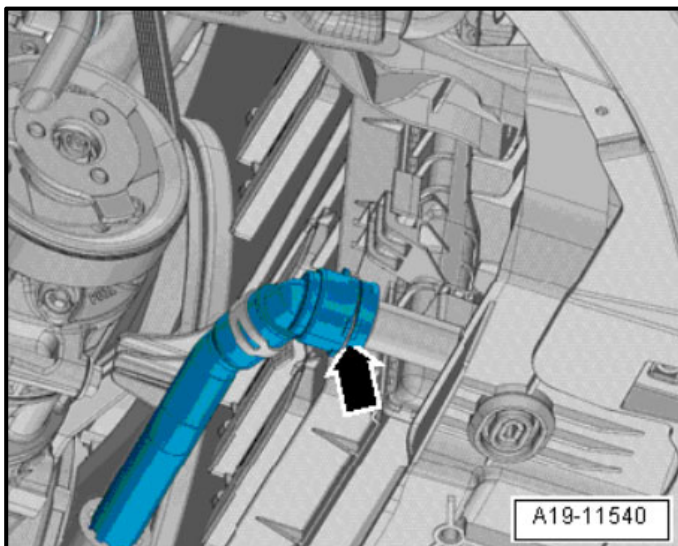
Replace lower radiator hose:

- Refer to ELSA Repair Manual: *Repair manual > Engine > 4-Cylinder Direct Injection 2.0L 4V TSI Engine (EA 888evo4) > 19 Cooling System*
