Safety Recall

Code: 47T2

Subject	Brake Lines																												
Release Date	December 14, 2022																												
Revision Summary	Updated vehicle counts																												
Affected Vehicles

Subject: Safety Recall 47T2 –Brake Lines

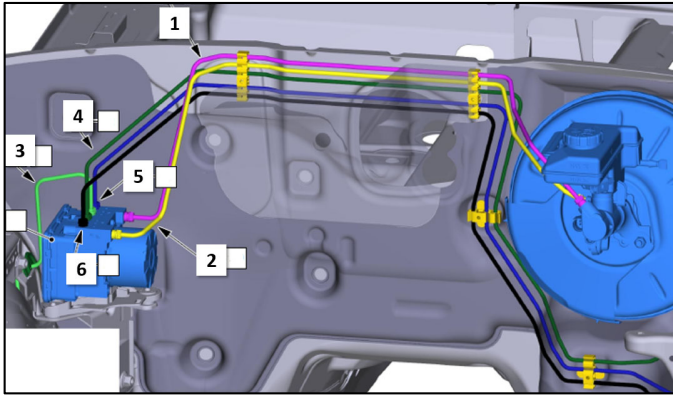
Repair Overview

- Replace all brake lines connected to the ABS hydraulic unit.

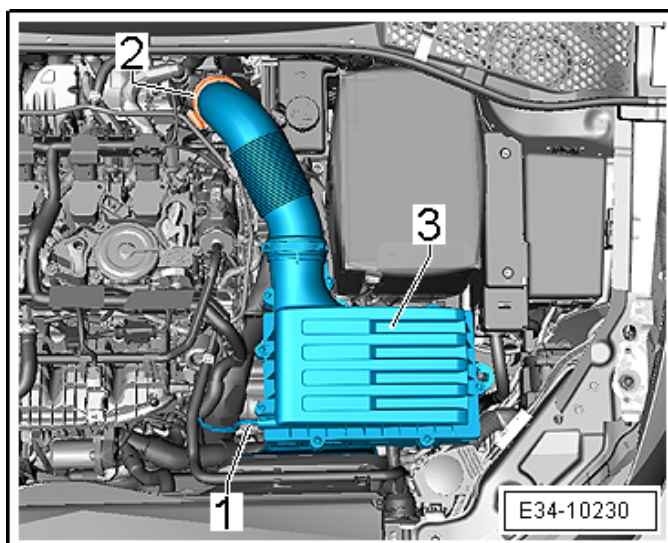
Remove air duct and air filter housing

- See ELSA Repair Manual: *Repair manual > Engine > 24 Multipoint Fuel Injection > Air Filter > Air Filter Housing, Removing and Installing*

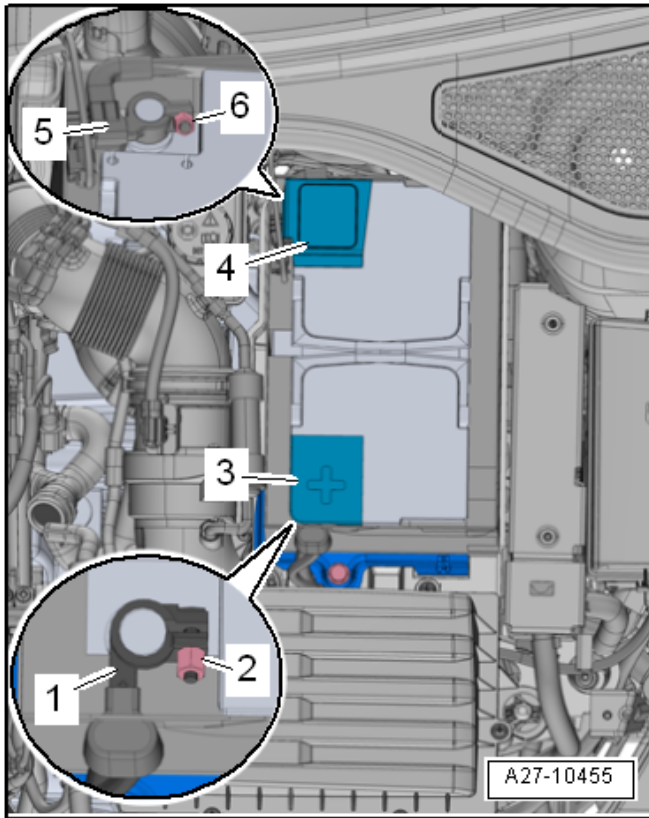
Remove 12V battery:

- See ELSA Repair Manual: *Repair manual > Electrical Equipment > 27 Battery, Starter, Generator, Cruise Control > Battery > Battery, Removing and Installing*

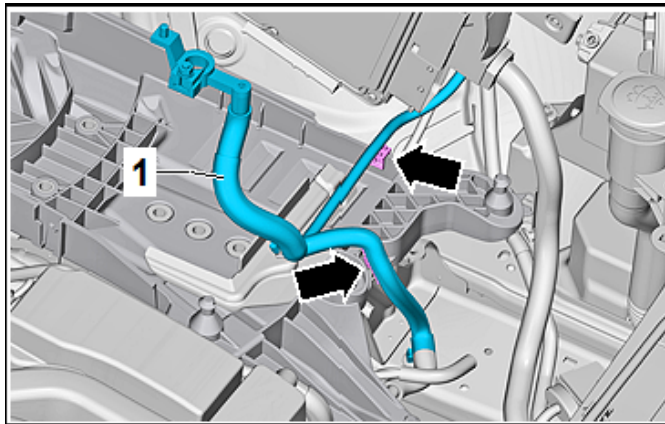
Remove battery tray:

- Remove the bracket <arrows> on the wiring harness <1> from the battery tray.

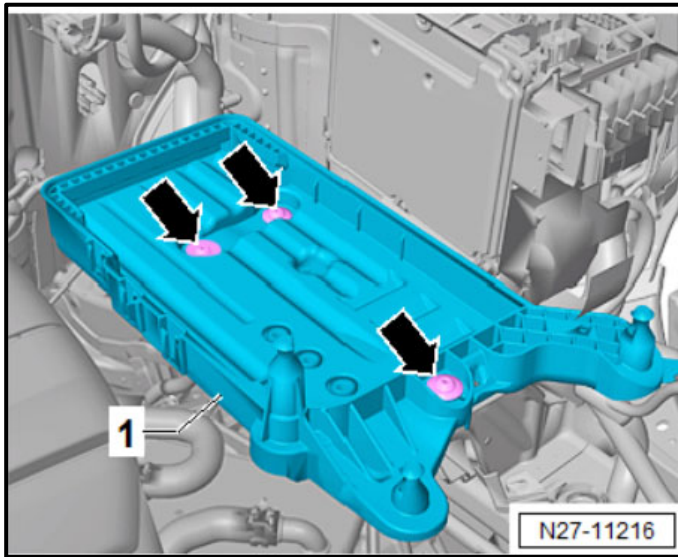
- Remove the bolts <arrows>.
- Remove the battery tray <1>.

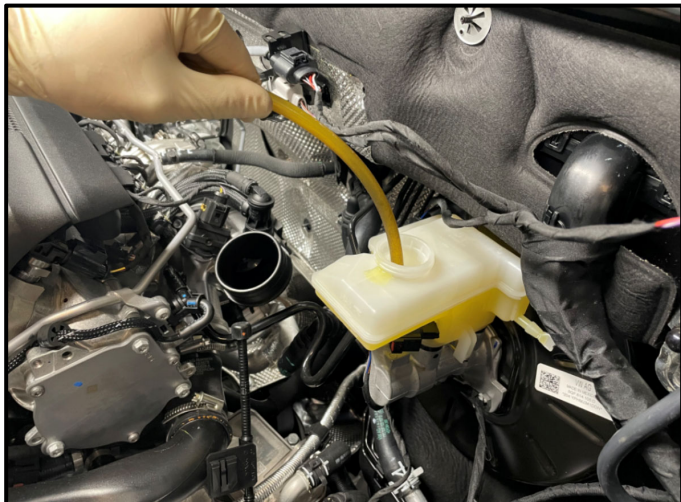
Remove brake fluid from reservoir:

- Suck out the brake fluid from the brake fluid reservoir.

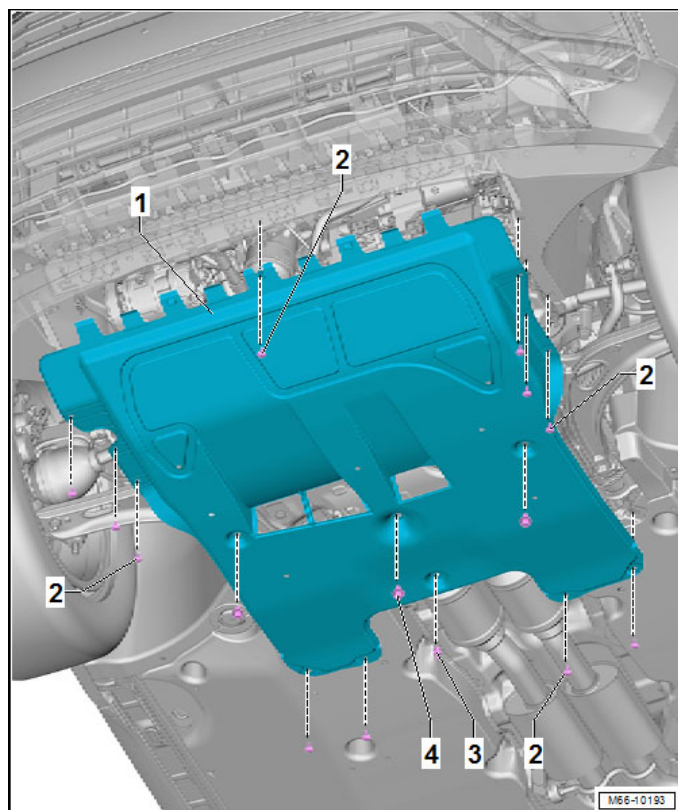
Remove noise insulation:

- See ELSA Repair Manual: *Repair manual > Body > Body Exterior > 66 Exterior Equipment > Noise Insulation*

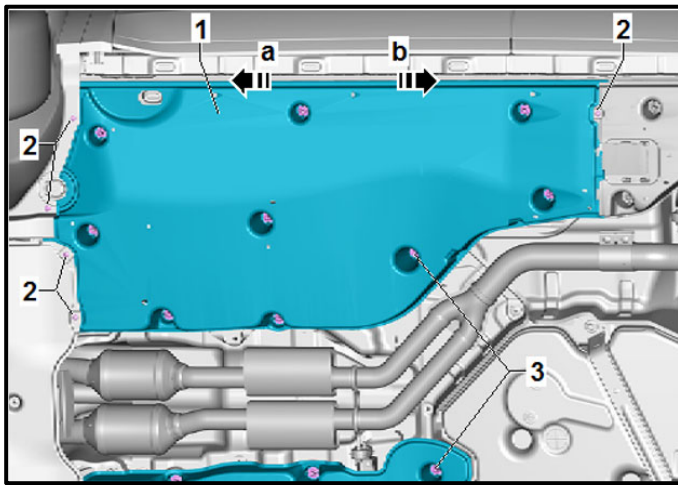
Remove driver side under body shield:

- Remove the nuts <3> and bolts <2>.
- Pull the underbody trim panel <1> forward in direction of <arrow a> out of the rear underbody trim panel.
- Pull the underbody trim panel <1> toward the rear in direction of <arrow b> out of the noise insulation.

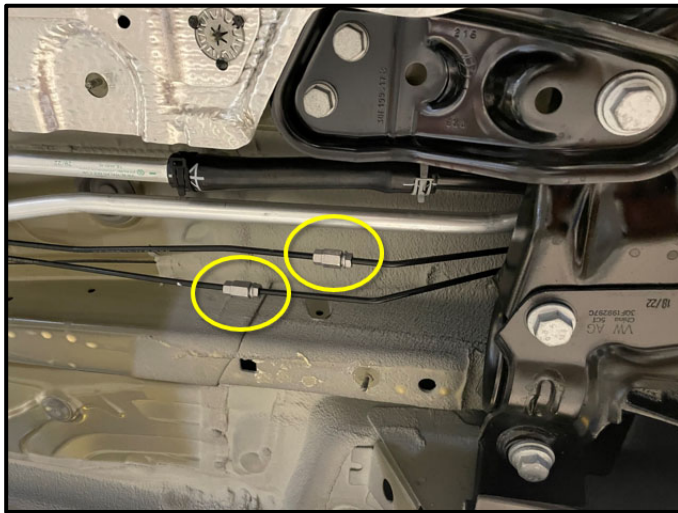
Disconnect underbody brake lines:

- Place a drip tray underneath the vehicle.
- Counterhold the union nuts and loosen the underbody brake line fittings <circles>.

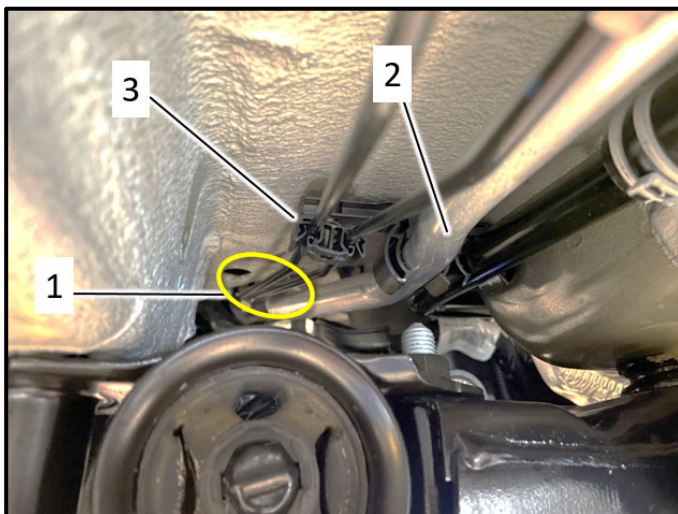
Remove brake line/heater hose bracket:

- Remove brake lines <1> and coolant pipe <2> from bracket <3>.
- Remove bracket <3> from the body.

The bracket <3> holding the brake lines and coolant pipe is located above the subframe.

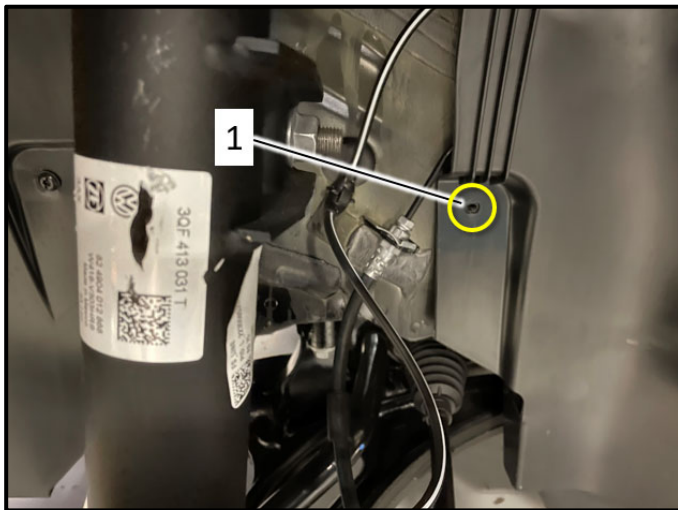
Remove front wheels and screws from front fender liners:

- Remove both front wheels.
- Remove the screw <1>, closest to the brake line, from the fender liner on both front fender liners.

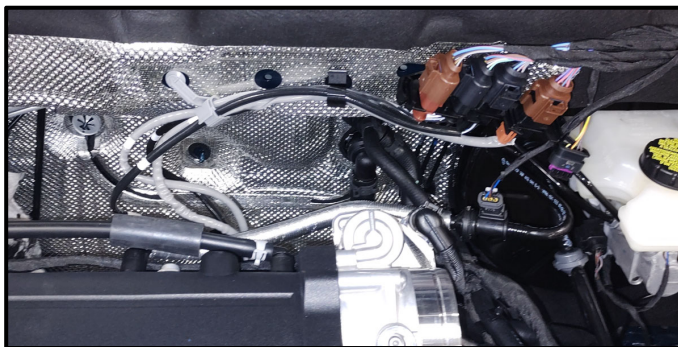
Free up wiring harness:

- Free up sensor wiring, vacuum line and ABS wiring from the firewall.
- Secure out of the way as needed.

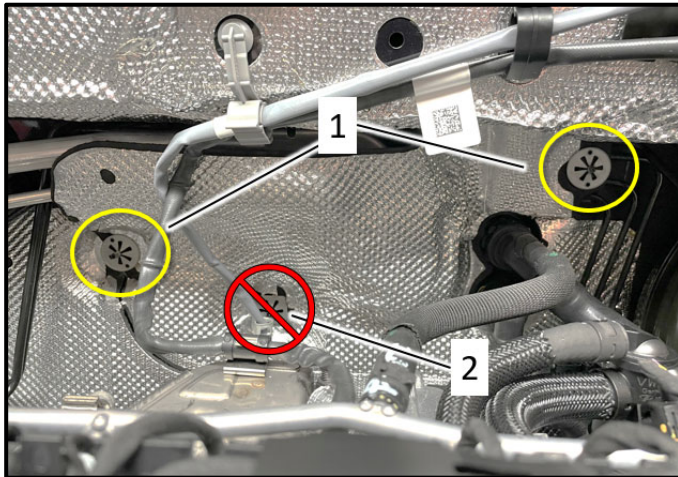
Remove firewall insulation clips:

- Remove clips <1> by unscrewing them.

Clip <2> does not require removal.

- Fold firewall insulation down to expose the brake lines.

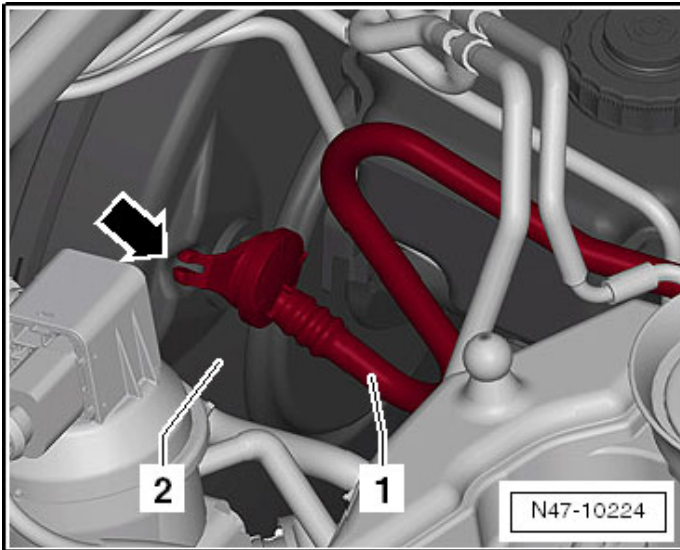
Remove vacuum hose from brake booster:

- Pull the vacuum hose <1> from the brake booster <2>.

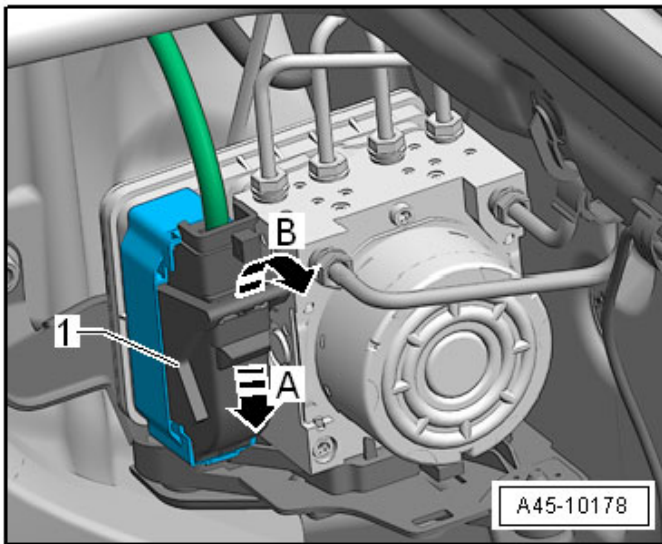
Disconnect ABS control module:

- Press the locking mechanism downward in direction of <arrow A>.
- Release the connector in direction of <arrow B>.
- Remove the connector <1>.

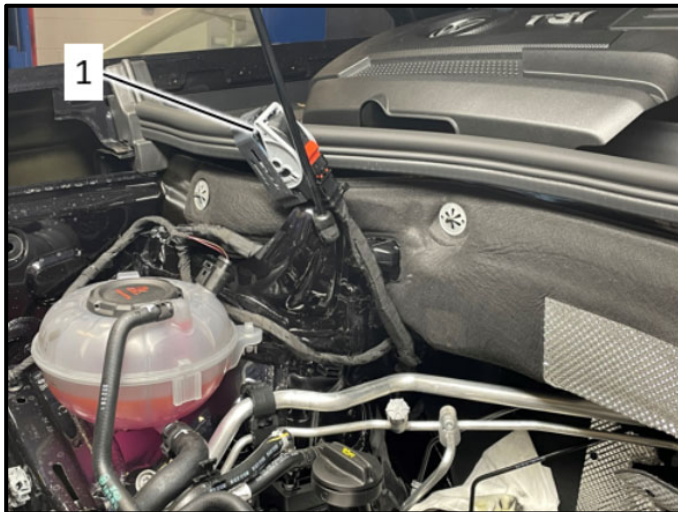
- Secure the ABS control module connector <1> out of the way.

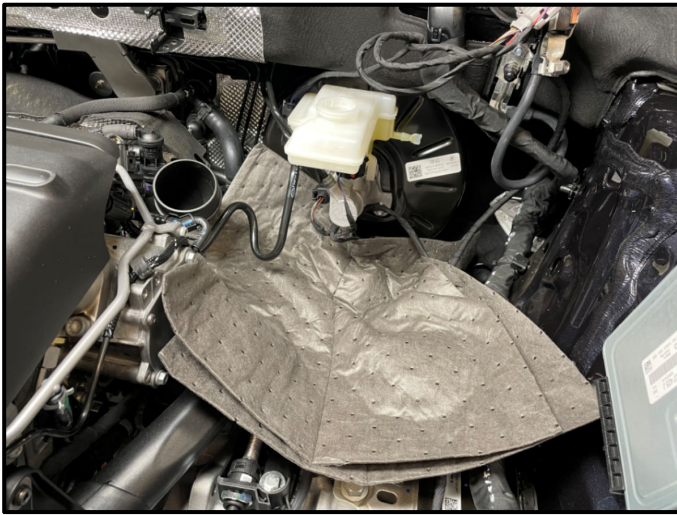
Prepare for brake line removal:

- Place absorbent cloths under the master cylinder AND the ABS control module to catch any escaping brake fluid.
- Clean brake fluid off painted surfaces immediately.

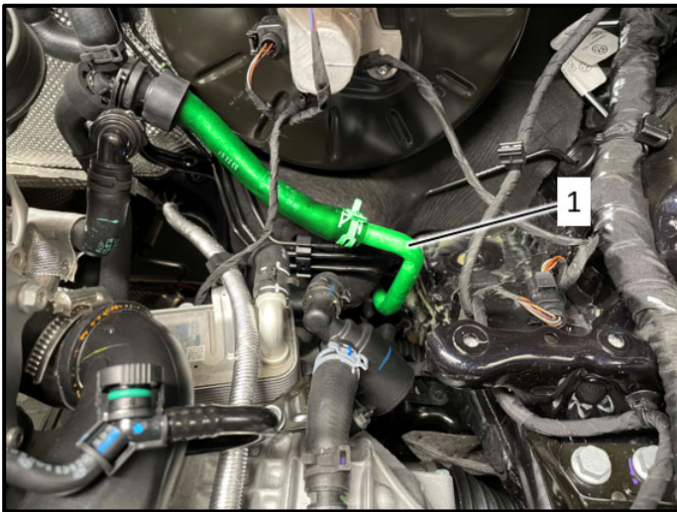
- Heater hose <1> must be freed from its brackets to allow brake lines to be removed.
- The hose DOES NOT have to be disconnected.
- Unplug electrical connectors as needed to allow removal of the brake lines.

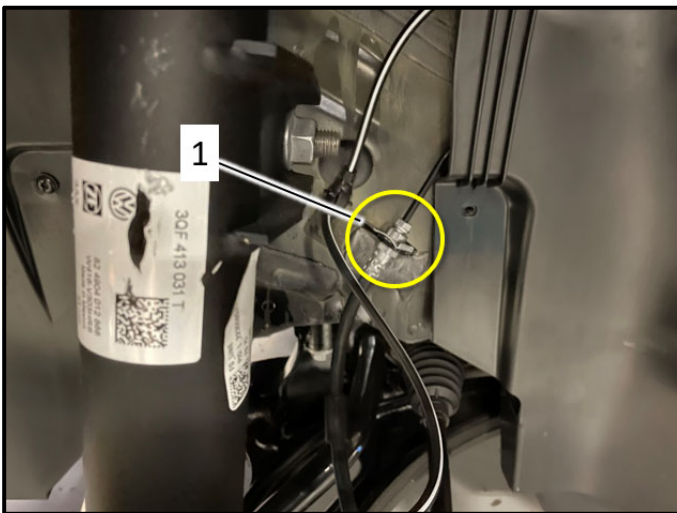
- Loosen the left front and right front brake line to brake hose fittings <1>.

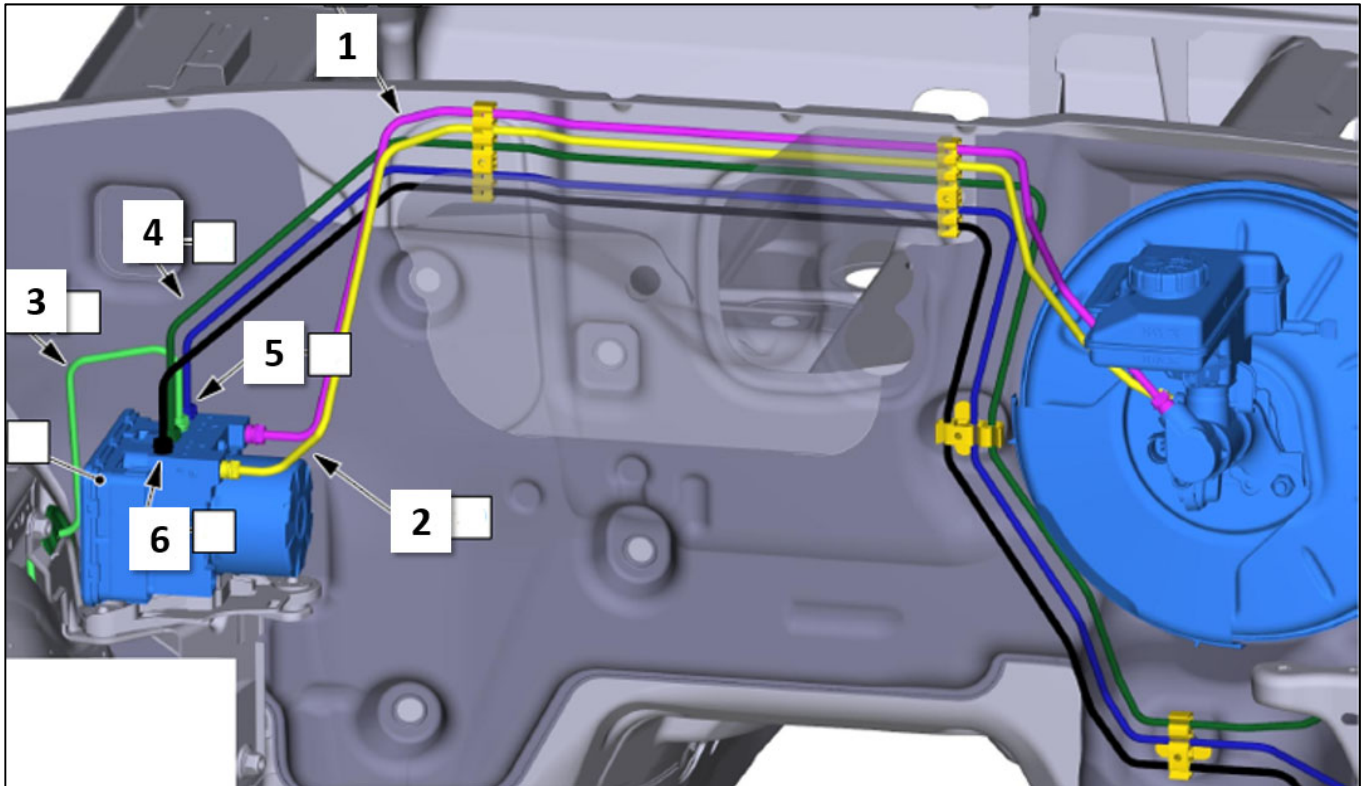
Removing brake lines:

Order	Color (on diagram)	Part Number	Brake Line Designation
1	Pink	3QF-614-740-A	Master Cylinder (secondary)
2	Yellow	3QF-614-739-A	Master Cylinder (primary)
3	Light Green	3QF-614-724-A	Passenger Front
4	Dark Green	3QF-614-723-A	Driver Front
5	Blue	3QF-614-725-A	Driver Rear
6	Black	3QF-614-726-A	Passenger Rear

- Remove brake lines one at a time in the order suggested above.
- Carefully loosen the brake line fittings for each brake line before removing it.
- Then carefully remove the brake line from the securing clips.
- Each brake line will have to be manipulated differently in order to remove it.
- Each brake line (except #3) will have to be moved slightly toward the passenger side of the vehicle and then over the A/C line in order to remove it.
- All brake lines can be removed without removing the A/C lines.

- The new brake lines are installed in the reverse order of removal.
- When installing the brake line fittings, they **MUST** be started by hand and extreme care must be used when threading the fittings into the ABS control module and master cylinder.
- Torque all brake line connections to 14 Nm.

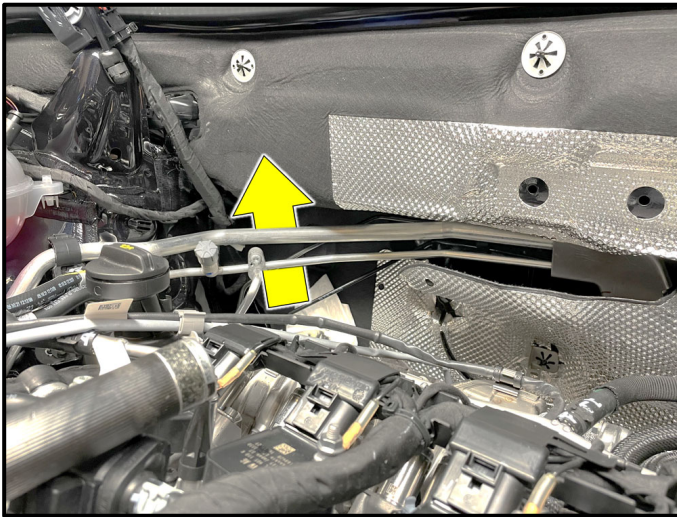
Brake lines can be removed by working them out behind the A/C lines.

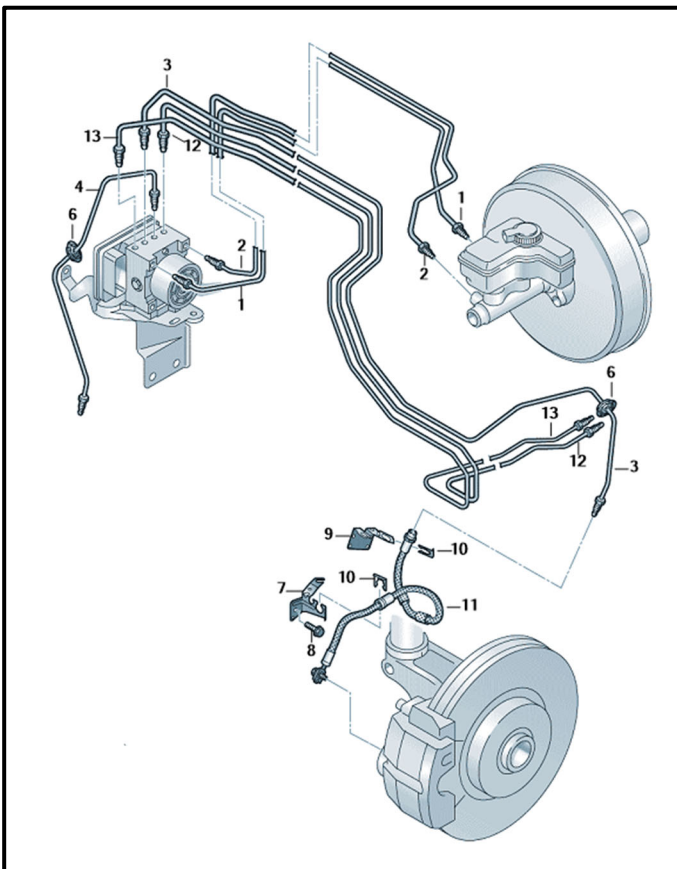
Installing brake lines:

Use extreme care when tightening the brake line fittings.

Start the brake line fittings before securing brake lines in their holders.

Thread the fittings all the way in by hand before torquing them.

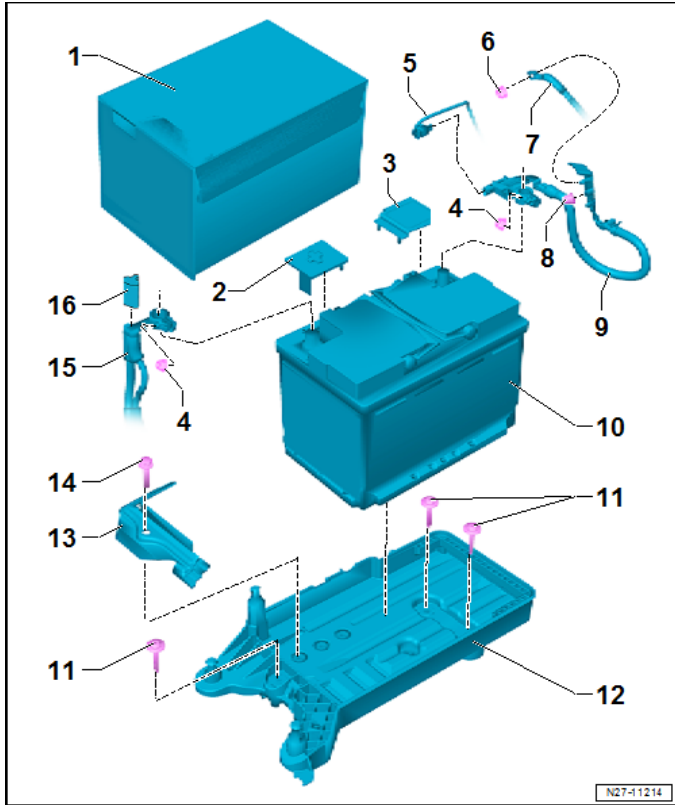
Reinstall battery tray and 12V battery:

- Installation is the reverse order of removal.
- Torque battery tray bolts <11> to 9 Nm.
- Torque hold down bolt <14> to 20 Nm.
- Torque battery terminals to 6 Nm.

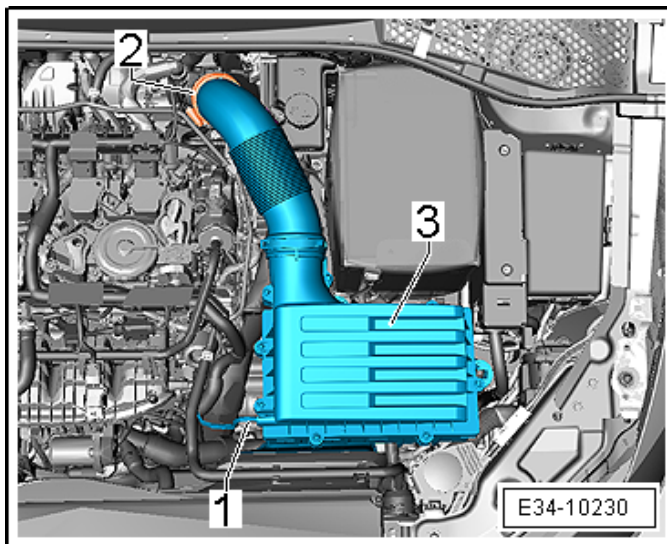
Reinstall air cleaner:

- Installation is the reverse order of removal.

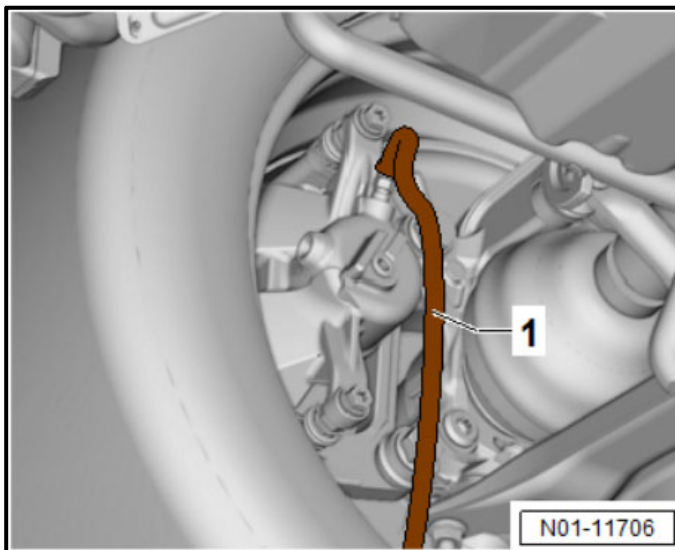
Bleed brakes:

- See ELSA Repair Manual: *Repair manual > Chassis > Brake System > 47 Hydraulic Components > Hydraulic System > Hydraulic System, Standard Bleeding*
