SERVICE BULLETIN

M1566

M1566: RECALL 0179 - RH975 HANDLEBAR

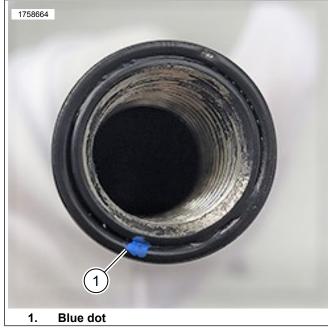
Figure 1. Handlebar Blue Dot

See Figure 1. If dealers have old stock, inspect the part to ensure a small blue paint dot is present on the end of the handlebar. If no dot is present then replace by following the credit procedures in Table 9 or Table 10.
