Safety Recall

Code: 13i4

Subject	Engine Connecting Rod																									
Release Date	October 21, 2022																									
Affected Vehicles

Subject: Safety Recall 13i4 - Engine Connecting Rod

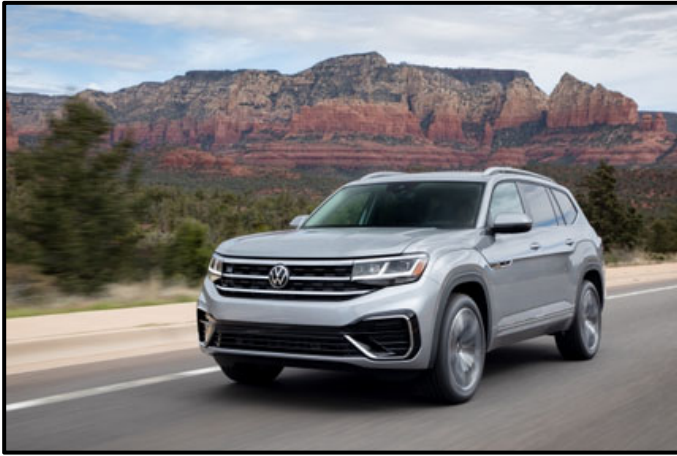
- Remove oil filter.
- **Install a new oil filter and seal.**
- Run engine at idle until it reaches operating temperature of 90°C.
- Turn on air-conditioning and all other engine loads.

- Activate Sport mode.
- Following all traffic laws, perform a road test, quickly accelerating from 1st to 2nd gear, bringing engine RPM up to 4500 RPM each time.

- Perform this road test **10 times** and pay attention to excessive engine knocking.
- Bring vehicle back to the shop.
- Let engine idle for at least 30 seconds.
