Dealer Service Instructions for:

# Safety Recall Z95 / NHTSA 22V-766

## Front Seat Belt Retractor

The front seat belt retractor on about 2,800 of the above vehicles may have an incorrectly welded Micro Gas Generator (MGG). An incorrectly welded MGG may lead to a pretensioner system failure. Pretensioner system failure may result in reduced occupant restraint during a vehicle crash, potentially increasing the risk of injury.

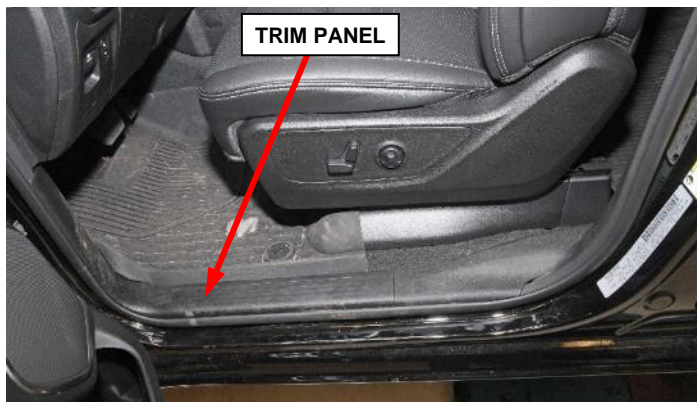
**Figure 3 – Cowl Trim Panel**

7. Using a trim stick or equivalent, disengage the retainer clips securing the cowl trim panel from the door sill (Figure 3).

8. Pull the cowl trim panel rearward and remove it from the vehicle (Figure 3).

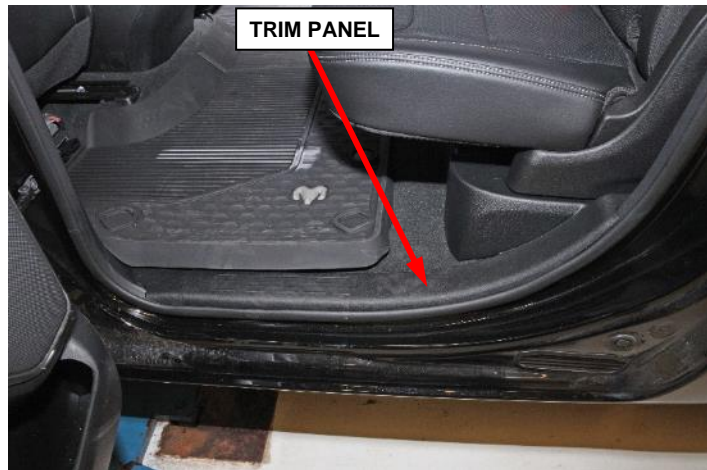
**Figure 4 – Rear Door Sill Trim Panel**

- 9. Using a trim stick or equivalent, release the retaining clips and lift the rear door sill trim panel near the B-pillar. It is not necessary to fully remove the door sill trim panel from the vehicle (Figure 4).

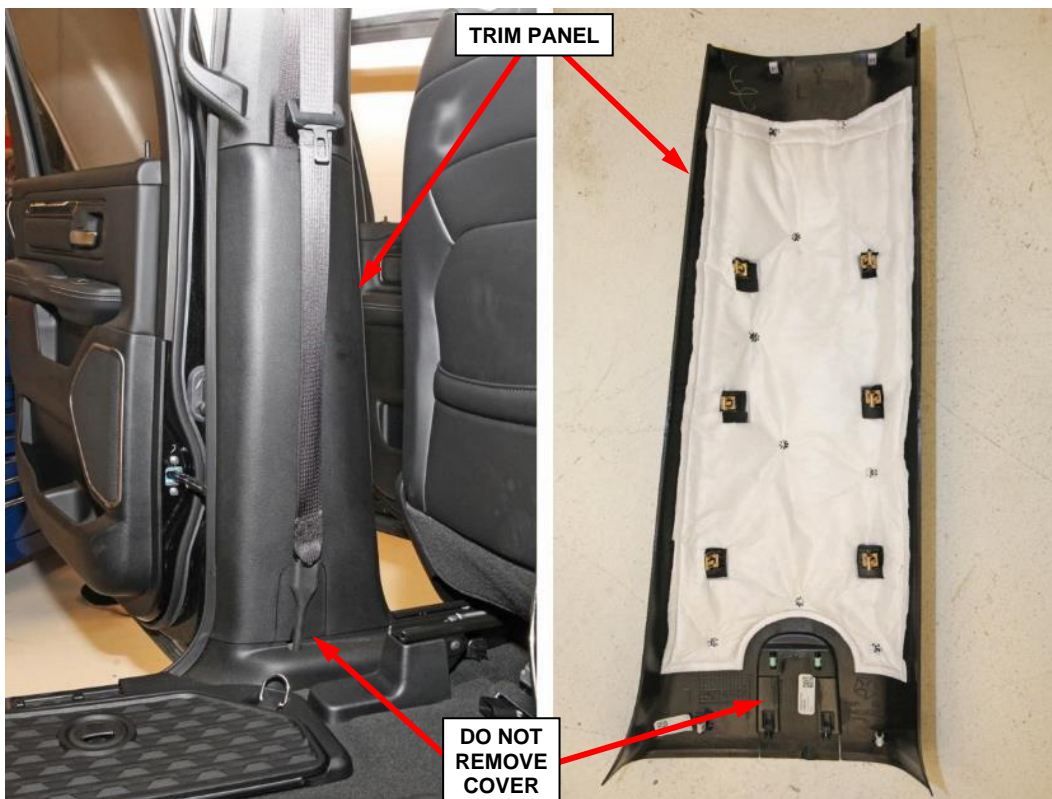
**Figure 5 – B-Pillar Middle Trim Panel**

- 10. Using a trim stick or equivalent release the retaining clips and remove the B-pillar middle trim panel as one piece. It is not necessary to remove the access cover from the trim panel (Figure 5).

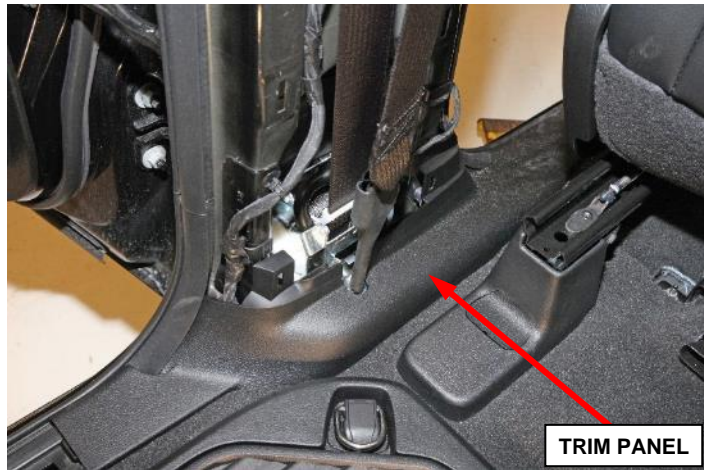
**Figure 6 – B-Pillar Lower Trim Panel**

11. Using a trim stick or equivalent release the retaining clips and remove the lower B-pillar trim panel (Figure 6).

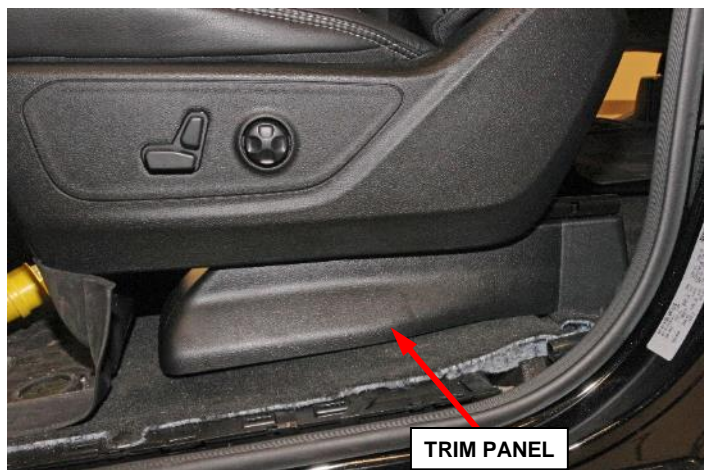
**Figure 7 – Seat Track Outboard Trim Panel**

12. Using a trim stick or equivalent release the retaining clips and remove the outboard seat track side trim panel (Figure 7).

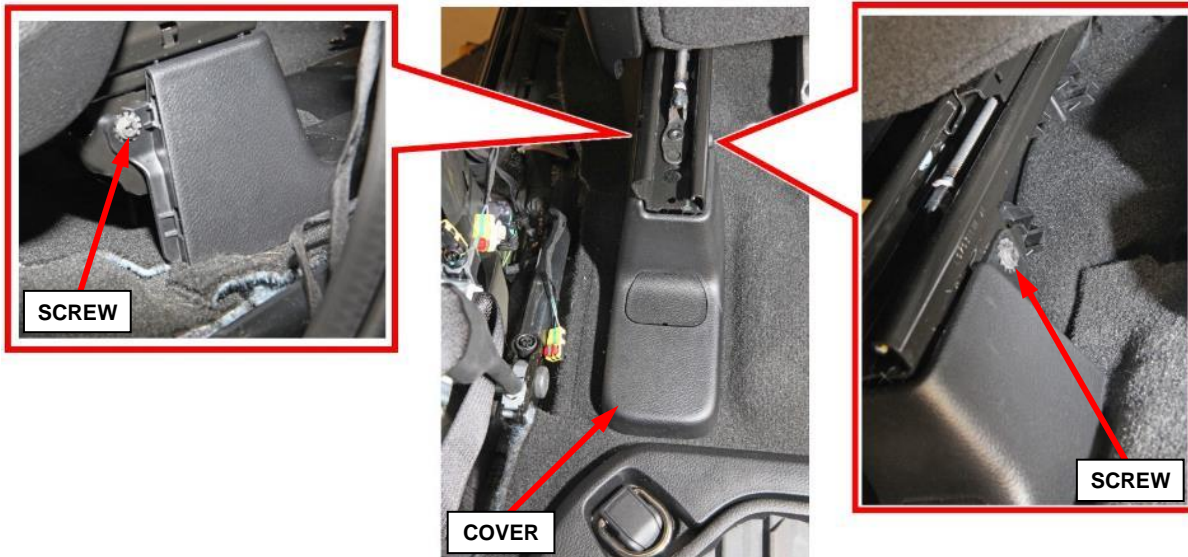
**Figure 8 – Seat Track Outboard Rear Trim Cover**

- Remove the two retaining screws then remove the outboard seat track rear trim cover (Figure 8).

31. Install the outboard seat track rear trim cover then secure with the two retaining screws (Figure 8).
32. Install the outboard seat track side trim panel and seat the clips fully (Figure 7).
33. Position the lower B-pillar trim and seat the clips fully (Figure 6).
34. Position the middle B-pillar trim and seat the clips fully (Figure 5).
35. Position the rear door sill trim panel to the rear door sill then seat the retaining clips fully (Figure 4).
36. Position the cowl trim panel to the door sill (Figure 3).
37. Push the cowl trim panel forward and then engage the retaining clips that secure the sill trim panel to the front door sill (Figure 3).

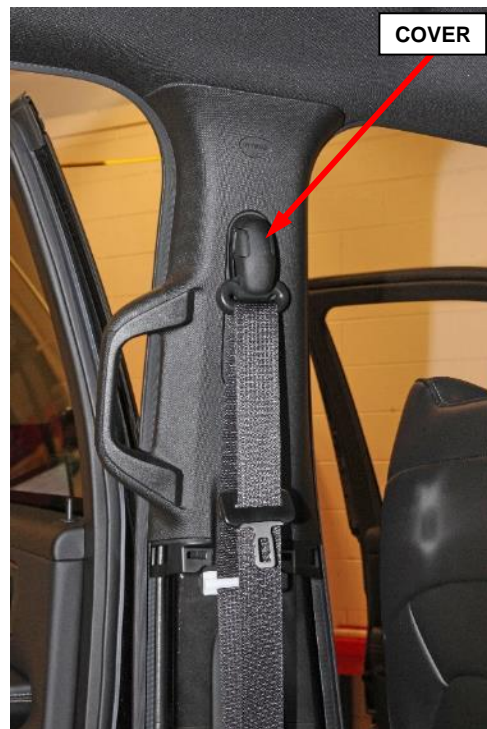
**Figure 9 – Seat Belt Height Adjuster Cover**

- Squeeze the release buttons together and gently unsnap the trim cover from the height adjuster on the upper B-pillar to access the front seat belt turning loop mounting nut (Figure 9).

28. Install the front seat belt turning loop nut and tighten the nut to 48 N·m (35 ft. lbs.) (Figure 11).
29. Install the retractor belt guide to the inner B-pillar (Figure 10).
30. Install the seat belt turning loop cover over the seat belt turning loop nut (Figure 9).

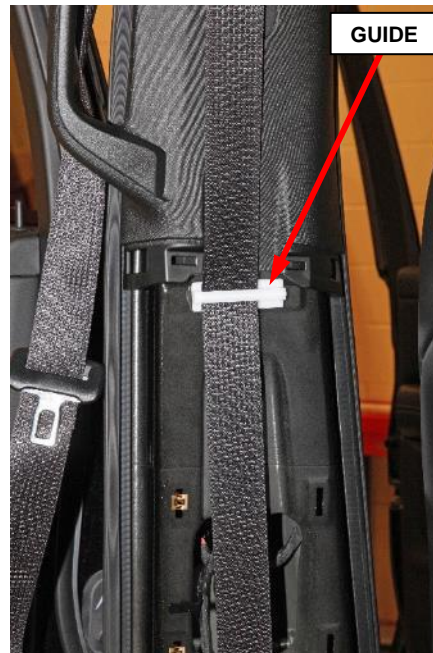
**Figure 10 – Seat Belt Webbing Guide**

15. Release the seat belt webbing guide from the B-pillar (Figure 10).

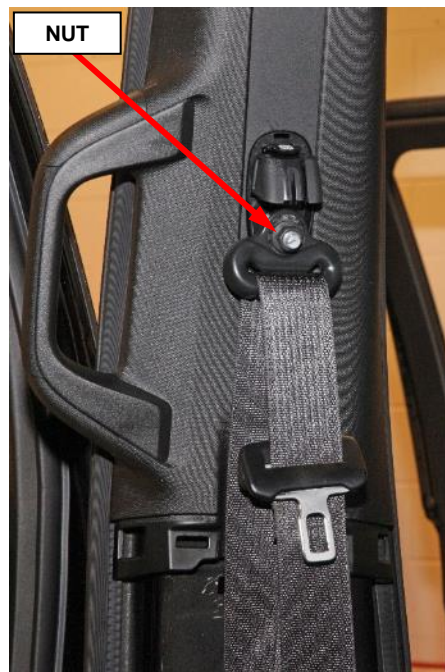
**Figure 11 – Seat Belt Turning Loop**

16. Remove and **SAVE** the nut that secures the seat belt turning loop to the height adjuster (Figure 11).

17. Remove the seat belt turning loop from the height adjuster (Figure 11).

24. Install the front seat belt retractor and tensioner bolt and tighten the bolt to 48 N·m (35 ft. lbs.). Ensure the tensioner is held securely after tightening. If the tensioner can be rotated easily, increase the torque by as much as additional 5 N·m (4 ft. lbs.) if necessary (Figure 13).
25. Connect the wire harness connectors to the tensioner and the retractor (Figure 12).
26. Wipe clean the turning loop stud threads to remove any loose debris.
27. Position the seat belt turning loop to the height adjuster (Figure 11).

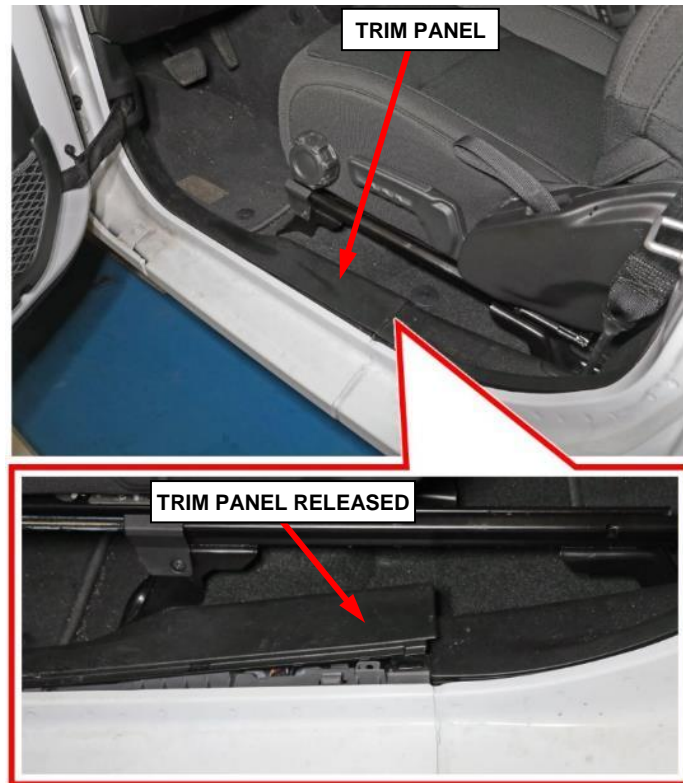
**Figure 16 – Cowl Trim Panel**

7. Using a trim stick or equivalent, release the retainer clips and lift the rear portion of the front door opening cowl trim panel (Figure 16).

36. Guide the seat belt webbing through the slot in the B-pillar lower trim panel (Figure 19).
37. Position and secure the retaining clips attaching the B-pillar lower trim panel (Figure 19).
38. Position and secure the retaining clips attaching the B-pillar seat belt access cover (Figure 18).
39. Position and secure the retaining clips attaching the B-pillar middle trim panel (Figure 18)
40. **(JT) Gladiator ONLY:** Position and secure the retaining clips attaching the front portion of the rear door opening quarter panel trim (Figure 17).
41. Secure the retaining clips attaching the rear portion of the front door opening cowl trim panel (Figure 16).

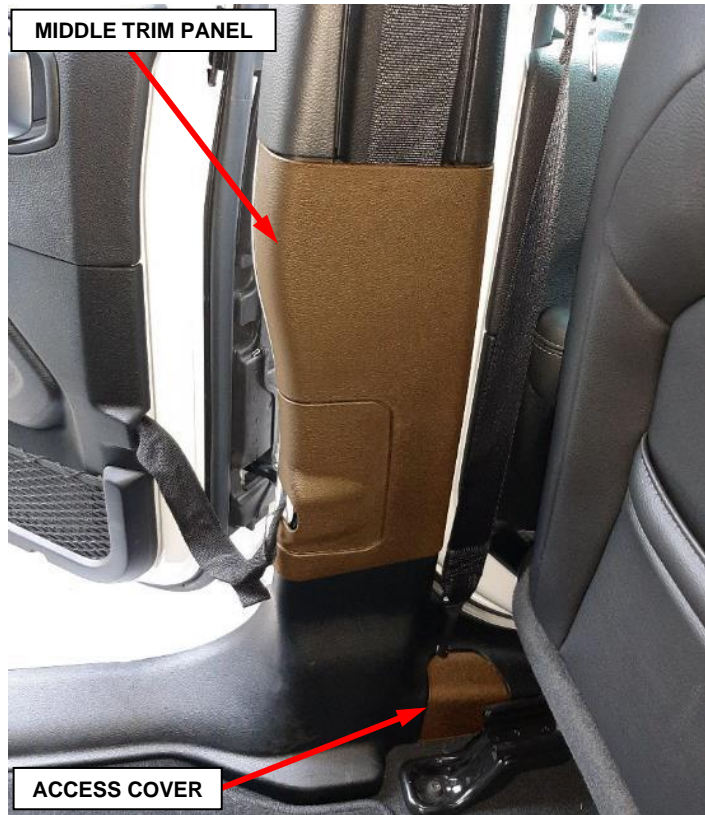
**Figure 18 – B-Pillar Middle Trim Panel and Seat Belt Access Cover**

9. Using a trim stick or equivalent, remove the B-pillar middle trim panel (Figure 18).

10. Using a trim stick or equivalent, remove the B-pillar seat belt access cover (Figure 18).

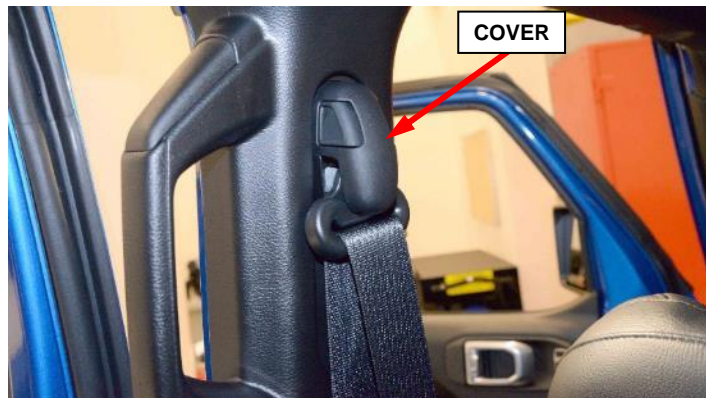
**Figure 21 – Seat Belt Height Adjuster Cover**

- 17. Remove the protective cover from over the nut for the seat belt height adjuster (Figure 21).

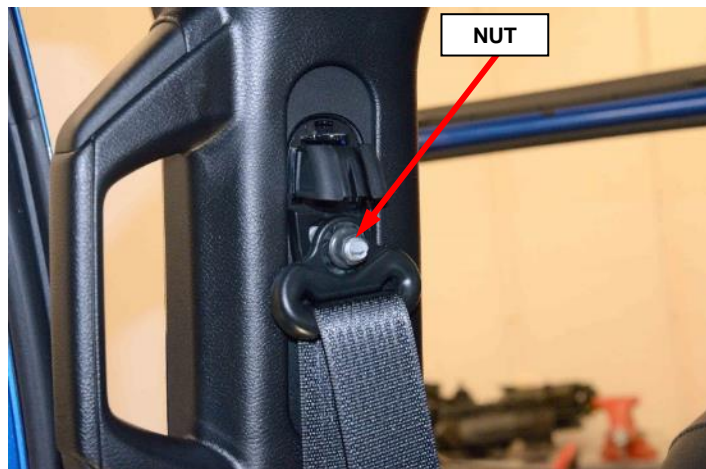
**Figure 22 – Seat Belt Turning Loop**

- 18. Remove and **SAVE** the nut that secures the seat belt turning loop to the height adjuster (Figure 22).

- 19. Remove the seat belt turning loop from the height adjuster (Figure 22).

29. Install the bolt that secures the tensioner to the B-pillar. Tighten the bolt to 45 N·m (33 ft. lbs.). Ensure the tensioner is held securely after tightening. If the tensioner can be rotated easily, increase the torque by as much as additional 9 N·m (7 ft. lbs.) if necessary (Figure 24).
30. Connect the two wire harness connectors to the retractor and the tensioner (Figure 23).
31. Wipe clean the height adjuster turning loop stud threads to remove any loose debris (Figure 22).
32. Position the seat belt turning loop to the height adjuster (Figure 22).

33. Reuse and install the nut that secures the turning loop to the height adjuster. Tighten the nut to 45 N·m (33 ft. lbs.) (Figure 22).
34. Install the cover over the nut at the top of the seat belt turning loop (Figure 21).
35. Install the seat belt webbing guide to the B-pillar (Figure 20).
