Tesla, Inc. Service Bulletin		<h2 style="margin: 0;">Inspect 2nd Row Seat Belt and Buckle Stacking</h2>	
SB-22-20-004 October 27, 2022			
Classification		Section/Group	Mobile Service
Recall Bulletin		20 - Safety and Restraint	Can Perform (where permitted)
Model Year	Model	Country/Region	Build Location
2017 - 2022	Model 3	All	Fremont, Giga Shanghai
<small>The model(s) and model year(s) listed are a general approximation of the affected VIN list. Refer to the VIN/Bulletin Tracker or Customer/Vehicle profile to determine applicability of this bulletin for a particular vehicle.</small>

Some Model 3 vehicles may require the second-row center seat belt anchor and LH seat buckle bracket to be reassembled to Tesla specifications.

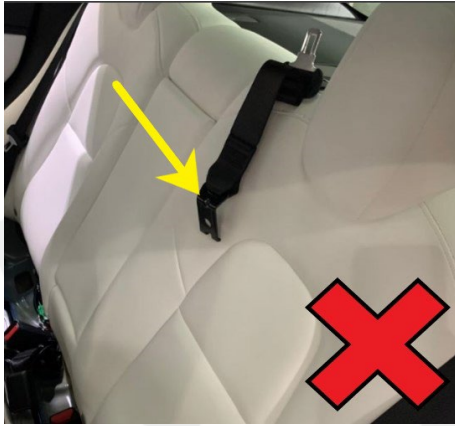
1. Remove the 2nd row lower seat cushion (refer to Service Manual procedure [13051002](#)).
2. Verify that the 2nd row center seat belt anchor is not free floating (Figure 1), or “hooked” onto the 2nd row LH seat buckle harness (Figure 2).
 - If either of these conditions exist, go to the “Correct Seat Belt and Buckle Stacking” section of this document.
 - If none of these conditions exist, go to the next step.

❌ Figure 1 — Anchor free floating

Inspect the vehicle for symptoms related to the condition. If symptoms are present, correct the stacking of the center seat belt anchor and LH seat buckle bracket.

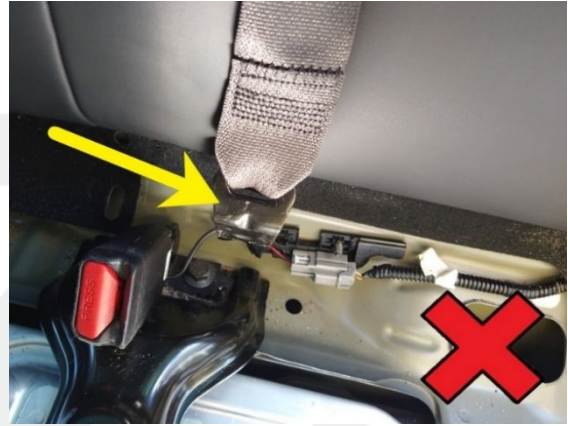
❌ Figure 2 — Anchor hooked onto harness

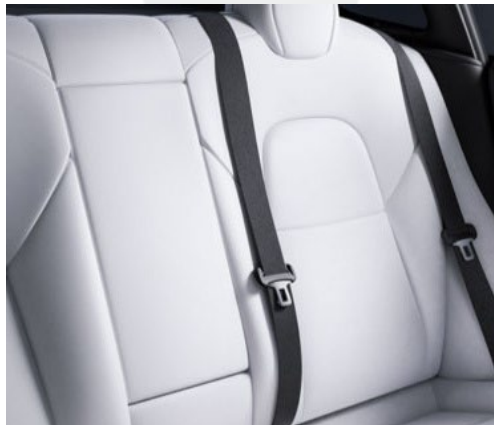
3. Inspect the stacking of the 2nd row center seat belt and the 2nd row LH seat buckle:
 - a. Verify that the 2nd row center seat belt is without twists, and lays flat against the 2nd row seat back with the tongue pointing forward (Figure 3).

✅ Figure 3 — Seat belt untwisted, lays flat, and tongue points forward

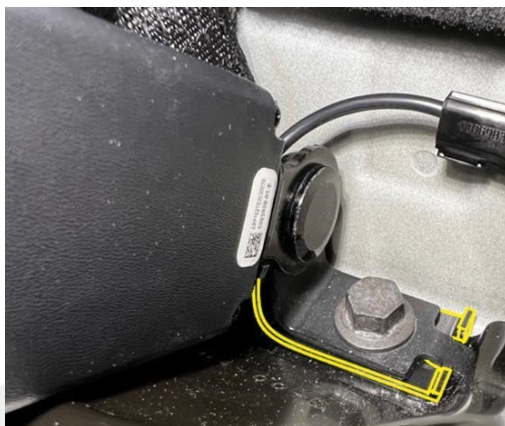
- b. Verify the 2nd row center seat belt anchor has the belt to the RH side and is on top of the 2nd row LH inner penthouse rail (Figure 4).

✓ **Figure 4 — Anchor has belt to RH side**

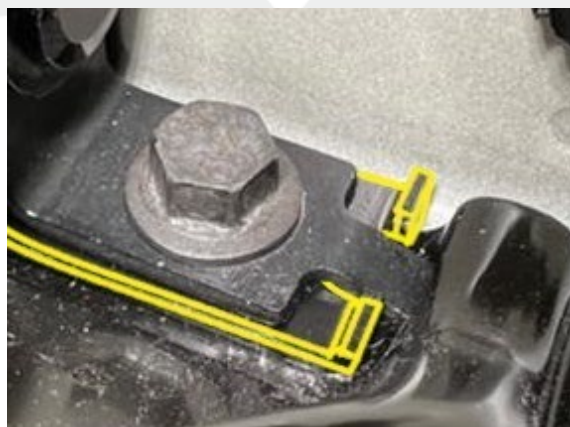
- c. Verify the 2nd row LH seat buckle bracket is on top of the 2nd row center seat belt anchor, and the guide pin of the bracket is aligned in the slot of the anchor (Figure 5)

✓ **Figure 5 — Guide pin aligned with slot**

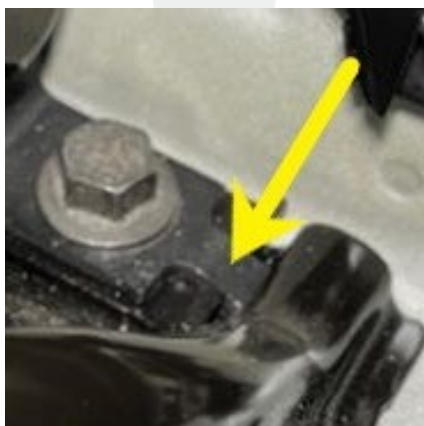
- d. Verify the guide pin of the 2nd row LH seat buckle bracket enters the hole in the 2nd row LH inner penthouse rail (Figure 6).

✓ **Figure 6 — Guide pin in hole of penthouse rail**

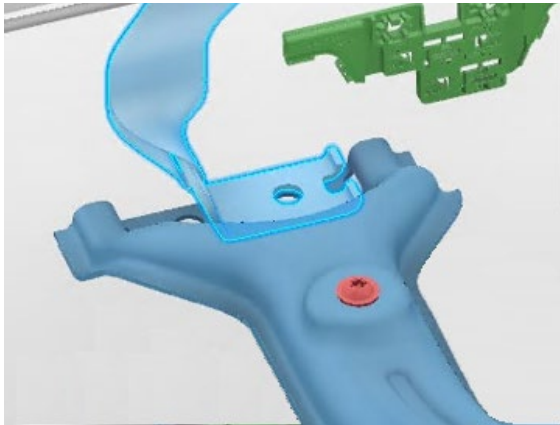
Figure 9 — Belt is to the RH side

- Set the 2nd row center seat belt anchor onto the 2nd row LH inner penthouse rail, with the belt to the RH side (Figure 9).

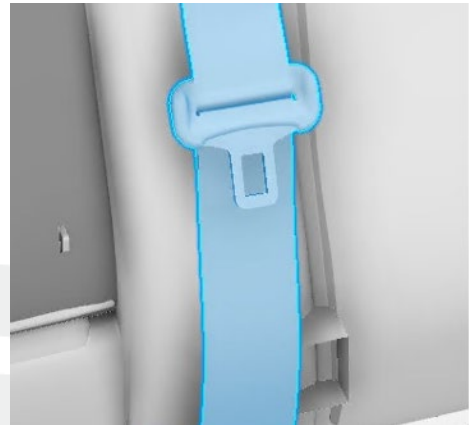
Figure 10 — Belt lays flat against seatback

NOTE: Make sure that the belt is not twisted, and lays flat against the 2nd row seat back with the tongue pointing forward (Figure 10).
