SERVICE PROCEDURE

22524 / 22550
JANUARY, 2023

SUBJECT: SAFETY RECALL 22524 Variation 22550
Hex Flange Lock Nut on certain International® LT®,
RH™, and LoneStar® Series trucks built 02/13/2022
thru 08/16/2022.

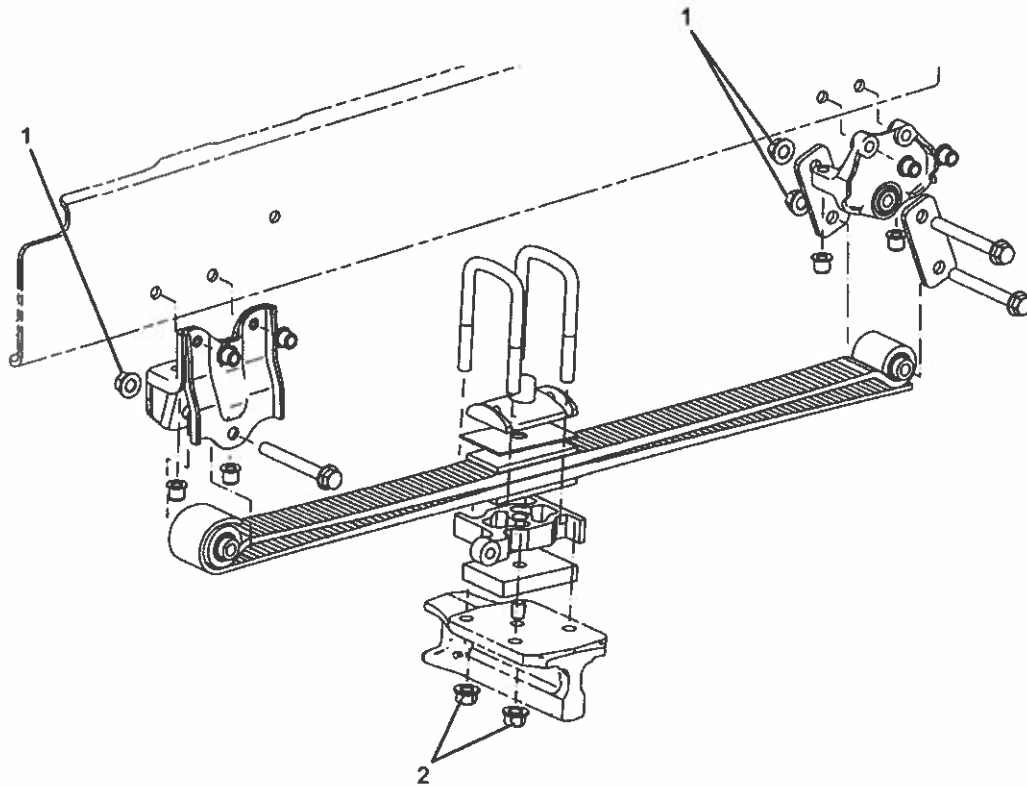
Figure 1. Steer Axle Shackle and U-Bolt

1. Nut (3)
2. U-bolt nut (4, 2 not shown)

7. Access nut (Figure 1, Item 1) securing the front steer axle shackle.

8. Remove and replace nuts (Figure 1, Item 1). Using a torque wrench, tighten nuts to 330 - 370 lb-ft (450 - 500 N·m).
9. Repeat Steps 7-8 for the opposite side.

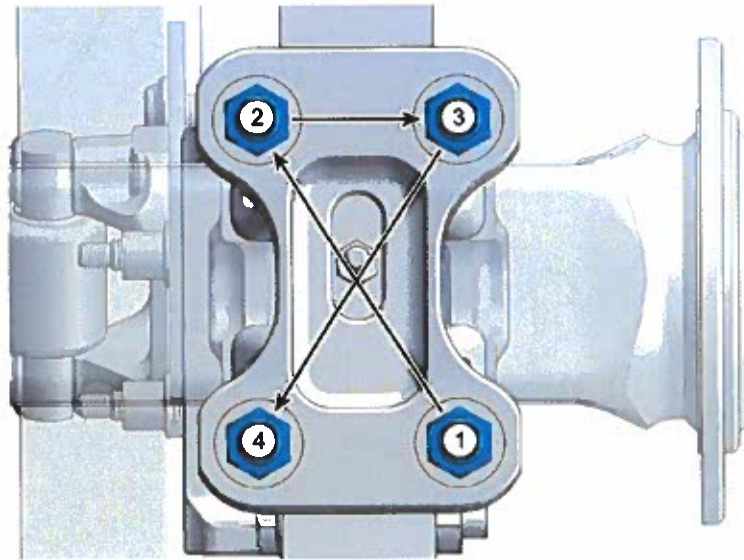
Figure 2. U-Bolt Torque Sequence

10. Access nuts securing U-bolt to axle (Figure 1, Item 2).
11. Is vehicle equipped with Hendrickson STEERTEK™ Axle?
 - a) Vehicle equipped with Hendrickson STEERTEK™ Axle. Proceed to Step 12.
 - b) Vehicle NOT equipped with Hendrickson STEERTEK™ Axle. Proceed to Step 13.

12. Vehicles equipped with Hendrickson STEERTEK™ Axle, remove and replace U-bolt nuts one at a time. Using a torque wrench, tighten U-bolt nuts using torque sequence (Figure 2):
 - a) Tighten nuts to 15 lb-ft (20 N·m)
 - b) Tighten nuts to 100 lb-ft (135 N·m)
 - c) Tighten nuts to 200 lb-ft (270 N·m)
 - d) Tighten nuts to 300 lb-ft (405 N·m)
 - e) Tighten nuts to 400 lb-ft (540 N·m)

13. Vehicles not equipped with Hendrickson STEERTEK™ Axle, remove and replace U-bolt nuts one at a time. Using a torque wrench, tighten U-bolt nuts using torque sequence (Figure 2):
 - a) Tighten nuts to 15 lb-ft (20 N·m)
 - b) Tighten nuts to 100 lb-ft (135 N·m)
 - c) Tighten nuts to 200 lb-ft (270 N·m)
 - d) Tighten nuts to 300 lb-ft (405 N·m)
14. Repeat Steps 11-13 for opposite side.
15. Raise front of vehicle, remove jacks and lower vehicle.
16. Using jack, raise rear axles and support vehicle on jack stands.

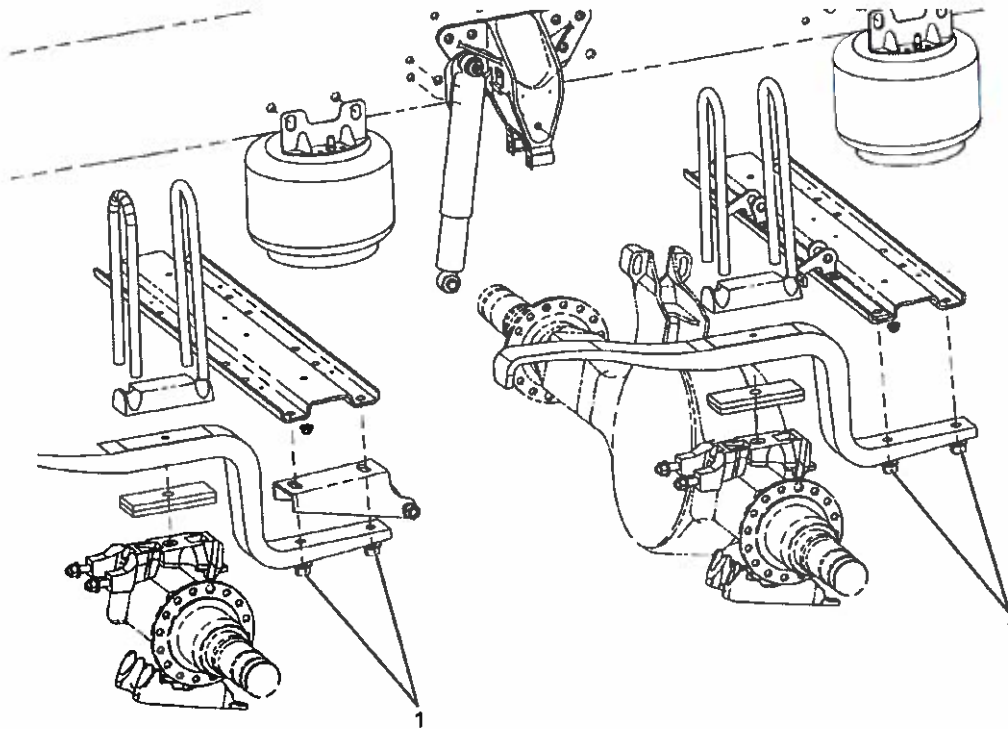
Figure 3. HAS Cross Brace

1. Nut (4)

17. Access four nuts (Figure 3, Item 1) securing rear axle(s) to cross brace.

18. Remove and replace nuts one at a time. Using a torque wrench, tighten nuts to 330 - 370 lb-ft (450 - 500 N·m).

19. Repeat Steps 17 and 18 for opposite side.
