July 2023
FL960AB
NHTSA #22V-876 (School Bus)
NHTSA #22V-877
Transport Canada #2022-674 (School Bus)

Subject: Foil Pack Harness

Models Affected: Specific model year 2023 Freightliner Custom Chassis MT50e vans and Thomas Built Saf-T-Liner C2 Jouley school buses manufactured December 21, 2021, through September 2, 2022.

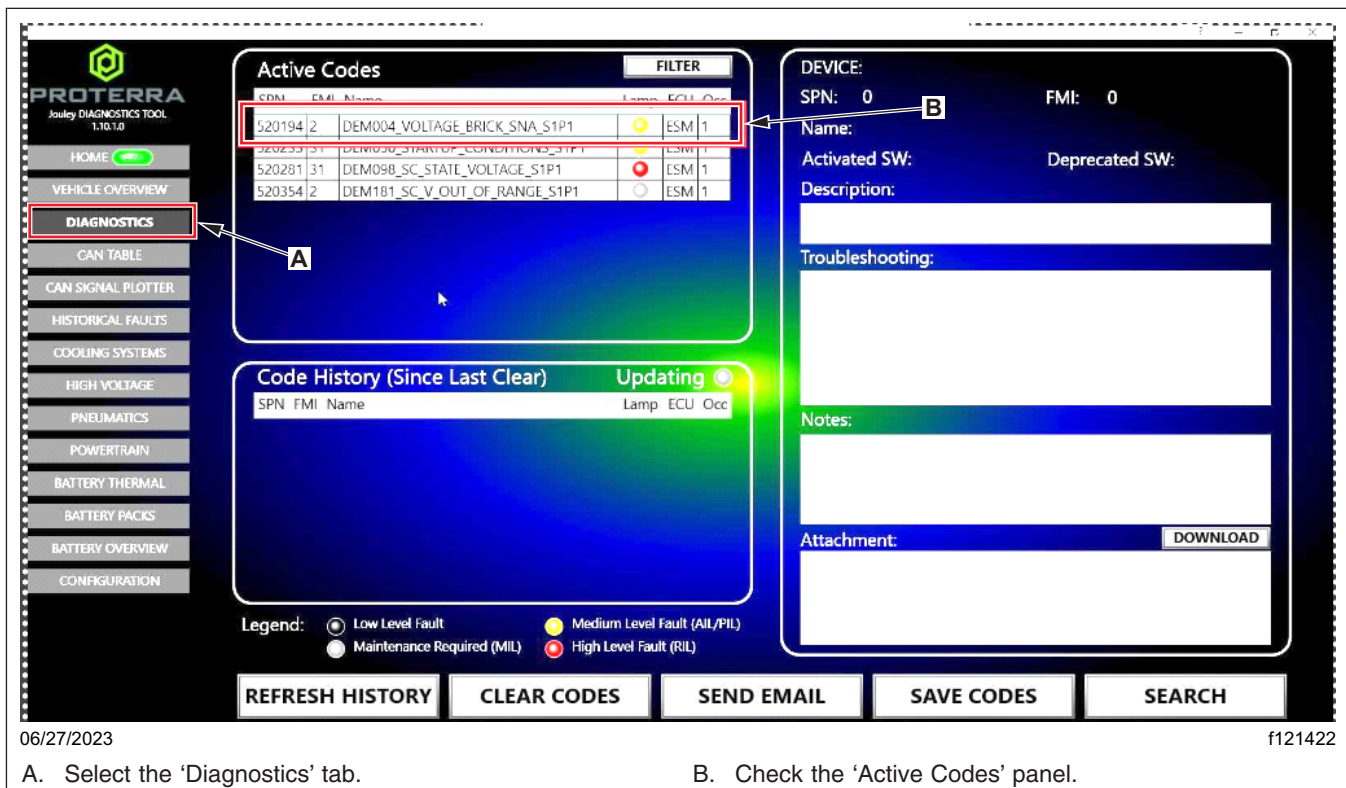
Fig. 1, Proterra Jouley Diagnostic Tool

1. Park the vehicle on a level surface, turn the keyswitch to the OFF position, place the transmission in neutral or park, and set the parking brake. Chock the tires.
2. Turn the ignition to the ON position.
3. Connect the Jouley Proterra Diagnostics Tool® to the vehicle.
4. Once connected, go to the 'Diagnostics' tab.
5. Check the 'Active Codes' panel for the presence of the following suspect parameter numbers (SPNs). See [Fig. 1](#).
 - SPN 520194 FMI 2 DEM004_VOLTAGE_BRICK_SNA_S1P1
 - SPN 521102 FMI 2 DEM004_VOLTAGE_BRICK_SNA_S2P1

Are any of the two SPNs present under the 'Active Codes' panel?

YES → Contact the FCCC Service at 1-800-385-4357 for further instructions.

NO → The inspection is complete. Place the 'Battery Pack' sticker on the battery pack in a visible location, on the front of the battery pack.

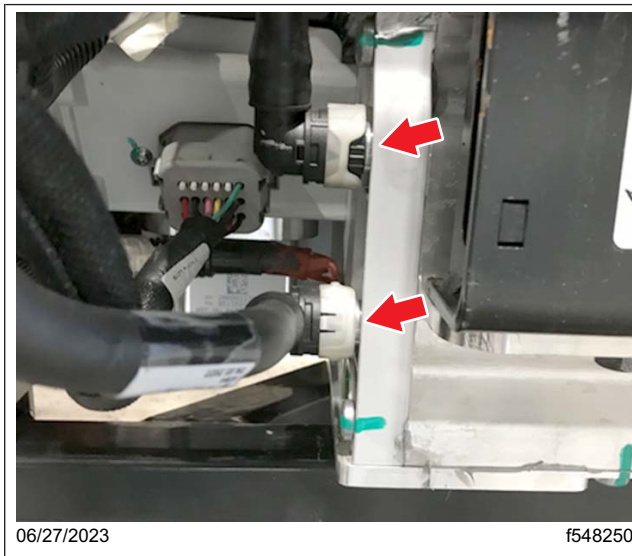
Fig. 2, Coolant Lines Location

5. Remove the 12 fasteners from the rear of the cradle and 10 fasteners from the front of the cradle, then remove the cradle from under the battery. Retain the fasteners for installing the cradle in a later step.
6. Remove the coolant lines (total four) from each battery pack. See [Fig. 2](#).

22. Install the coolant lines (total four) from each battery pack, and remove the line clamps.
 23. Install the cradle. Tighten the fasteners 118 lbf·ft (160 N·m).

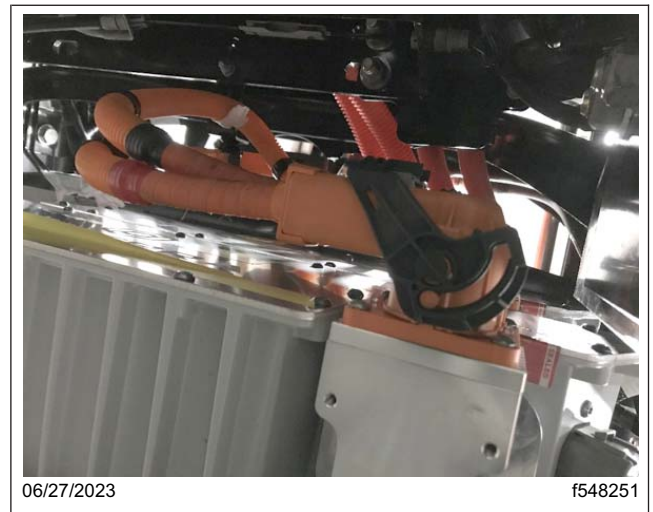
Fig. 3, High-Voltage Cable Connection Location

7. Disconnect the high-voltage (HV) cable connection (total two) from each battery in the pack. See [Fig. 3](#).

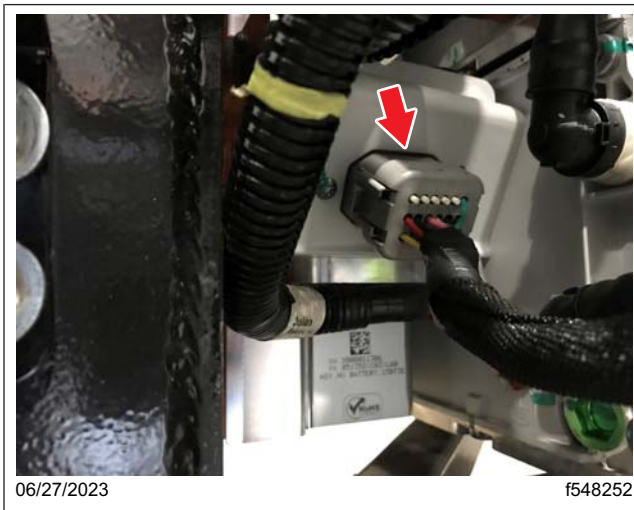
Fig. 4, Communication Harness Location

8. Remove the communication harness (total two) from each battery in the pack. See [Fig. 4](#).
9. Remove the ground cable connection (total two) from each battery in the pack. See [Fig. 5](#).

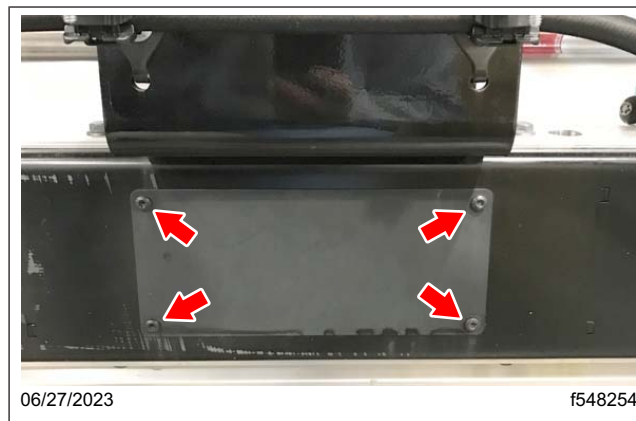
Fig. 6, Access Panel Mounting Fasteners Location

10. Raise the vehicle high enough and place the jack table under the battery.
11. Lower the vehicle down to the point where the battery rests on the jack table, but the weight of the vehicle is not supported by the jack table.
12. To access the mounting fasteners, remove the three access panels from each side of the battery pack (total six), using a torch bit. See [Fig. 6](#).

18. Raise the battery in place and secure the 12 fasteners at all mounting locations. Tighten the fasteners 63 lbf·ft (85 N·m).
 19. Install the six access panels on each battery pack. Tighten the fasteners 62 lbf·in (700 N·cm).

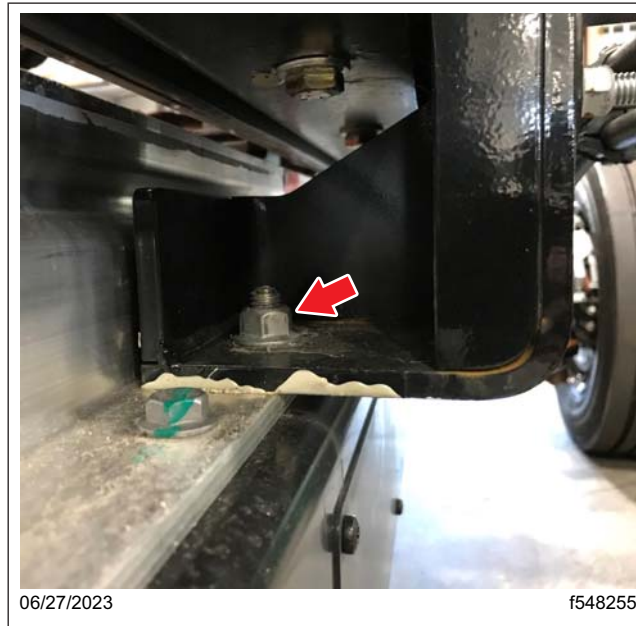
Fig. 7, Battery Pack Mounting Fastener Location

13. Remove the 12 mounting fasteners located at six locations, with three locations on either side of the chassis. See [Fig. 7](#).

NOTE: There should be minimal resistance while lowering the battery pack away from the chassis. If there is any resistance, check that all mounting fasteners have been completely removed from all mounting locations.
