SAFETY RECALL

50 GALLON FUEL TANK PICK UP TUBE

RECALL NO: AASJ0 DATE: 12-7-2022 REFERENCE: QA-221207-N1 **SUBJECT VEHICLES**: Certain 2022 and 2023 model year Conventional trucks equipped with a 50 gallon fuel tank produced at the Mineral Wells, WV assembly plant between October 21, 2021 and October 12, 2022.

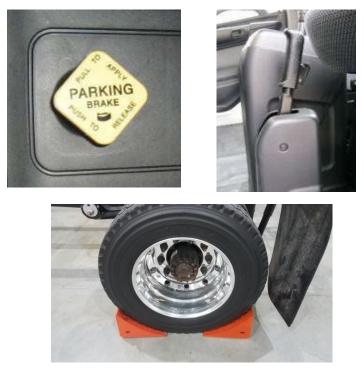
2. Apply the parking brake. Chock all of the wheels.

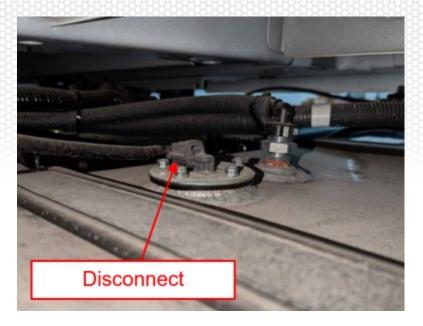
3. Disconnect the fuel level sending unit electrical connection.

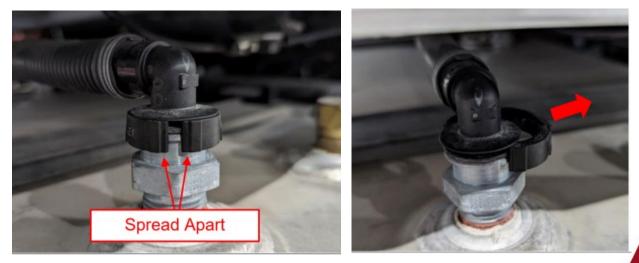
4. Remove the locking ring from the fuel pick up tube at the rear of the fuel tank. Carefully spread the open end of the clip and slide it off the connection. Wrap a rag around the fuel line and lift the fuel line from the fitting.

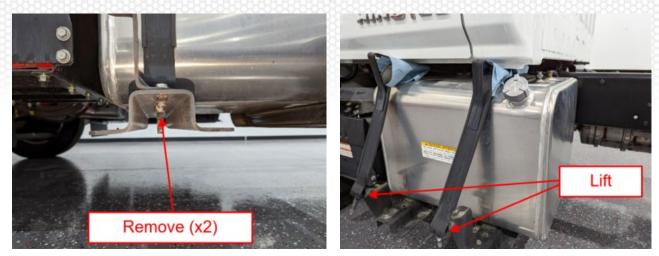
5. Remove the two nuts securing the fuel tank straps to the fuel tank mounting brackets. Discard these nuts, they will not be reused. Protect the underside of the cab with a cloth and lift the fuel tank straps upwards and away from the fuel tank.

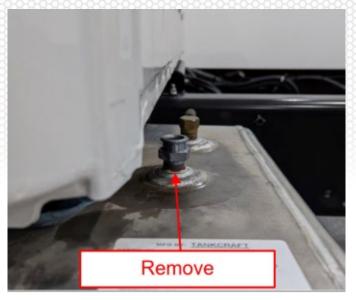
7. Remove the fuel pick up tube from the fuel tank.

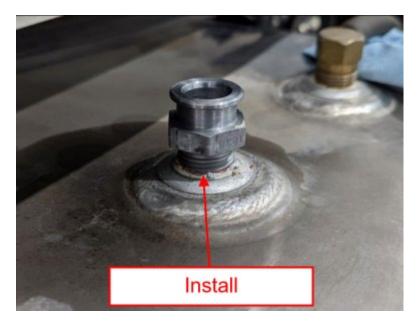
10. Install the fuel pick up tube in the fuel tank and tighten to the specified torque.

Specified Torque: 25 lb-ft (34 Nm)

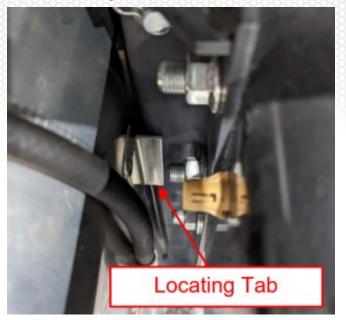
11. Return the fuel tank to its original location. Confirm the locating tabs on the inside of the tank are positioned around the rear tank bracket correctly.

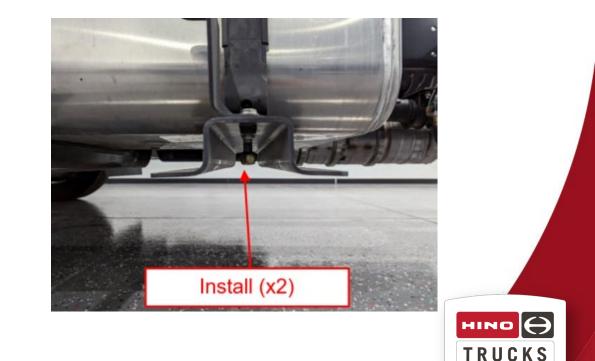
12. Reposition the two fuel tank straps and install a new SZ177-12005 nut on each strap. Do not tighten the nuts at this time.
