| REFERENCE: | Nova Bus Manuals |
| RS N°: | MQR 7621-2594 |
| NHTSA RECALL N°: | 22V902 |

| SUBJECT: | Green side marker light |

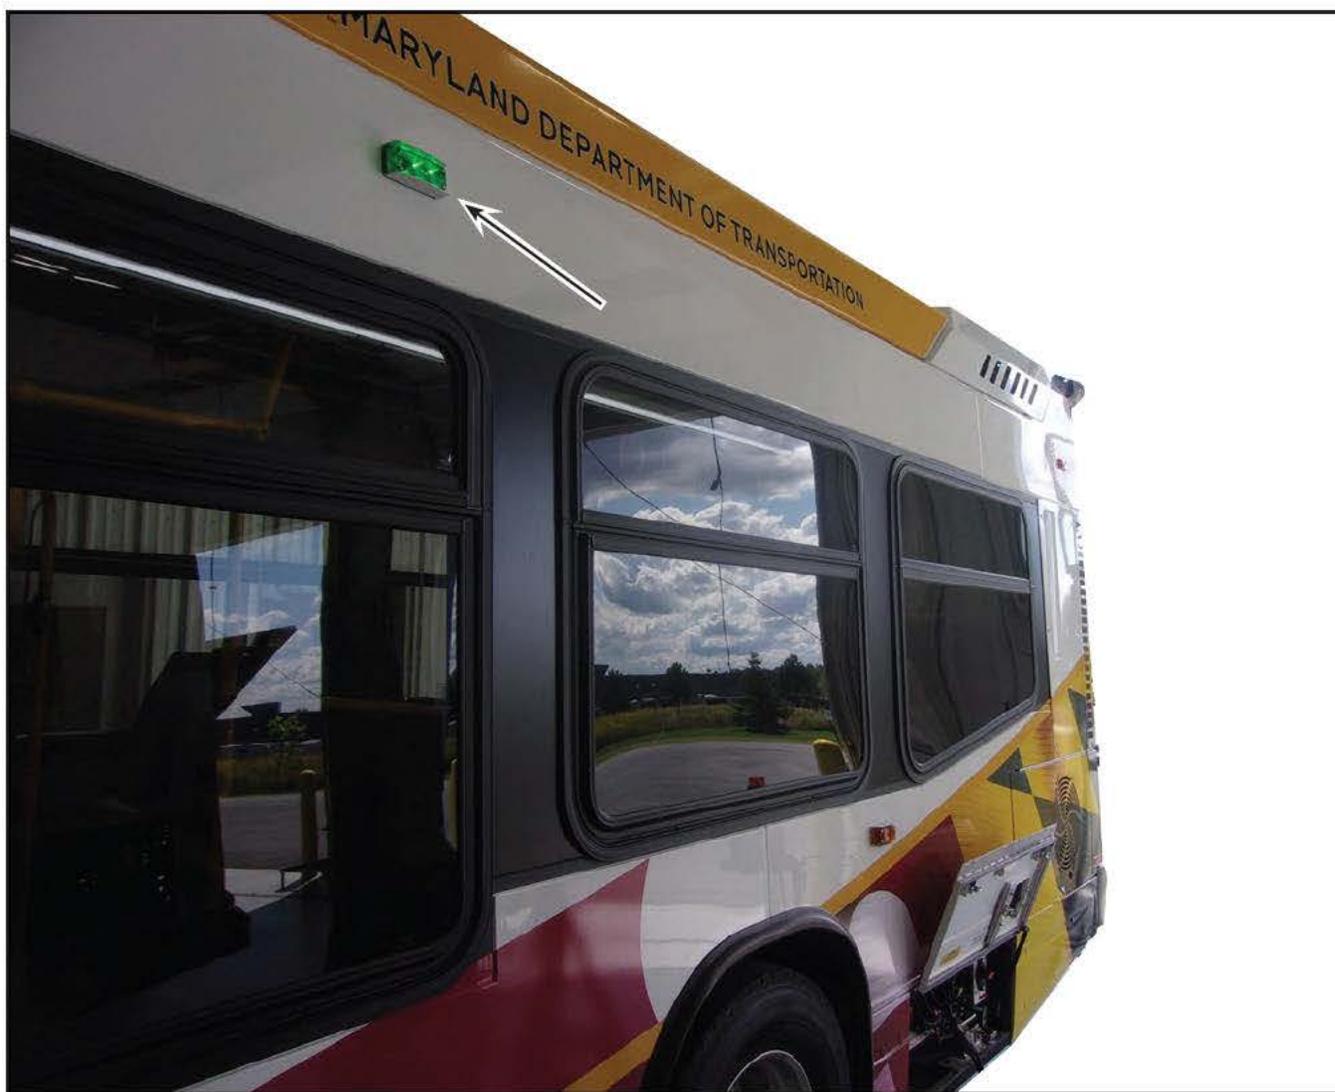
Figure 1 - Location of the Green Marker Light

- 1.6. From the outside of the vehicle, locate the marker light (see figure 1) and remove the 4 screws. Retain the hardware. Discard the light.
- 1.7. Install the new light with new gaskets. Make sure the surfaces are clean to avoid water intrusion inside the vehicle. Torque the screws at 11.5 lb-in (1.3 ± 0.1 N·m)

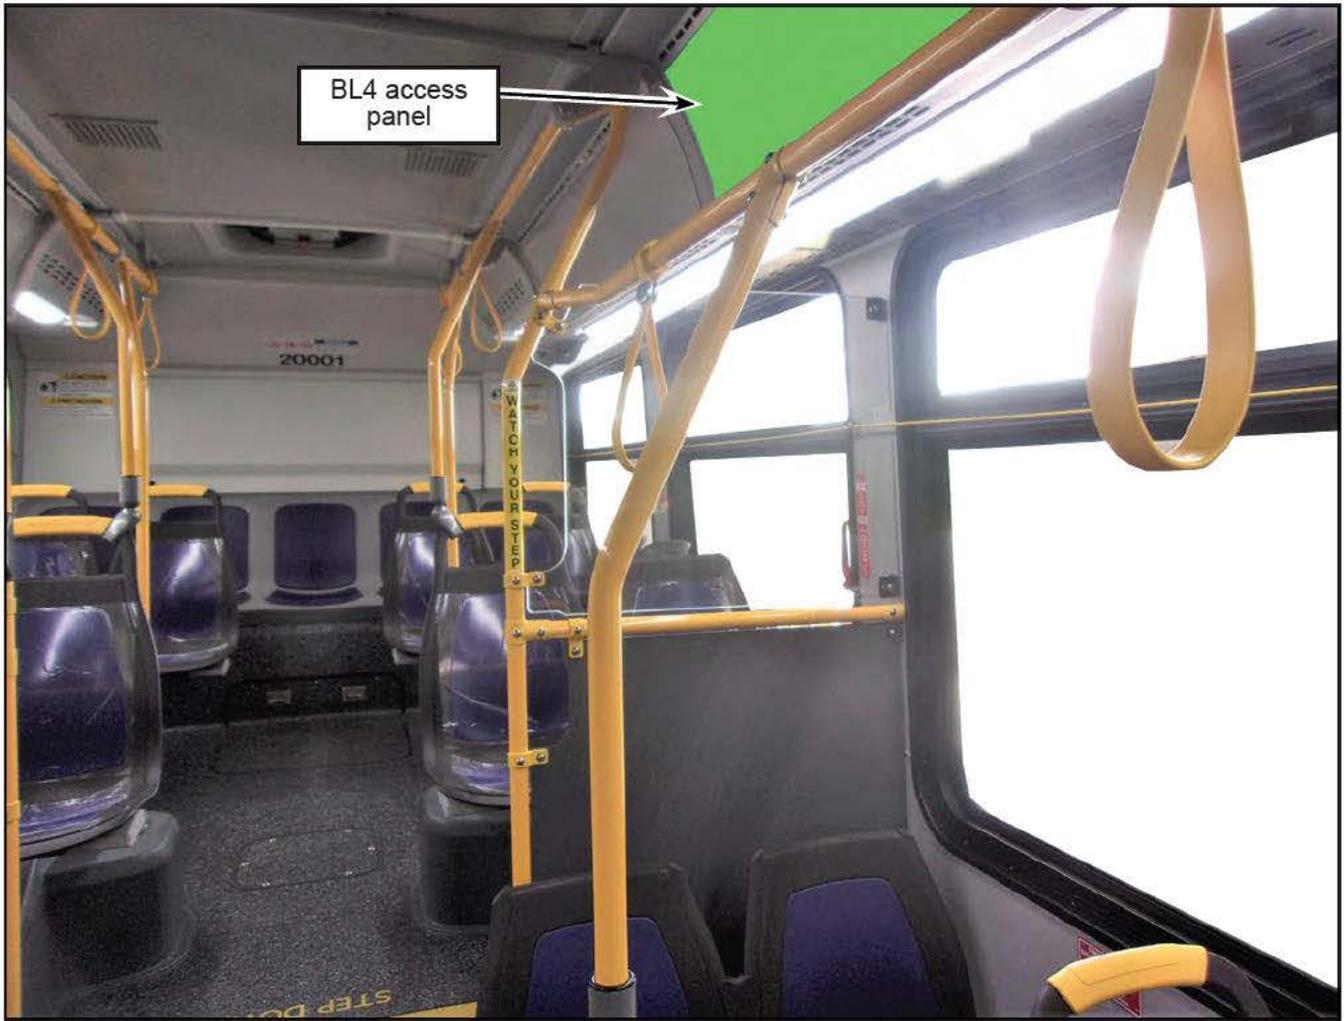
1.4. From the inside of the vehicle, open the access panel BL4.

Figure 2 - Open the Access Panel BL4.

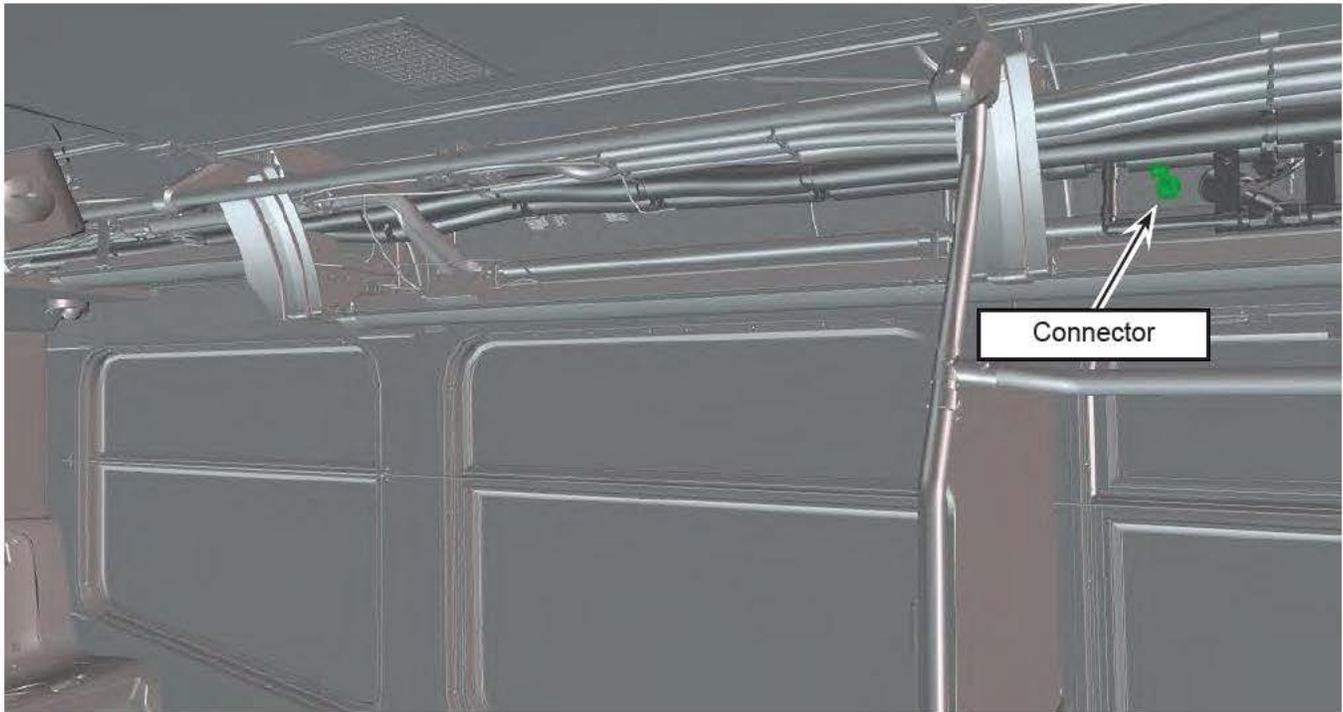
- 1.5. Locate the marker light connector and unplug it.

Figure 3 - Locate the Connector

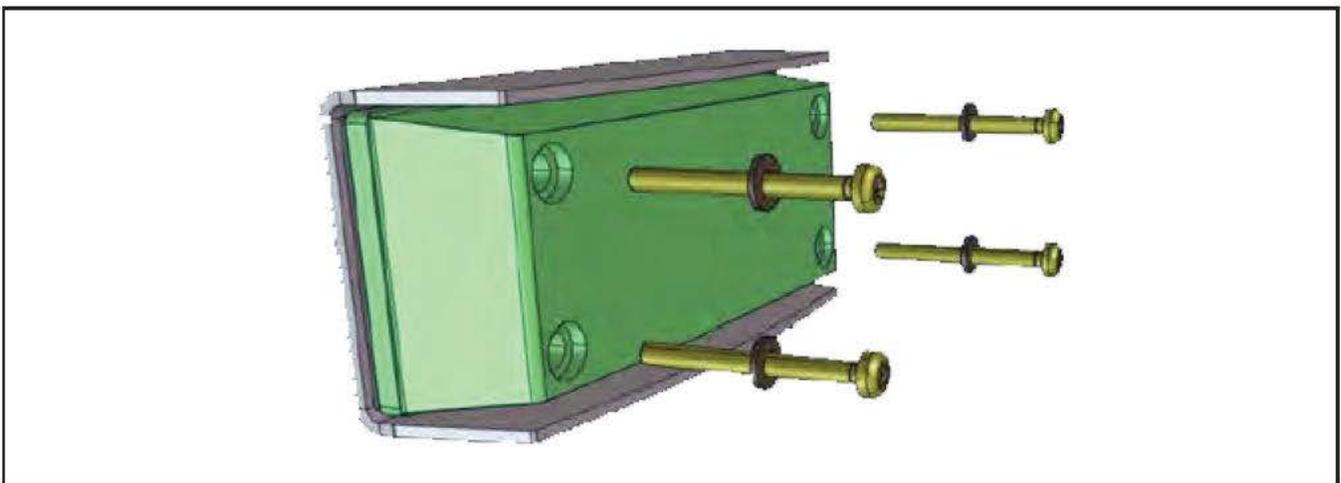
Figure 4 - Replace the Light and the Gaskets
