May 2023
FL962A-S
NHTSA #22V-919
Transport Canada #2022-715

Subject: Tire and Wheel Combination Conformance

Models Affected: Specific model years 2019-2023 Freightliner 108SD, 114SD, 122SD, Business Class M2, and Cascadia; and Western Star 4700 and 4900 vehicles manufactured June 14, 2018, through June 6, 2022.

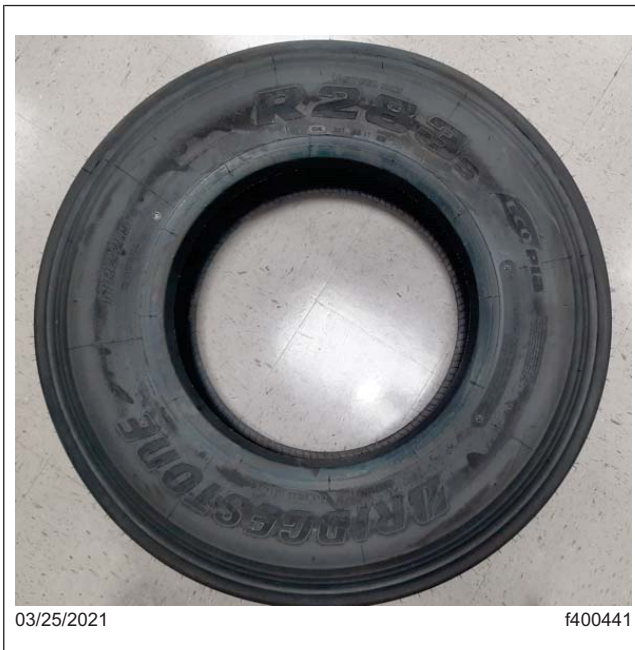
Fig. 1, Bridgestone® R283s Tire

1. Locate the department of transportation (DOT) tire identification number (TIN) on each tire. See [Fig. 1](#), [Fig. 2](#), and [Fig. 3](#).

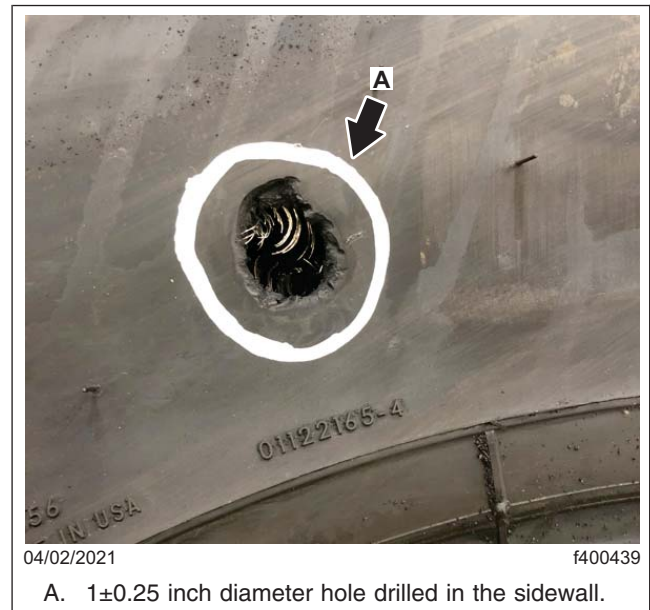
Fig. 4, Hole Drilled

2. Drill a 1±0.25 inch diameter hole in the sidewall of the tire, as shown in [Fig. 4](#).

A. 1±0.25 inch diameter hole drilled in the sidewall.

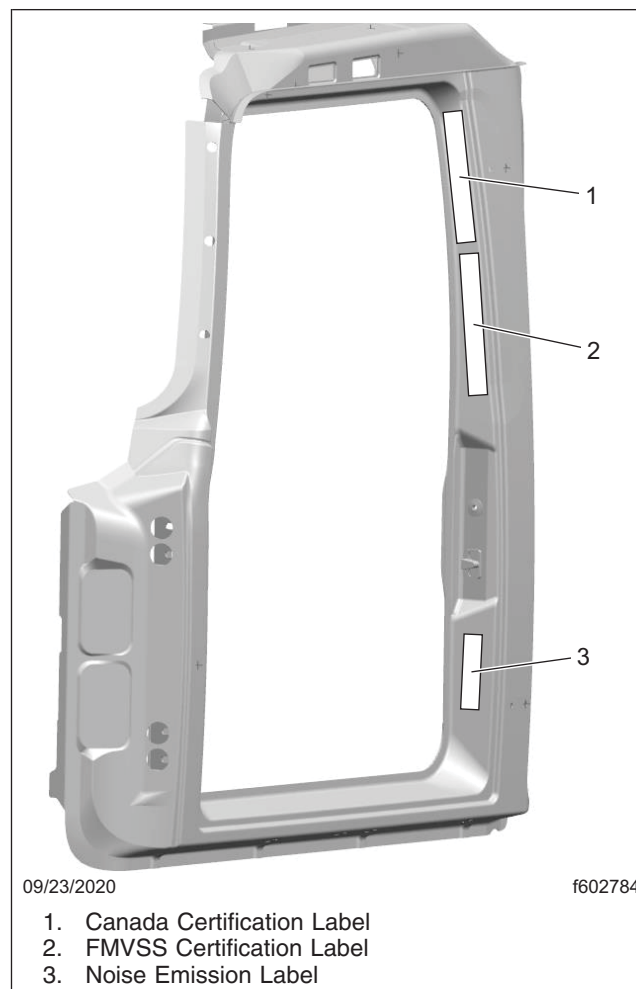
Fig. 13, Western Star Driver's Door B-Pillar Labels

1. Park the vehicle on a level surface, shut down the engine, and set the parking brake. Chock the tires.
2. Open the driver-side door, and locate the Federal Motor Vehicle Safety Standard (FMVSS) certification label, shown in Fig. 12, attached to the B-pillar. See Fig. 13.

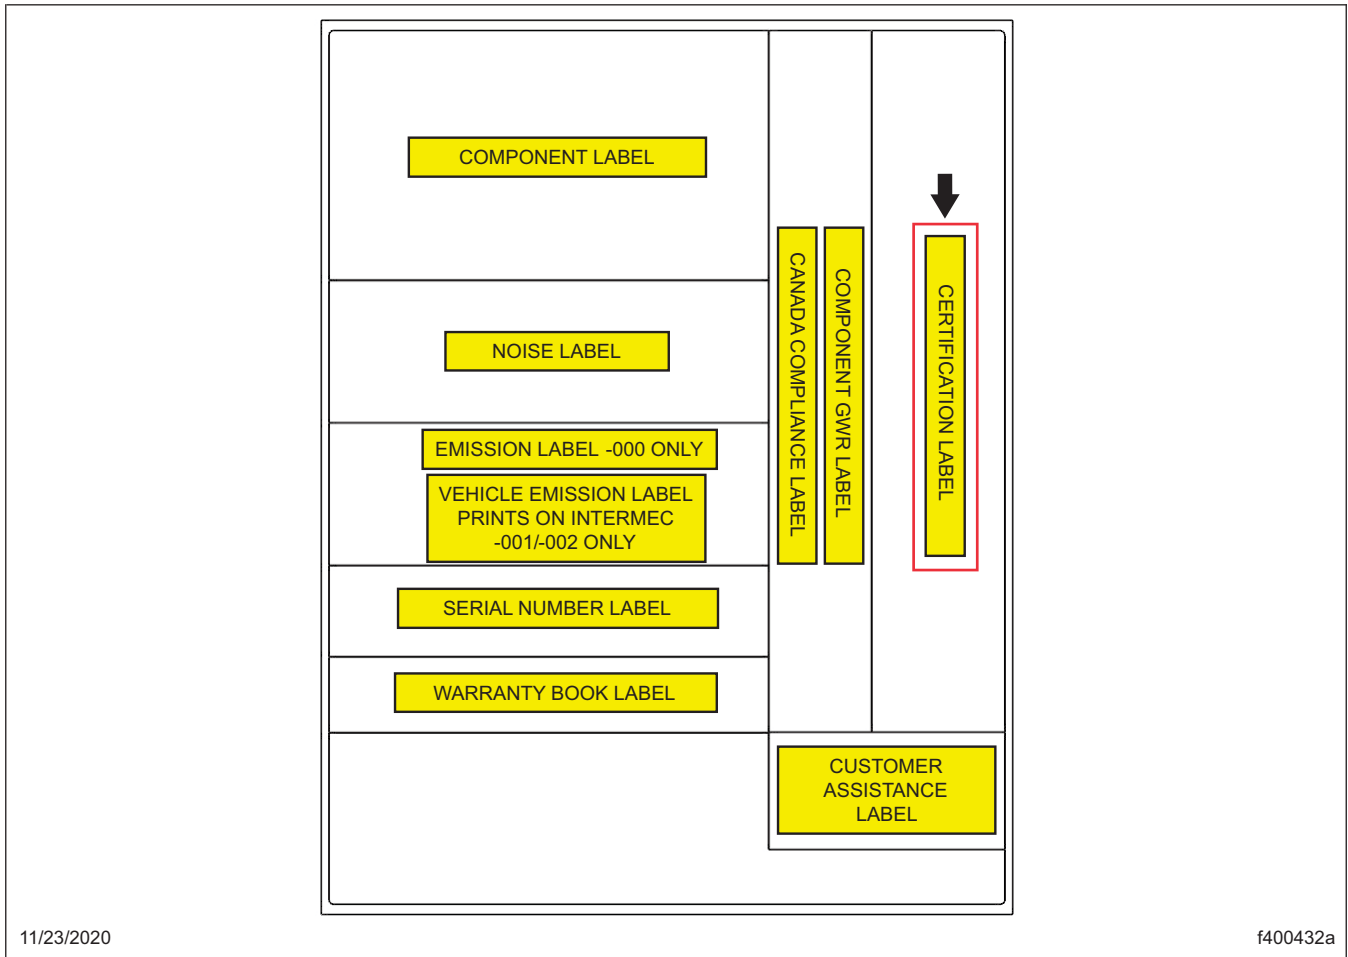
Fig. 14, FMVSS Certification Label Location, Recall Kit, Western Star

3. Locate the new FMVSS certification label. See [Fig. 14](#) for the label location on the label sheet. Make sure the VIN on the current FMVSS certification label matches the VIN on the new FMVSS certification label.

4. Remove the current FMVSS certification label by peeling the clear topcoat label off, and then remove the white base label.
5. Clean the adhesive residue from the label location.
6. Ensure that the area is clean and dry, then affix the new FMVSS certification label with the correct GAWR on it.
7. Affix a new clear topcoat label over the new FMVSS certification label.
8. If the vehicle was certified by a body builder based on the previous GAWR listed on the FMVSS certification label, it will need to be re-certified by the body builder based on the current GAWR rating.
9. Clean a spot on the base label (Form WAR259), and attach a recall completion sticker for FL962 (Form WAR260), indicating this work has been completed.
