ANB8 - Checking Air-Spring Strut on the Front Axle and Replacing it if Necessary (Recall Campaign)

Model Line: **Taycan (Y1A/Y1B)**

Model Year: **2021**

Concerns: **Air-spring strut, front axle**

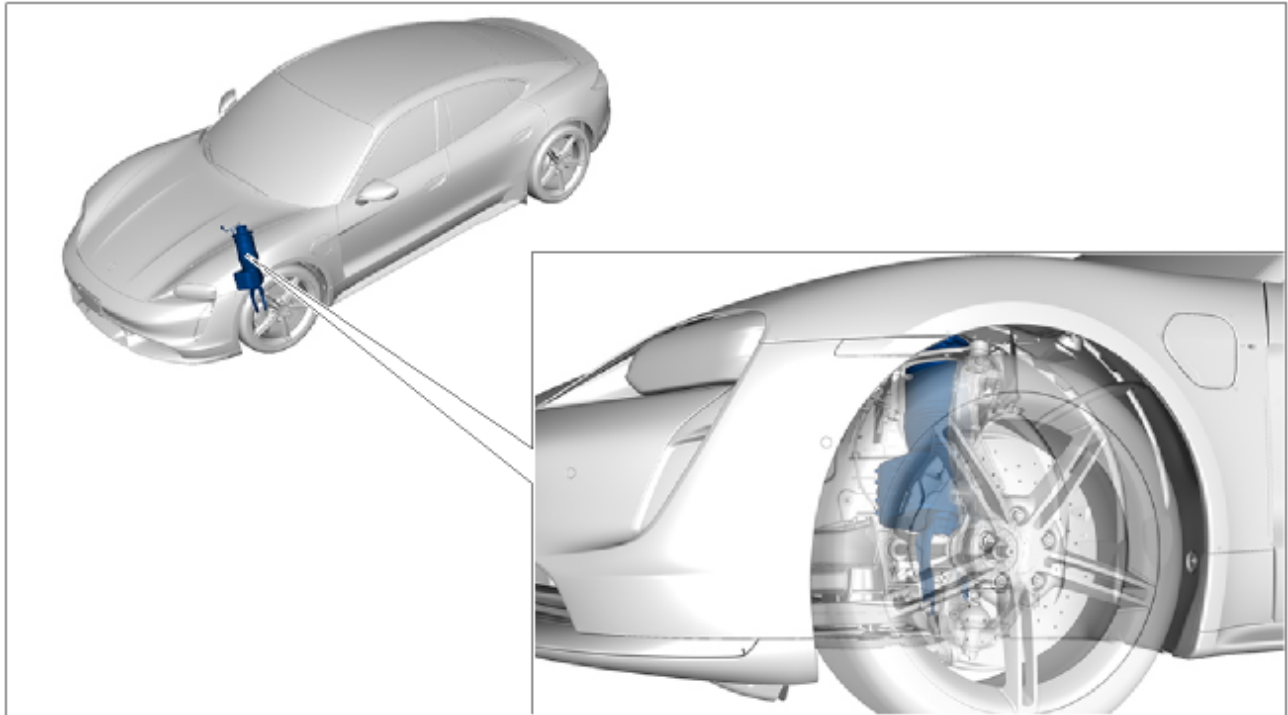
Installation position of air-spring strut

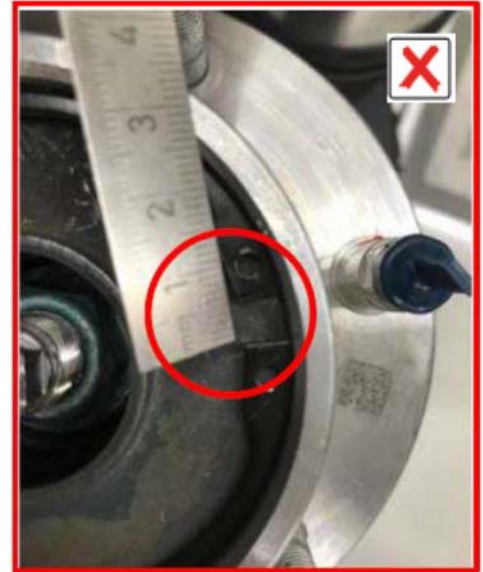
The distance between the ends of the circlips on the right and left side of the vehicle is larger than 9.5 mm/ 0.37 in: ⇒ <i>Test result OK.</i>	End of remedial action. Continue with Step 4.
The distance between the ends of the circlips on the right or left side of the vehicle is less than or equal to 9.5 mm/ 0.37 in: ⇒ <i>Test result not OK.</i>	Continue with Scope 2, 3 or 4 , depending on the vehicle type.
The distance between the ends of the circlips on the right and left side of the vehicle is less than or equal to 9.5 mm/ 0.37 in ⇒ <i>Test result not OK.</i> or The distance between the ends of the circlip on one side of the vehicle is less than or equal to 9.5 mm/ 0.37 in and the vehicle has a mileage/km greater than 18,641 mls/ 30,000 km:	Continue with Scope 5, 6 or 7 , depending on the vehicle type.

Test result not OK.

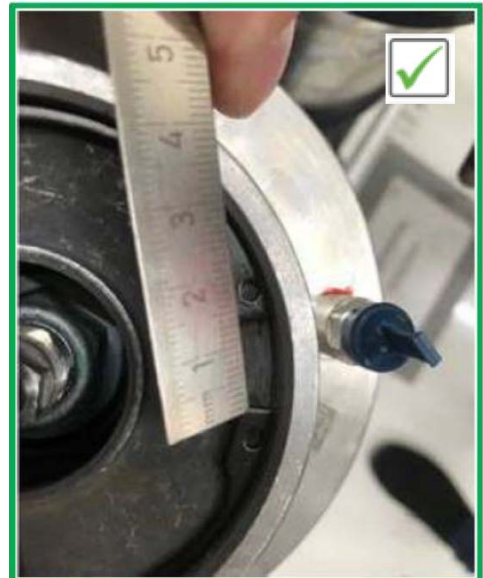
Test result OK.
