Recall Campaign Bulletin

Campaign No. 2023010006, January 2023

SUBJECT: **Model C-Class, CLK-Class, E-Class, CLS-Class (203, 209, 211, and 219 platform)
Model Year 2001-2011**

Check Sliding Roof Bonding

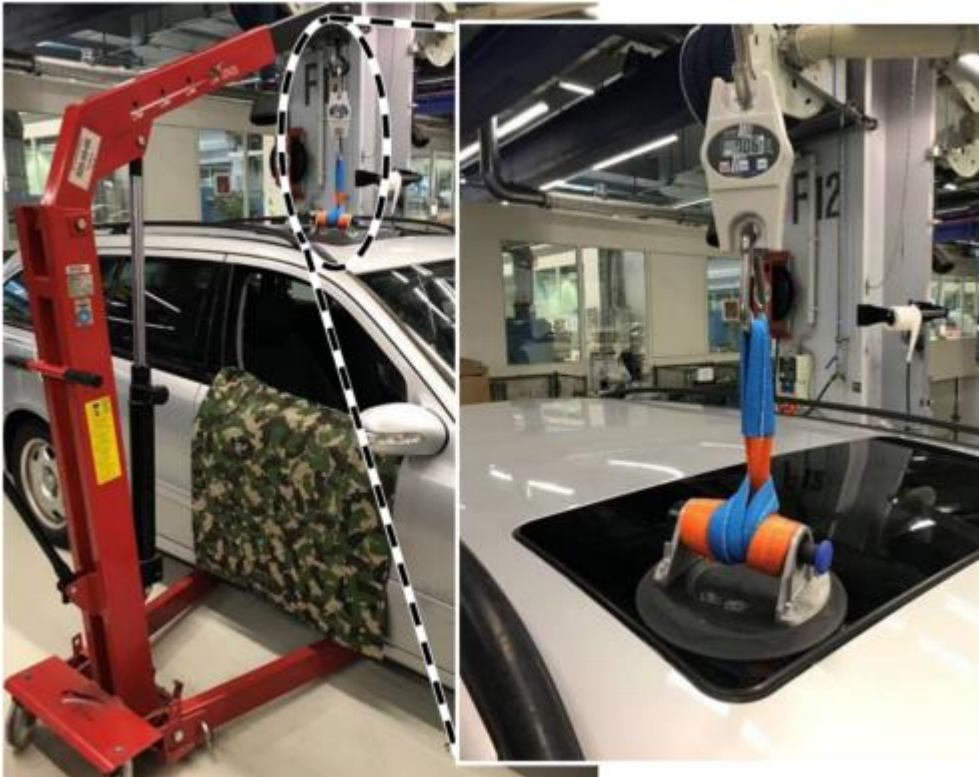
Figure 2

i Special caution must be exercised during the check. The suction cup tool may be used for this check.
 3. Position suction cup tool (figure 2) and pull as **vertically** as possible (tolerance of ± 10 degrees) using lifting tool.

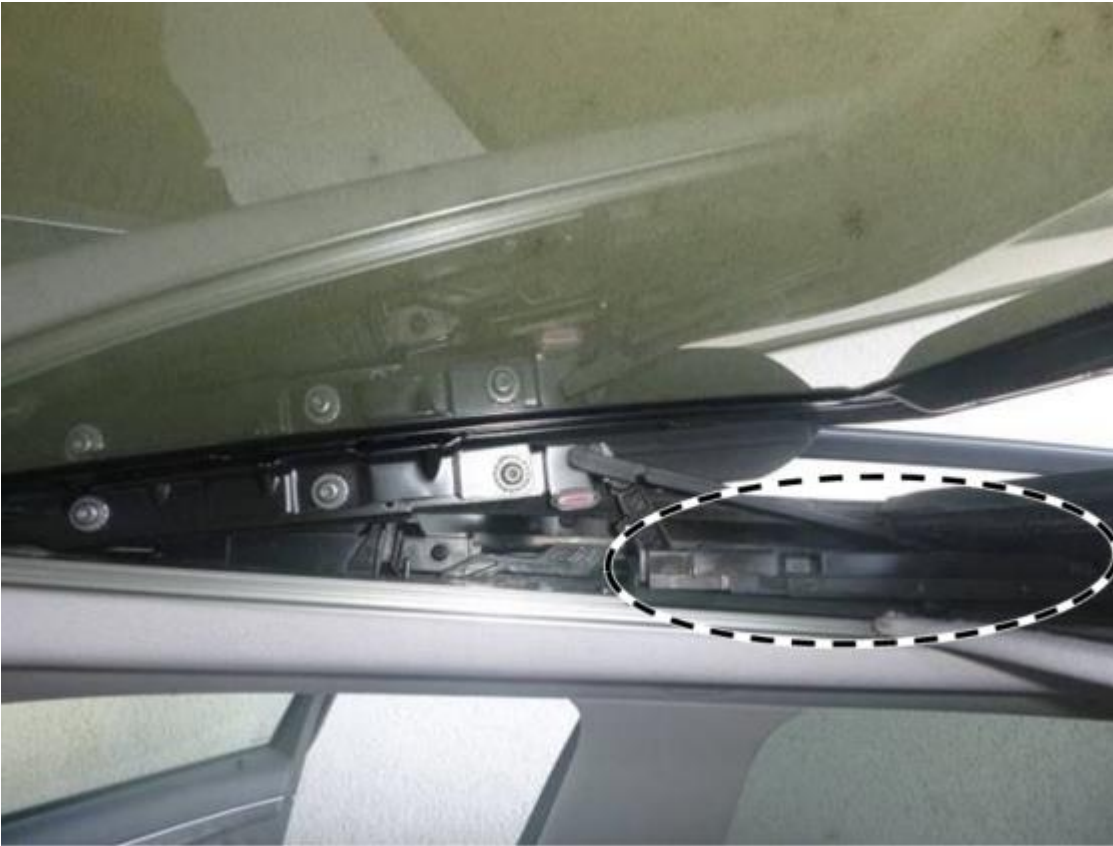
Figure 6

i The accordion boot **need** not be removed completely. It is sufficient to slide it back (figure 6).

1. Replace sliding sunroof.
