# EQUIPMENT SAFETY RECALL – NORTH AMERICA

## Malfunctioning SCCM - Equipment

Reference: B3A / NHTSA 23E-092

**Parts Recalled** MOPAR Steering Column Control Modules 68508697AB, 68508699AB, 68508698AB, 68508700AB, 68508701AF, 68508702AF and 68508704AF intended for use on some 2023-2024 (D2) RAM 3500 Pickup, 2023-2024 (DD) RAM 3500 Cab/Chassis, 2023 (DF) RAM 3500 10K LB. Cab/Chassis, 2023-2024 (DJ) RAM 2500 Pickup, 2023-2024 (DP) RAM 4500/5500 Cab Chassis and 2023 (DS) RAM 1500 Pickup vehicles

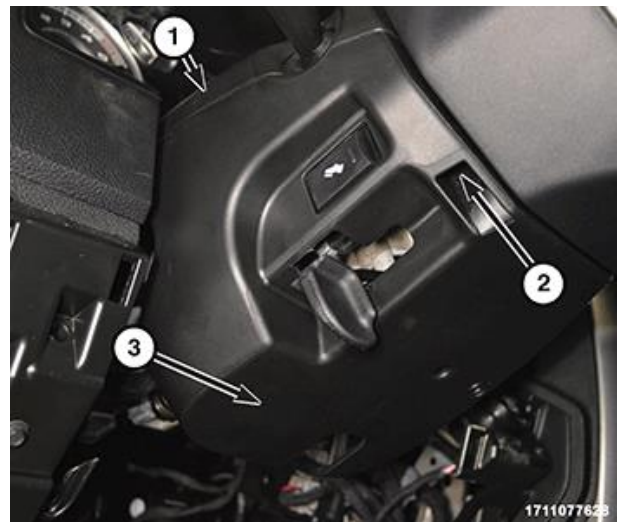
Figure 1 – Steering Column Upper Shroud

1. Place the front wheels in the straight-ahead position.
2. Disconnect and isolate the negative battery cable. If equipped with an Intelligent Battery Sensor (IBS), disconnect the IBS connector first before disconnecting the negative battery cable.
3. From below the steering column, remove the two outboard screws within the recess areas (2) that secure the upper shroud (1) to the lower shroud (3) (Figure 1).

4. Remove the upper shroud (1) by pushing gently inward and upward on both sides of the upper shroud above the parting line of the lower shroud to release the snap features that secure the two shroud halves to each other (Figure 1).
5. Release the steering column tilt lever and lower the column to its most downward position for easiest driver airbag removal access.

21. Position the upper shroud (1) onto the steering column over the lower shroud (3) (Figure 1).
22. Align the snaps features on the upper and lower shroud halves and apply hand pressure to snap together.
23. From below the steering column, install the two outboard screws within the recess areas (2) that secure the upper shroud (1) to the lower shroud (3) (Figure 1).

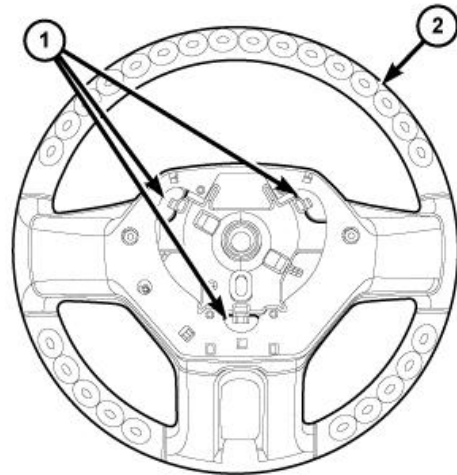
**Figure 2 – Airbag Retainer Access Holes**

- There are three airbag retainer access holes (1) on the instrument panel side of the hub of the steering wheel (2), located at the two o'clock, six o'clock and ten o'clock positions. The steering wheel must be rotated to bring each of these access holes up to the twelve o'clock position of the steering column one at a time for removal access (Figure 2).

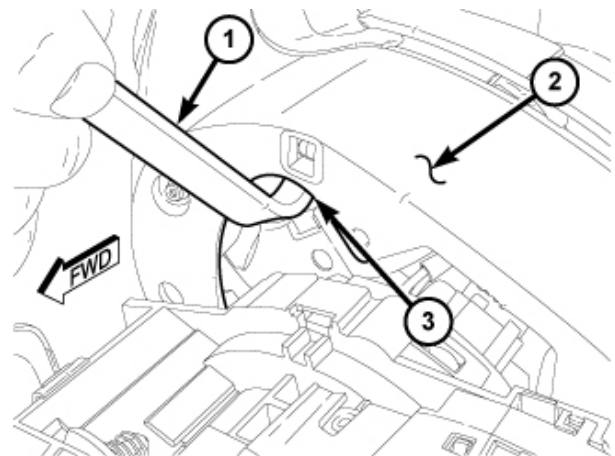
**Figure 3 – DAB Removal Tool 10187**

- Insert the short blade (Tip A) of the DAB Removal Tool (Special Tool Number 10187 ) (1) or the blade of an equivalent prying tool into either of the upper (two o'clock or ten o'clock) access holes (3) of the steering wheel hub rear trim cover (2), being certain to place the blade of the tool on the inboard (steering wheel hub) side of the airbag snap retainer wire loop (Figure 3).

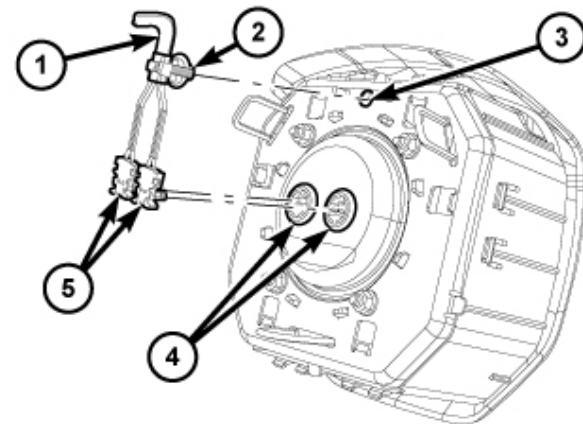
**Figure 5 – Pigtail Wiring Harness Retainer**

11. Pull the DAB away from the steering wheel far enough to access and disengage the plastic push-in retainer (2) of the clockspring pigtail wire harness (1) from the locator hole (3) at the 12 o'clock position on the back of the airbag housing (Figure 5).

15. Position the Driver AirBag (DAB) close enough to the steering wheel to reconnect the two clockspring DAB pigtail wire (1) electrical connections (5) to the inflator connector receptacles (4) on the back of the airbag housing (Figure 5).

17. Be certain to fully engage the plastic push-in retainer (2) of the clockspring pigtail wires into the locator hole (3) at the 12 o'clock position on the back of the airbag housing (Figure 5).

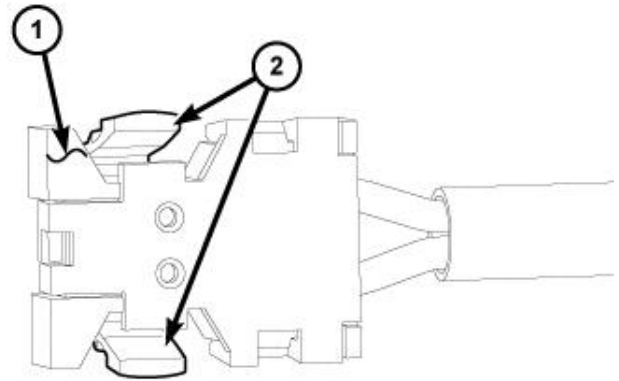
Figure 6 – Connector Insulator Latches

12. The clockspring DAB pigtail wire connector insulators (1) are secured by integral latches (2) to the airbag inflator connector receptacles, which are located on the back of the airbag housing. Pinch both latches firmly, then pull the insulators straight out from the airbag inflator to disconnect them from the connector receptacles (Figure 6).
13. Remove the DAB from the steering wheel.
14. Remove the steering wheel bolt and **DISCARD**.

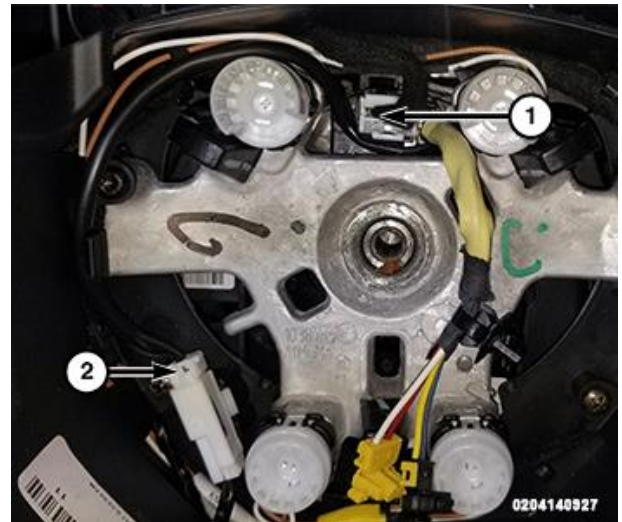
Figure 7 – Wire Harness Connectors

15. Disconnect the wire harness connectors (1) and (2) (Figure 7).
16. Remove the steering wheel.

13. Install the **NEW** steering wheel bolt. Tighten the bolt to 61 N·m (45 ft. lbs.).
14. Connect the wire harness connectors (1) and (2) (Figure 7).

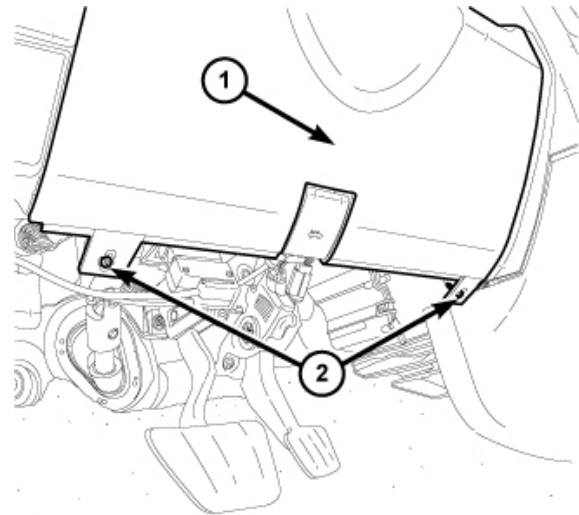
**Figure 8 – Steering Column Opening Cover**

17. Using a trim stick C-4755 or equivalent, disengage the retainer clip that secures the hood release to the steering column opening cover, and remove the hood release handle from the cover (Figure 8).
18. Remove the two fasteners (2) that secure the bottom of the steering column opening cover (1) to the instrument panel (Figure 8).

7. Lift the steering column opening cover into position. Connect necessary wire harness connectors.
8. Align the retainer clips that secure the steering column opening cover (1) to the instrument panel and install the cover (Figure 10).
9. Install the Data Link Connector (3) to the steering column opening cover (2) through the opening on the back side of the cover (Figure 9).
10. Install the two fasteners (2) that secure the bottom of the steering column opening cover (1) to the instrument panel and tighten securely (Figure 8).
11. Engage the retainer clip that secures the hood release to the steering column opening cover (Figure 8).

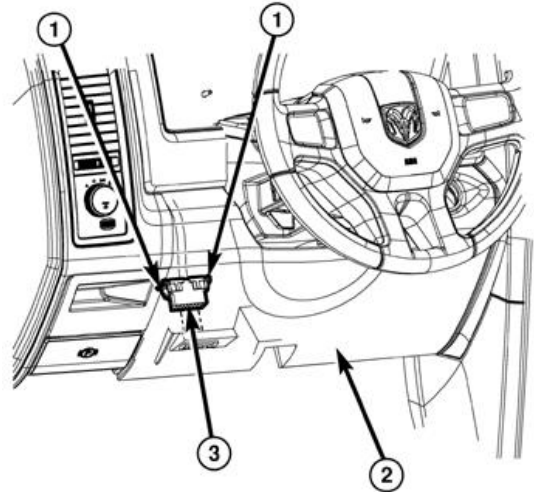
**Figure 9 – Data Link Connector**

19. Remove the Data Link Connector (3) from the steering column opening cover (2) by pressing in the tabs (1) and pushing the connector through the opening on the back side of the cover (Figure 9).

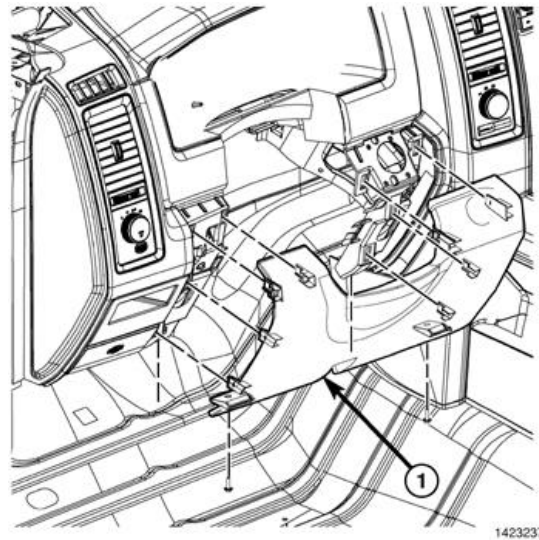
**Figure 10 – Steering Column Opening Cover**

- 20. Using a trim stick C-4755 or equivalent, release the retainer clips that secure the steering column opening cover (1) to the instrument panel and remove the cover (Figure 10).
- 21. Disconnect necessary wire harness connectors.

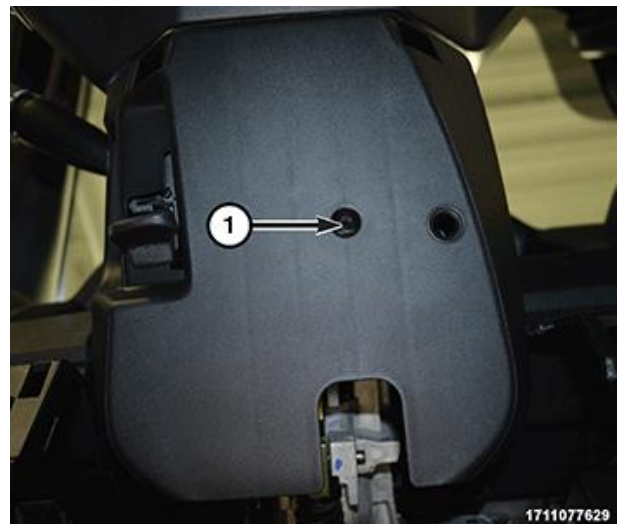
**Figure 11 – Steering Column Lower Shroud**

- 22. Remove the lower shroud to column retaining screw (1) and carefully move the lower shroud over the steering column tilt lever and off the steering column (Figure 11).

6. Install the lower shroud, shroud to column retaining screw (1) and tighten securely (Figure 11).

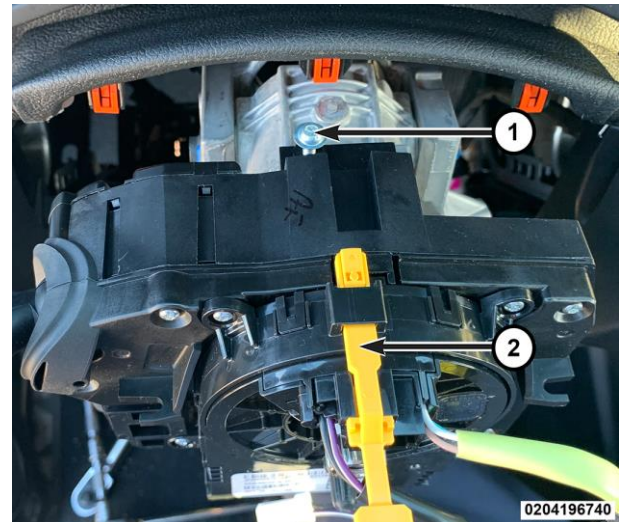
**Figure 12 – SCCM Screw**

- 23. Remove the screw (1) (Figure 12).

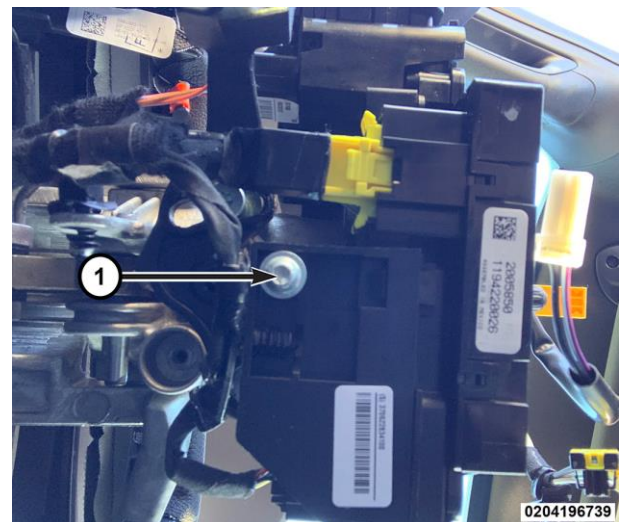
**Figure 13 – SCCM Screw**

- 24. Remove the screw (1) (Figure 13).
- 25. Pull the SCCM slightly away from the steering column and disconnect the pedal adjustment wire harness connector, if equipped.

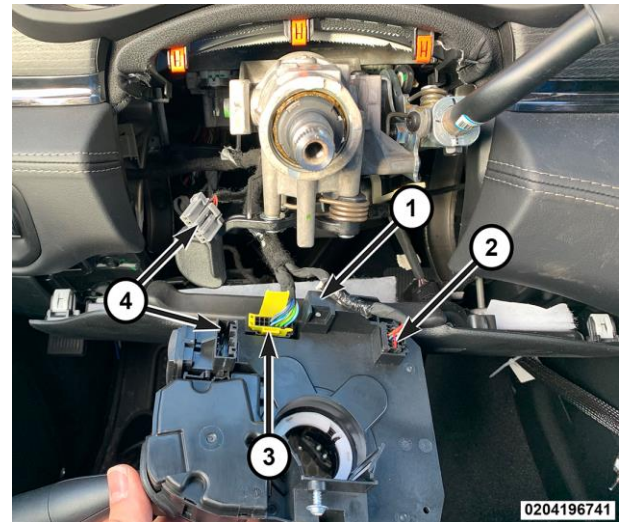
**Figure 14 – SCCM Removal**

26. Remove the SCCM from the steering column (Figure 14).
27. Disengage the wire harness routing clip (1) (Figure 14).
28. Disconnect the wire harness connectors (2 & 3) (Figure 14).
29. Remove and DISCARD the SCCM from the vehicle.

1. Connect the wire harness connectors (2&3) (Figure 14).
2. Secure the wire harness routing clip (1) (Figure 14).
3. While sliding the SCCM over the steering column connect the pedal adjustment wire harness connector, if equipped.
4. Install and securely tighten the screws (1) (Figures 12 & 13).
5. Remove the lock tab or any other device that is being used to secure the SCCM rotor to the SCCM case to maintain SCCM centering.

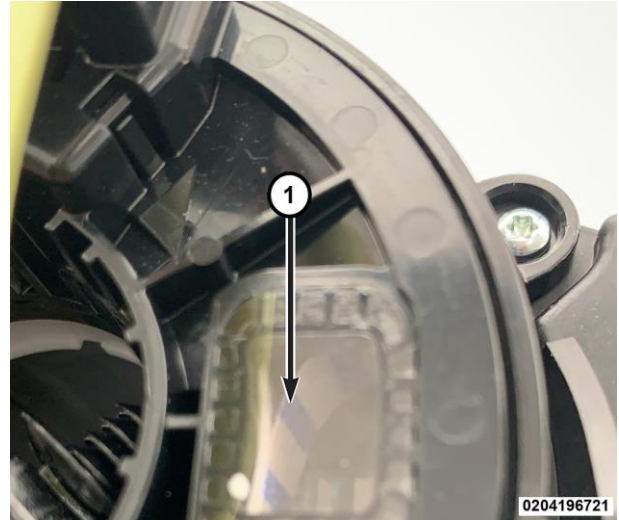
**Figure 15 – Blue Stripe Ribbon**

**NOTE: The Steering Column Control Module (SCCM) centering can be verified by visually confirming the blue striped ribbon is present in the sight glass (Figure 15).**

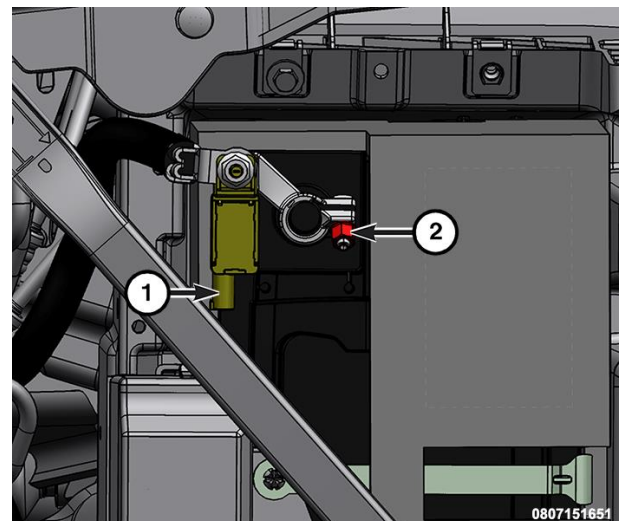
Figure 16 – IBS Connector

2. Disconnect the Intelligent Battery Sensor (IBS) wire harness connector (1) (Figure 16).

3. Loosen the ground terminal nut (2) and remove the negative battery cable with IBS from the battery and isolate it.

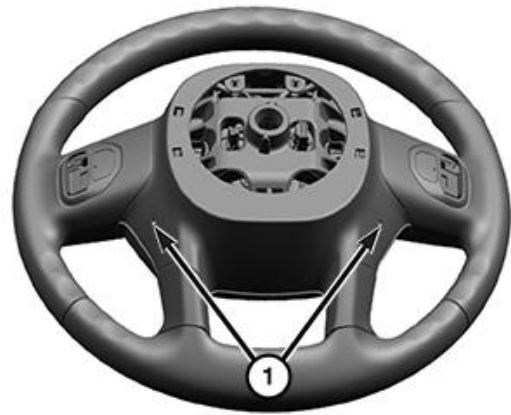
**Figure 17 – DAB Removal**

5. Wait 2 minutes for capacitor discharge.
6. Locate the access hole dimples (1) in the lower surface of the steering wheel hub rear trim cover near each of the two horizontal spokes.
7. Using the Remover, Driver Air Bag 2050200100, pierce the trim cover at the dimple and insert it through one of the steering wheel access holes. A guide and notch integral to each side of the steering wheel hub rear trim cover and the mounting/horn switch plate will assist in directing the tool to the ends of the retainer spring (Figure 17).

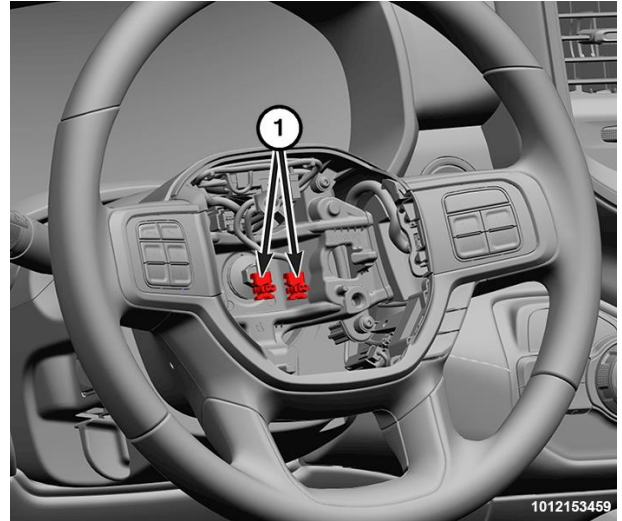
**Figure 18 – Steering Wheel Wire  
Harness Connectors**

11. Pull the DAB away from the steering wheel far enough to access the steering wheel wire harness connector to the DAB inflator initiators (1) (Figure 18).

13. Connect the two steering wheel wire harness connectors (Figure 18).
14. Position the DAB close enough to the steering wheel to connect the steering wheel wire harness connectors to the DAB inflator initiators (1) (Figures 18 and 19).

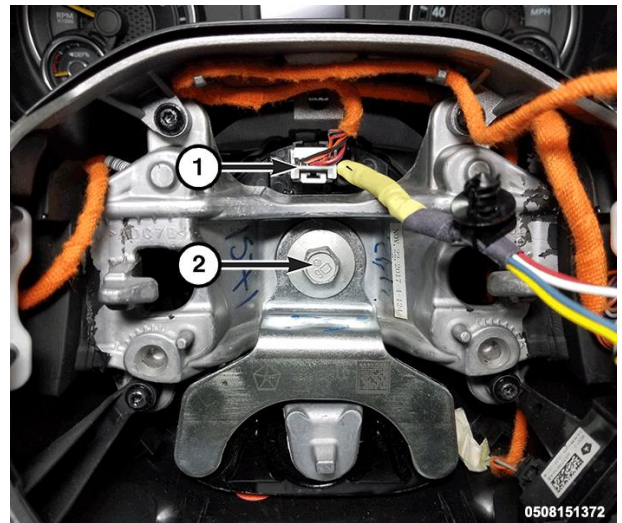
**Figure 19 – Steering Wheel Wire Harness Connectors**

12. The clockspring DAB pigtail wire connector insulators are secured by integral latches and a Connector Position Assurance (CPA) lock to the airbag tether cutter and inflator connector receptacles, which are located on the back of the floating horn switch plate and the DAB housing. Pull the lock straight away from the connector insulator, then pull the insulators straight away from the connector receptacles to disengage and disconnect them (Figure 18).
13. Remove the DAB and floating horn switch plate from the steering wheel as a unit.
14. Disconnect the steering wheel wire harness connectors (1) (Figure 19).
15. If equipped, disconnect the heated steering wheel wire harness connectors.
16. Remove and **DISCARD** the steering wheel bolt (2) and retain the damper if equipped (Figure 19).

11. Install the steering wheel to the steering column.
12. If equipped, position the damper to the steering wheel, then install a **NEW** steering wheel bolt and tighten the nut to 61 N·m (45 ft. lbs.) (Figure 19).

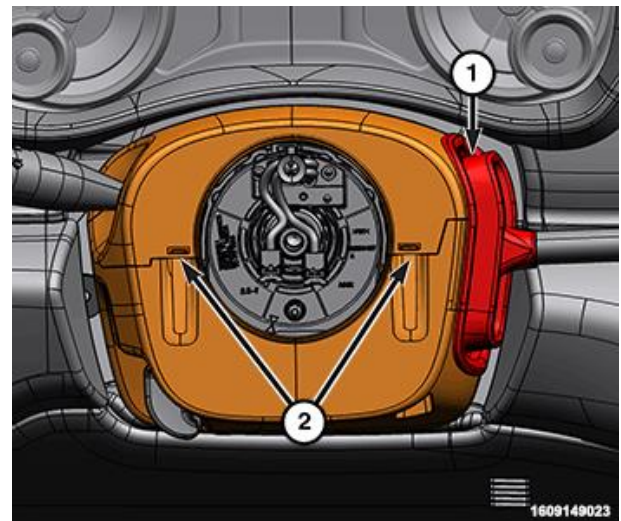
**Figure 21 – Steering Column Shroud**

- 18. If equipped, release the shifter boot (1) from the steering column shroud (Figure 21).
- 19. Disengage the upper steering column shroud tabs (2) from the lower steering column shroud (Figure 21).

7. Install the upper steering column shroud to the lower steering column shroud (Figure 21).
8. If equipped, install the shifter boot (1) to the steering column shroud (Figure 21).

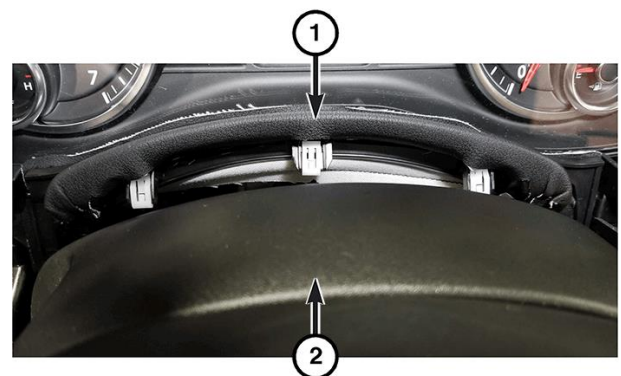
**Figure 22 – Gap Hider**

- 20. Disengage the gap hider (1) from the upper steering column shroud (2) and remove the upper steering column shroud (Figure 22).

6. Engage the upper steering column shroud (2) to the gap hider (1) (Figure 24). **Verify that the top shroud is properly secured to the gap hider. Move the tilt column up and down to ensure the gap hider stays connected to the upper shroud.**

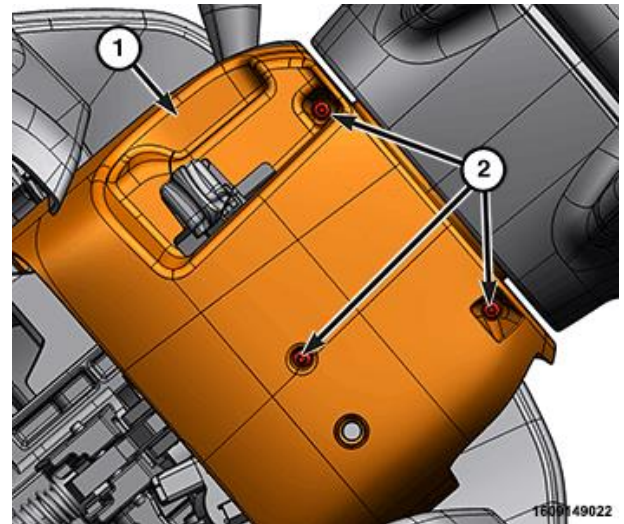
**Figure 23 – Lower Steering Column Shroud**

21. Remove the lower steering column shroud screws (2), then the shroud (1) (Figure 23).

4. Install and securely tighten the SCCM screws (1) (Figure 24 and 25).
5. Position the lower steering column (1) shroud to the steering column (Figure 23).

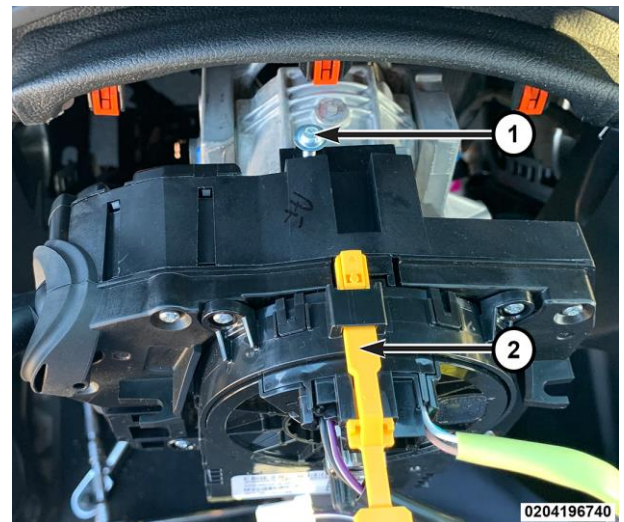
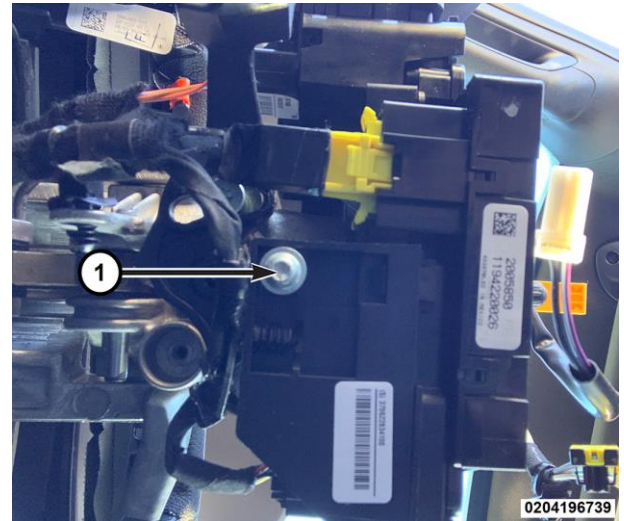
**Figure 24 – SCCM**

22. Secure the SCCM in the straight-ahead position.  
23. Remove the screws (1) (Figure 24 and 25).

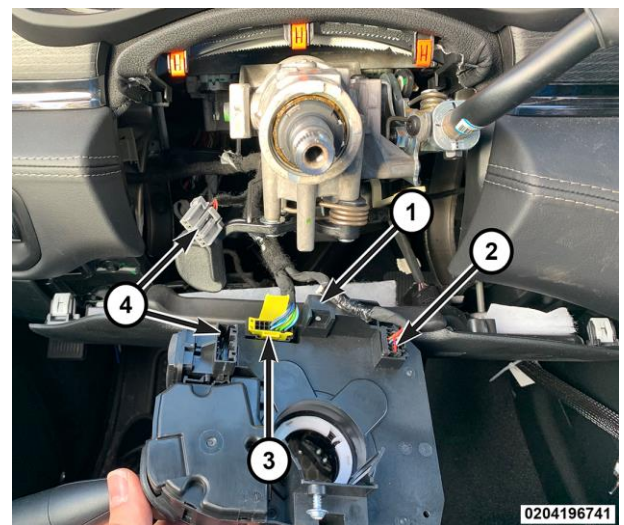
**Figure 26 – SCCM**

24. Pull the SCCM slightly away from the steering column and disconnect the pedal adjustment wire harness connector (4), if equipped (Figure 26).
25. Remove the SCCM from the steering column.
26. Disengage the wire harness routing clip (1) (Figure 26).
27. Disconnect the wire harness connectors (2 & 3) (Figure 26).

1. Connect the wire harness connectors (2 & 3) (Figure 26).
2. Secure the wire harness routing clip (1) (Figure 26).
3. While sliding the **NEW** SCCM over the steering column connect the pedal adjustment wire harness connector.

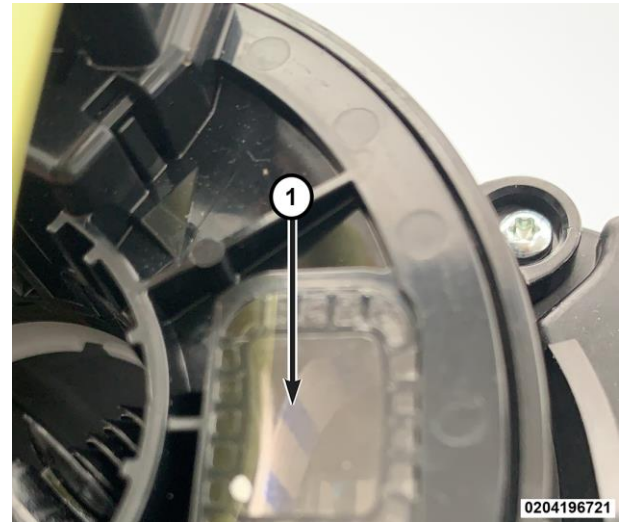
**Figure 27 – Blue Stripe Ribbon**

**NOTE: The Steering Column Control Module (SCCM) centering can be verified by visually confirming the blue striped ribbon is present in the sight glass (Figure 27).**
