SAFETY RECALL BULLETIN

NHTSA RECALL 23V019

AUTOCAR, LLC SAFETY RECALL ACX-2302

Autocar, LLC has determined that certain ACX models manufactured with an external sun visor obstructs the roof mounted clearance lamps.

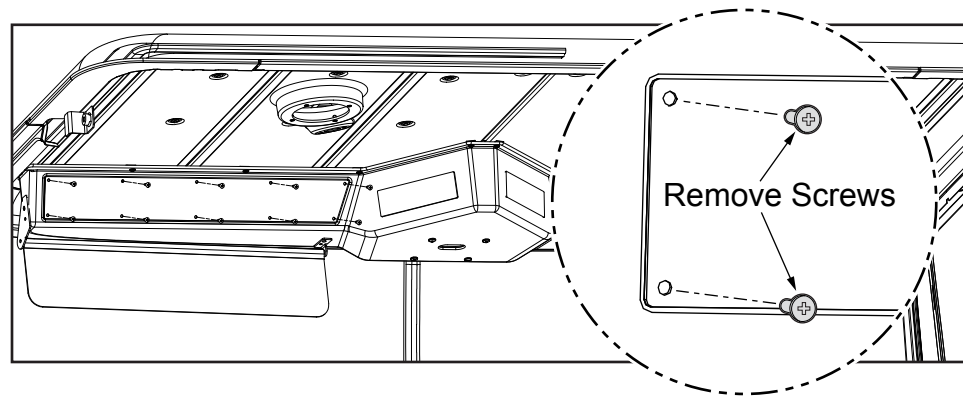
Figure 1

1. Follow all lockout/tagout procedures and verify the battery disconnect switch is in the "OFF" position. If the unit is not equipped with a battery disconnect switch, disconnect the battery cables beginning with the negative cables, followed by the positive cables.
2. Unlock and open both cab doors.
3. Locate and remove the (20) screws from the overhead console covers, set the screws and covers aside for reinstallation (See *Figure 1*).

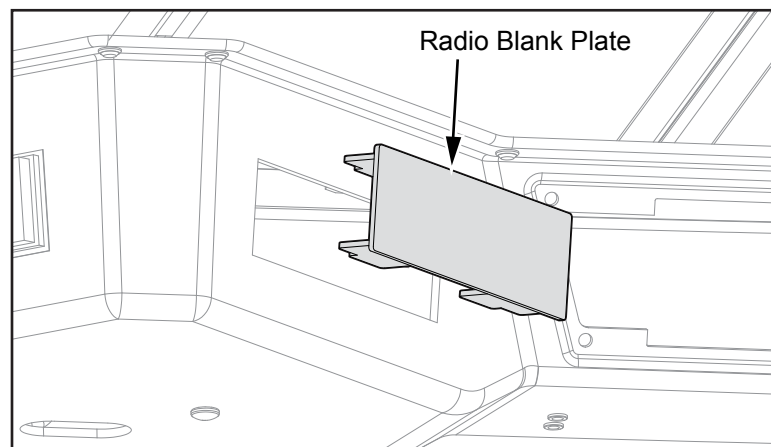
Figure 2

4. Remove the radio blank plate from the overhead console and set aside for reinstallation (See *Figure 2*).

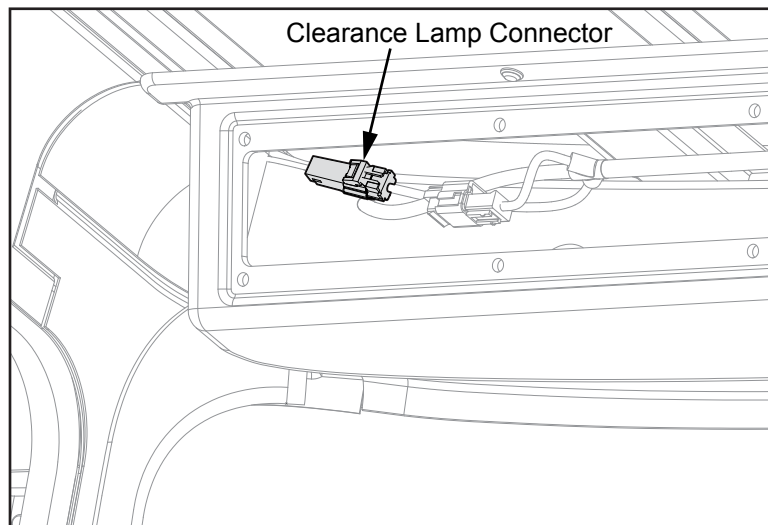
Figure 3

5. Locate (3) identification lamp and (2) clearance lamp connectors within the overhead console and disconnect them from the overhead harness (See Figures 3, 4 and 5).

Note: Figures 3, 4 and 5 represent the most common location and application. Due to production variations, your vehicle may vary from the illustrations.

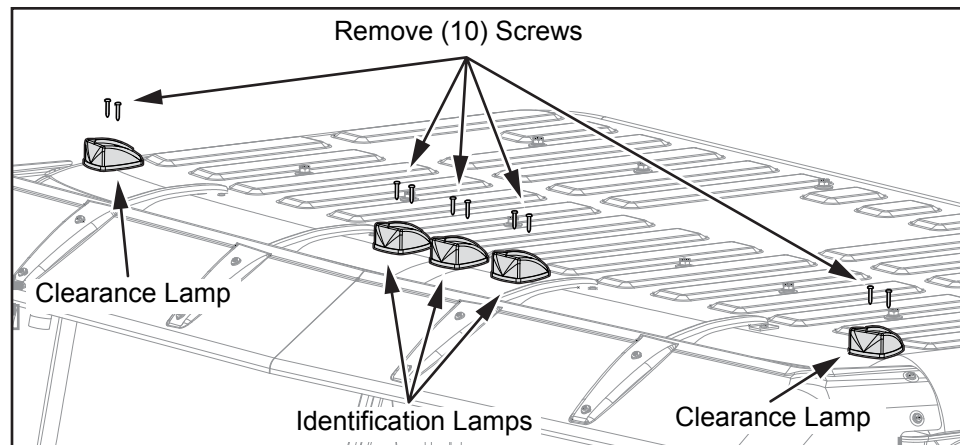
Figure 6

6. Locate the clearance and identification lamps. Remove and discard (10) mounting screws. Remove the clearance and identification lamps and set aside for reinstallation. Remove and discard any remaining seal and sealant from the cab roof and lamps (See Figure 6).

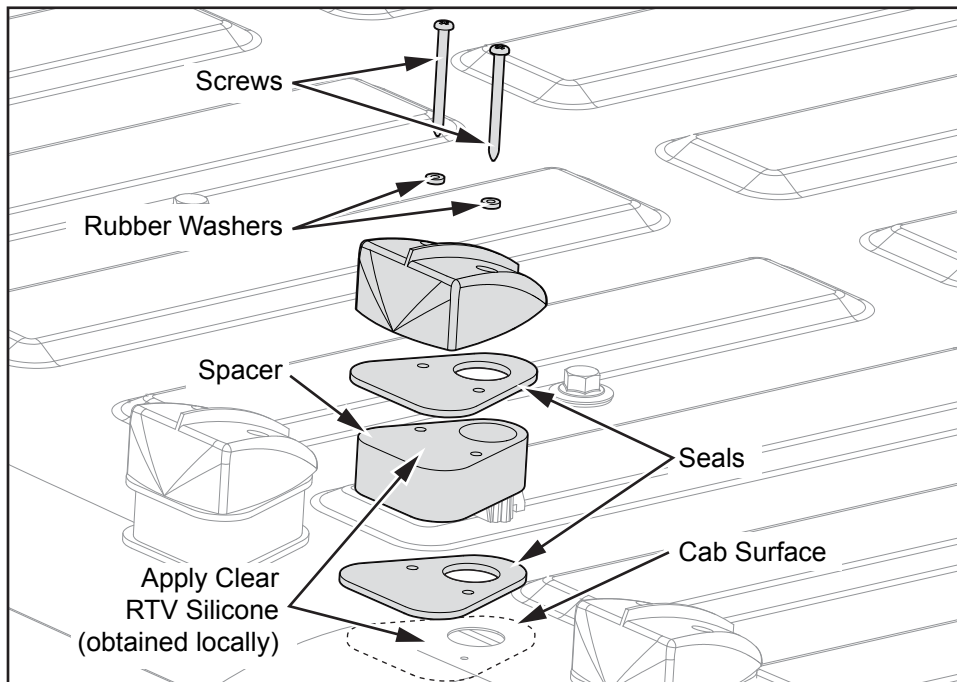
Figure 7

7. Apply clear RTV silicone (obtained locally) to the cab and spacer surface. Install (1) A8510067-001 spacer, (2) A8510068-001 seals, (2) GZ05003-001 rubber washers and the marker lamps set aside in step 6, using (2) GZ030010-002 screws. Repeat this process for the remaining (4) lamps (See Figure 7).
