<b>HYUNDAI</b> <b>Technical Service Bulletin</b>	<b>GROUP</b> <b>RECALL</b>	<b>NUMBER</b> <b>23-01-020H</b>
	<b>DATE</b> <b>MARCH 2023</b>	<b>MODEL</b> <b>SANTA FE</b> <b>Plug-In Hybrid</b> <b>(TM PHEV)</b>
<b>SUBJECT:</b> FUEL TANK LOT CODE INSPECTION AND REPLACEMENT (RECALL 240)

**Description:** On certain 2022MY Santa Fe Plug-In Hybrid (TM PHEV) vehicles, the fuel tank may be built out of specification which could lead to a fuel leak. Follow the service procedure to inspect the fuel tank LOT code and replace the fuel tank if necessary.

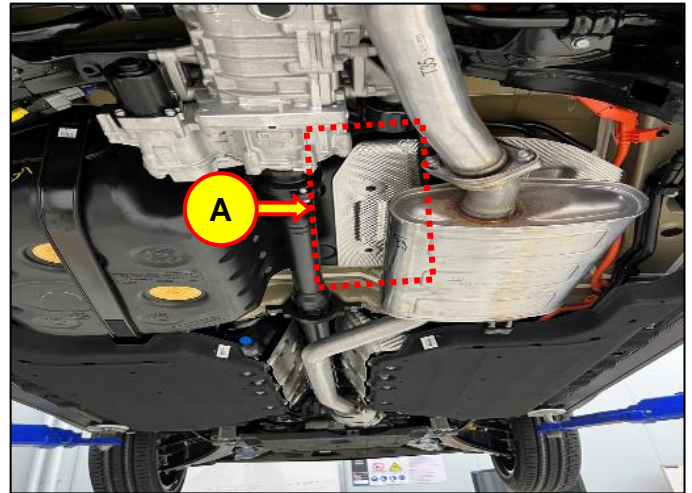
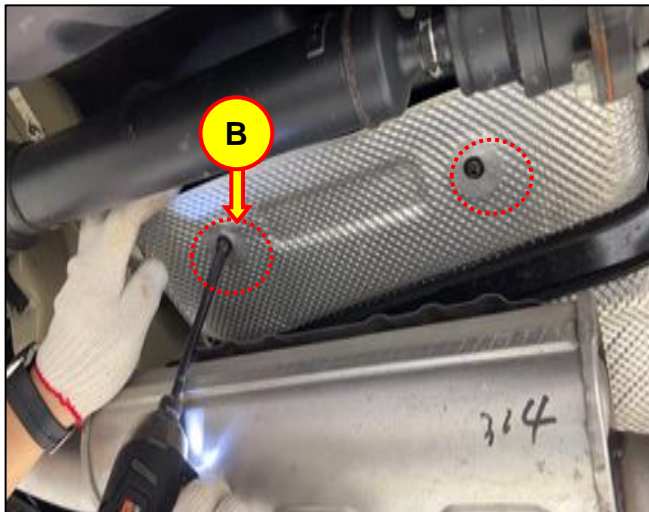
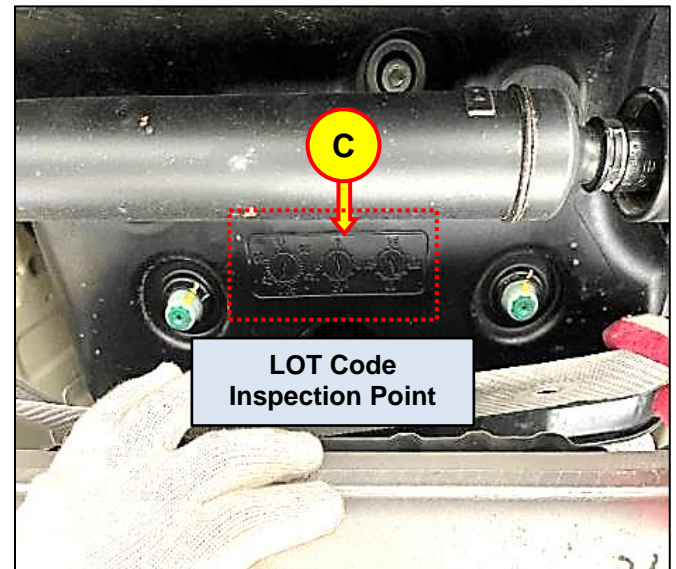
2. Lift vehicle on a hoist.
  - Refer to Shop Manual: General Information > Lift and Support Points
3. Locate the inspection point (A) after lifting the vehicle.
4. Remove the heat shield fasteners (B) of the fuel tank.

5. Position the heat shield slightly away to record the Year/Month/Day LOT Code (C) imprinted on the fuel tank and check if it is in the affected LOT range.

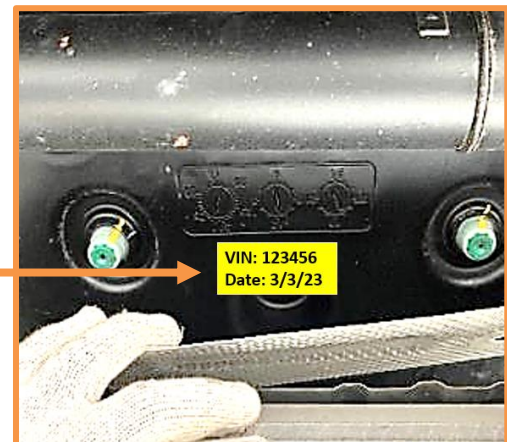
Using STUI in the GDS, take a picture of the **EXISTING** Fuel Tank LOT Code with last 6-digits of VIN and date of repair on a piece of paper.

Ensure the picture is in focus and **VIN with date of repair** are legible.

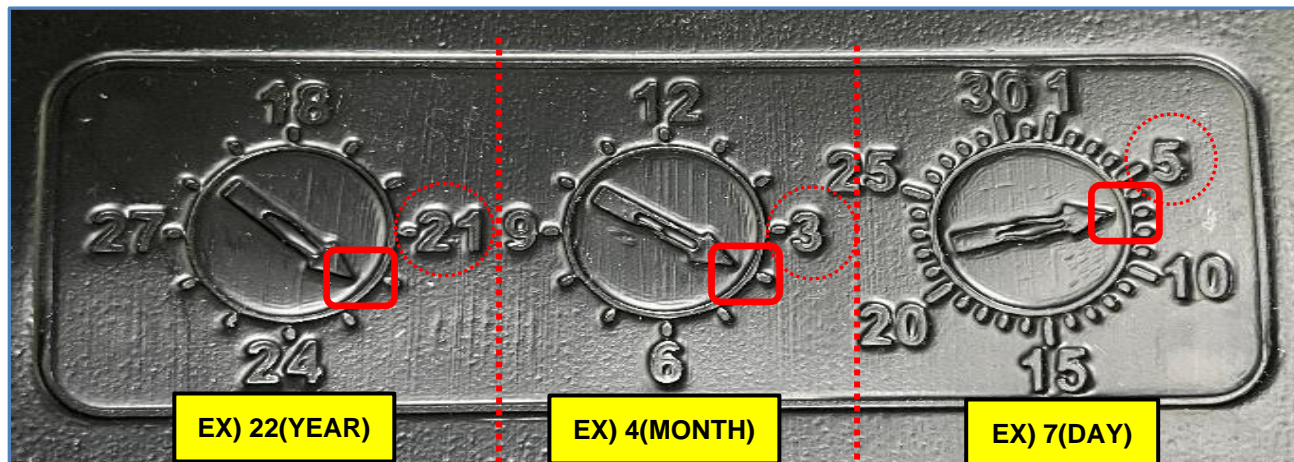
**NOTE:** Read the printed LOT Code with the numbers facing correctly (right side up, not upside down), starting from LEFT (Year), MIDDLE (Month), RIGHT (Day). The LOT Code indication arrows follow clockwise direction to indicate the number in 1 unit increments from the appropriate Reference Point.

- ❖ **Year** [Reference Points 18, 21, 24, 27]
- ❖ **Month** [Reference Points 3, 6, 9, 12]
- ❖ **Day** [Reference Points 1, 5, 10, 15, 20, 25, 30]

The following are **affected LOT Codes** that require fuel tank replacement:

- **22 4 7** (Year 22, Month 4, Day 7)
  - **22 4 8** (Year 22, Month 4, Day 8)
  - **22 4 9** (Year 22, Month 4, Day 9)
- If the inspected fuel tank LOT Code matches any of the affected LOT Codes listed above, then follow the remaining service procedure to perform **Fuel Tank Replacement**.
- If the inspected fuel tank LOT Code are not part of the affected LOT Codes, then the service procedure is complete. Do not replace the fuel tank.

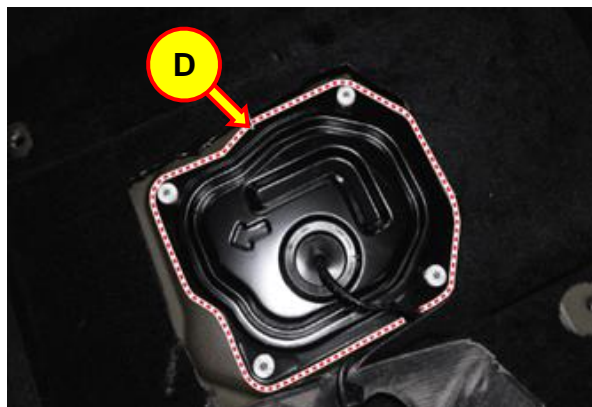
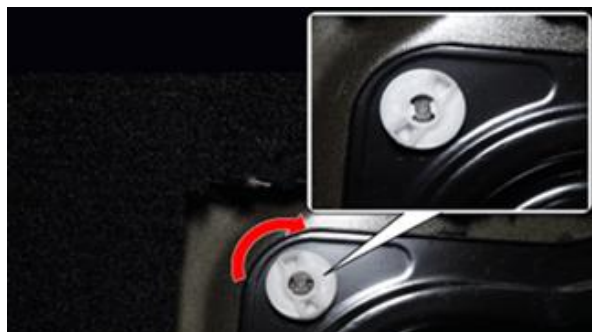
**NOTE:** Be sure to record radio presets before battery disconnection.
8. Remove the (LH) rear seat.
  - Refer to Shop Manual: Body > Rear Seat Assembly
9. Remove the fuel pump service cover (D).

**NOTE:** When removing the fuel pump service cover, remove the 4 clips by rotating them clockwise.

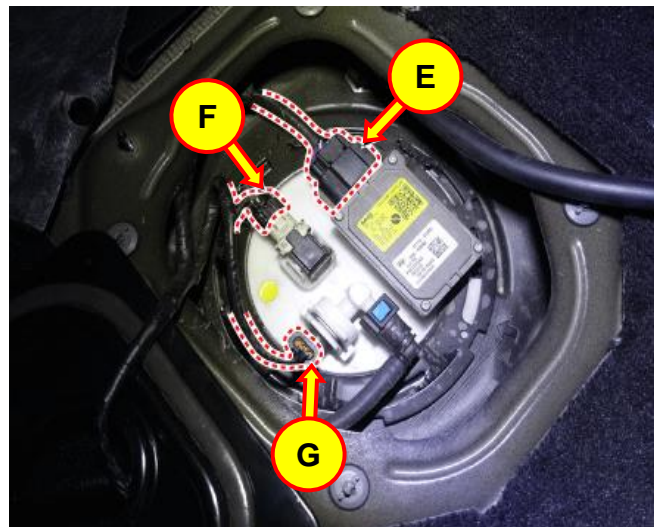
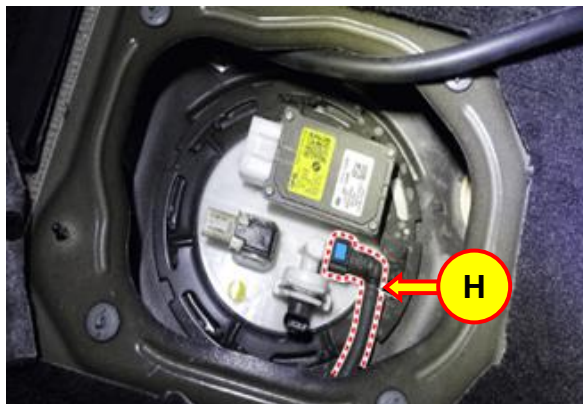
10. Disconnect the Fuel Pump Control Module (FPCM) connector (E).
11. Disconnect the fuel tank pressure sensor connector (F).
12. Disconnect the Fuel Pressure Sensor (FPS) connector (G).
13. Disconnect the fuel feed tube quick connector (H).

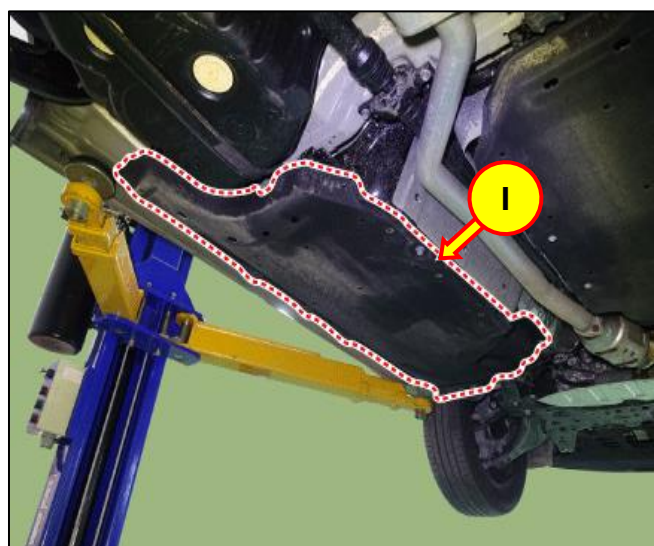
14. Lift the vehicle.
15. Remove the floor under cover (I).  
**Tightening Torque:**
  - Fasteners → 9.85 Nm (87 lb-in)
16. Remove the catalytic converter & center muffler assembly.
  - Refer to Shop Manual: Engine Mechanical System > Muffler
17. Remove the propeller shaft assembly.
  - Refer to Shop Manual: Driveshaft and Axle > Propeller Shaft Assembly

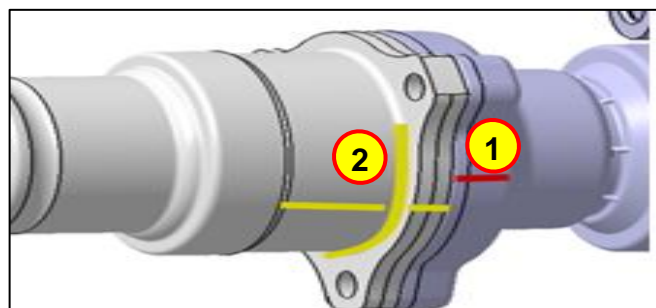
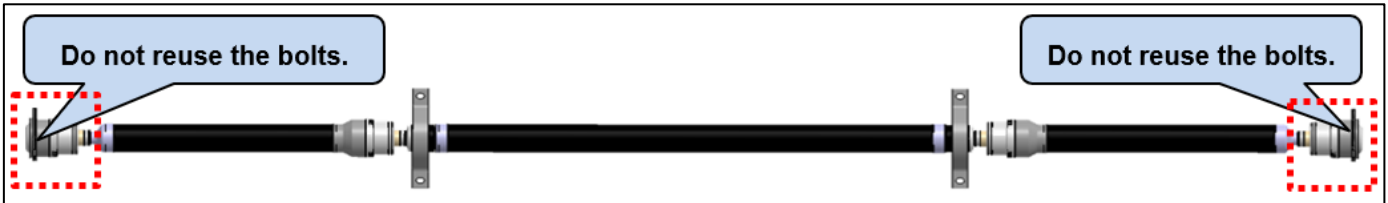
- Prior to removing the propeller shaft, be sure to note the "1" and "2" indexing marks at the front and rear flanges. It must be reinstalled at the same indexed positions.
- If necessary, use a paint pen to create new index marks at each end of the propeller shaft and mating flanges for reference.

- Remove the entire multiple propeller shaft pieces completely as one unit. To prevent possible damage or imbalance, do not try to separate the propeller shaft pieces.
- Do not reuse the propeller shaft flange bolts. Use the 6 newly supplied bolts with 14mm sized hex heads (P/N 11435-10256K) during propeller shaft reinstallation.
- When the propeller shaft is being reinstalled after installing the new fuel tank, be sure to realign and match the “1” and “2” indexing marks (or newly drawn lines) at the flanges.

- 6 Flange Bolts (**New**) → 61 Nm (45 lb.-ft)
- 4 Carrier Bolts (Reuse) → 61 Nm (45 lb.-ft)

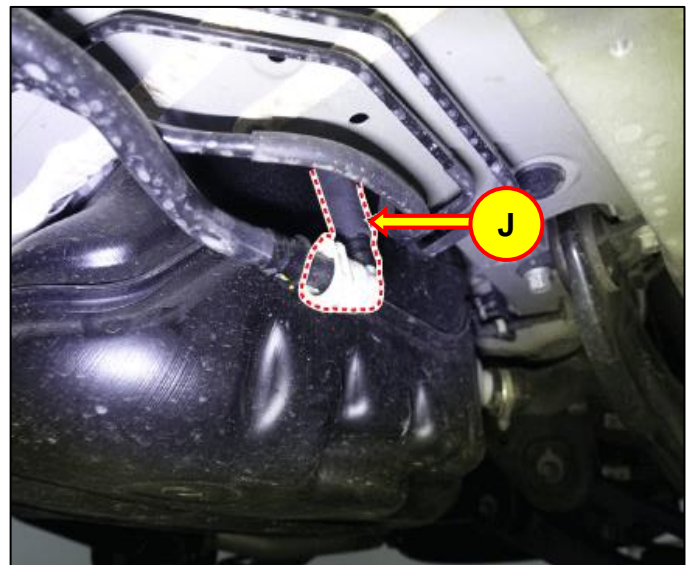
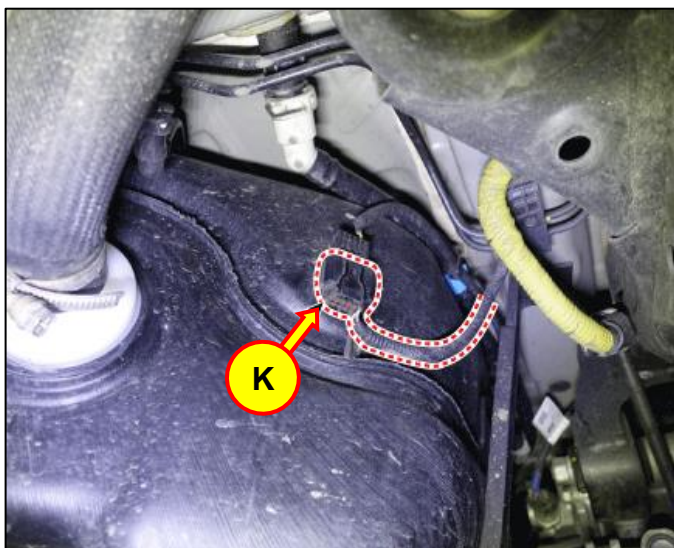
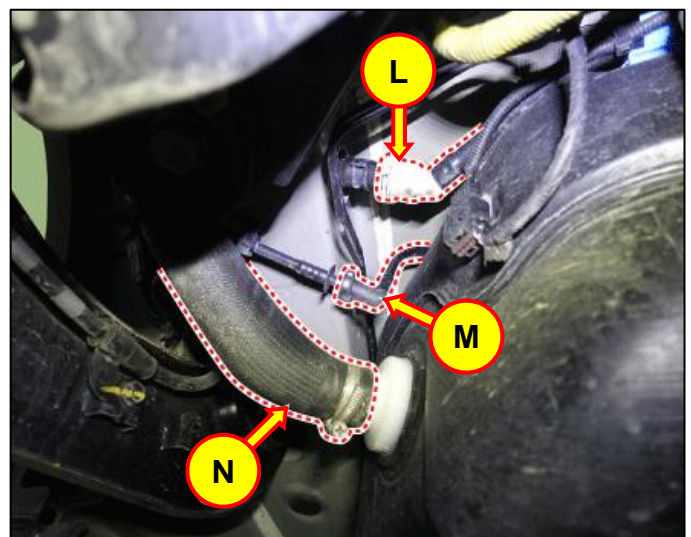
18. Disconnect the purge tube quick-connector (J).
19. Disconnect the Fuel Tank Isolation Valve (FTIV) extension wiring connector (K).
20. Disconnect the recirculation tube quick-connector (L).
21. Disconnect the air vent tube quick-connector (M).
22. Separate the fuel filler neck hose (N).

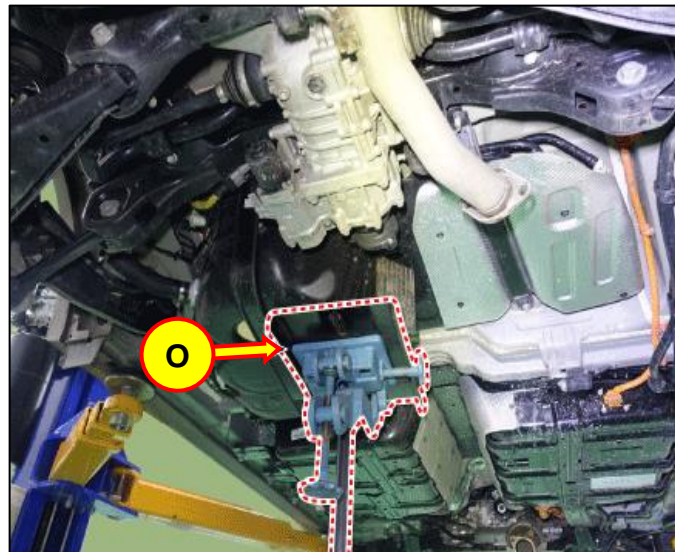
23. Support the fuel tank with a jack or suitable component lifting platform (O).

**NOTE:** Insert the rubber block (or equivalent) between the fuel tank and jack/platform to prevent damage to the fuel tank.

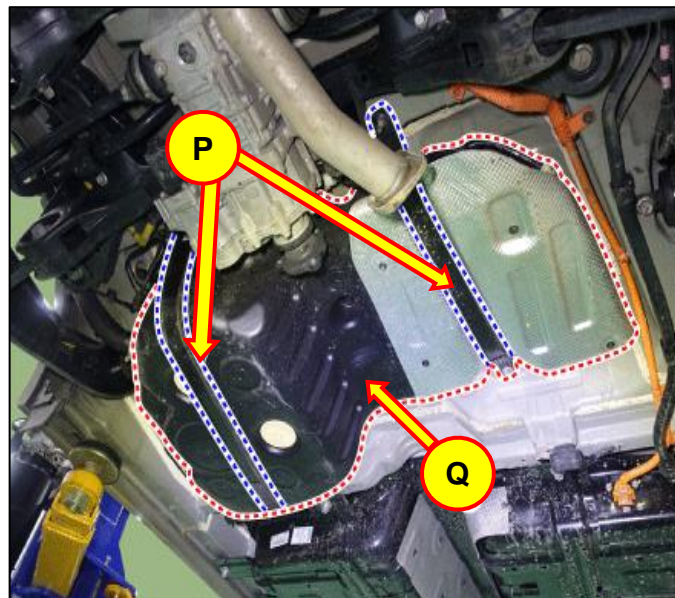
24. Remove the fuel tank bands (P) and then remove the fuel tank (Q).

- Fuel Tank Band Fasteners → 5 Nm (44 lb-in)

**NOTE:** Do not over-torque.

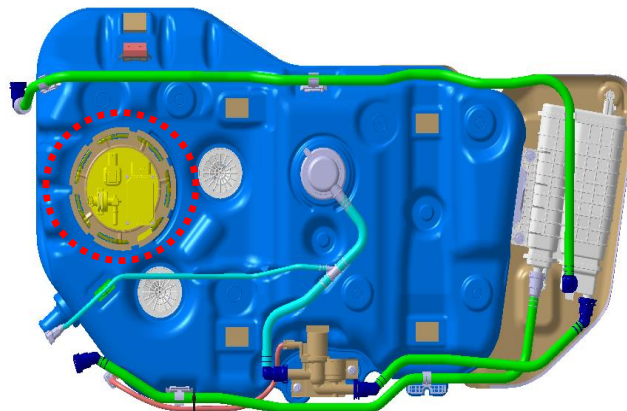
25. Remove the fuel pump module and remove the fuel inside the fuel tank (to transfer over to the new fuel tank using a suitable siphoning pump).

**NOTE:** The newly supplied O-ring of the fuel pump module top plate must be installed during reinstallation.

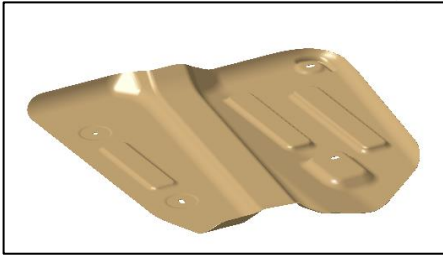
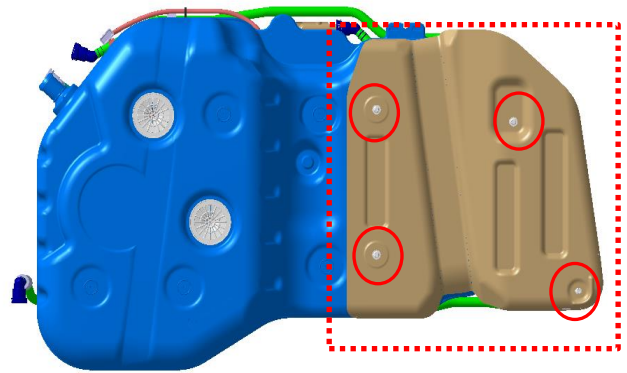
26. Loosen the heat shield fixing bolts.

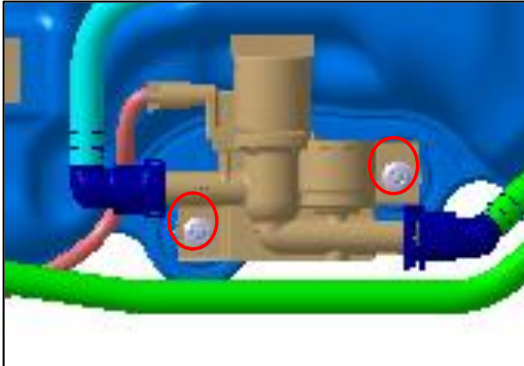
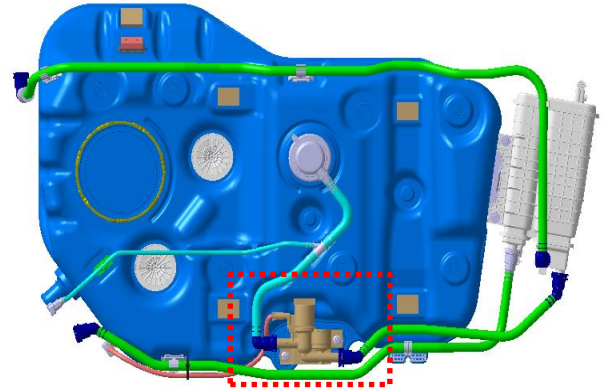
27. Loosen the 2 fasteners of the Fuel Tank Isolation Valve (FTIV).

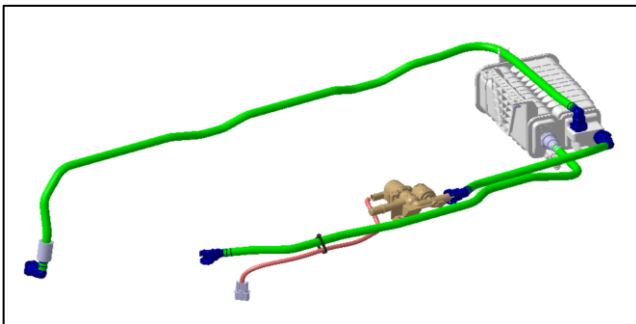
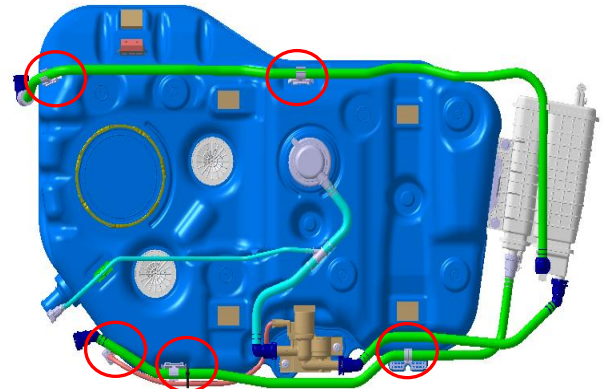
28. Disconnect the tube and wiring from the 5 fixed locations.

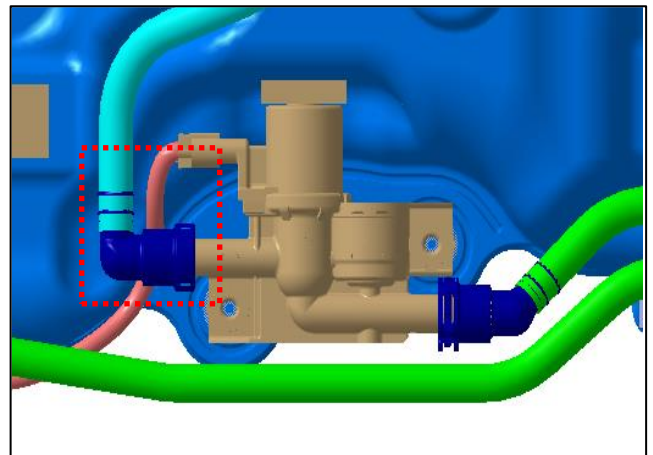
29. Remove the quick connector of the Fuel Tank Isolation Valve (FTIV).

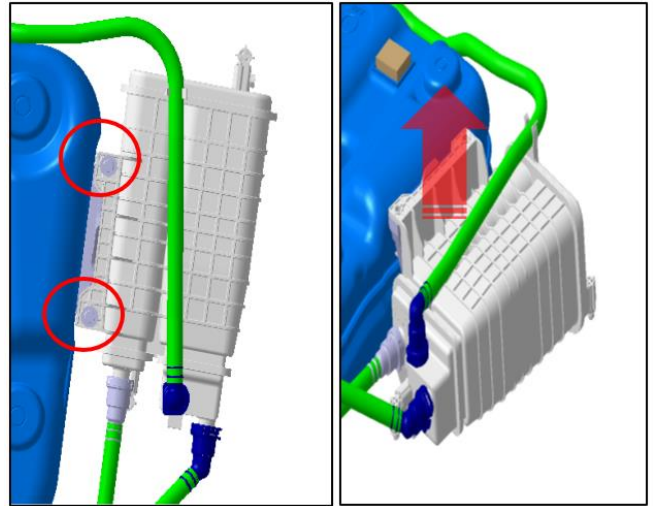
30. Loosen the 2 charcoal canister mounting fasteners and raise the canister upwards to dislodge it from the fuel tank.

- Mounting Fasteners → 4 Nm (35 lb-in)

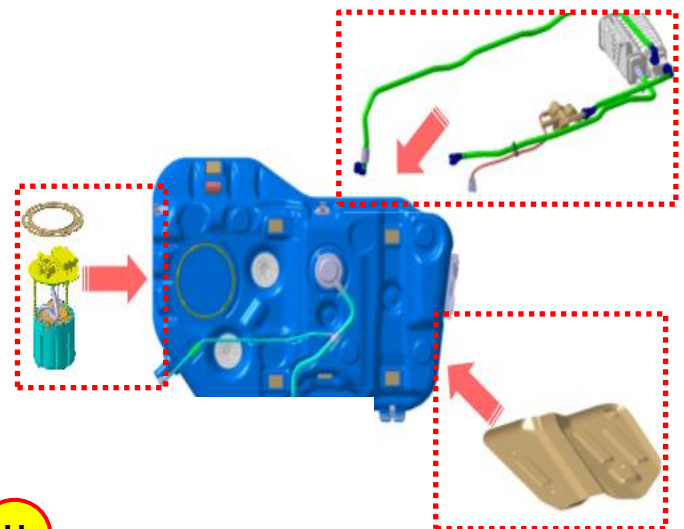
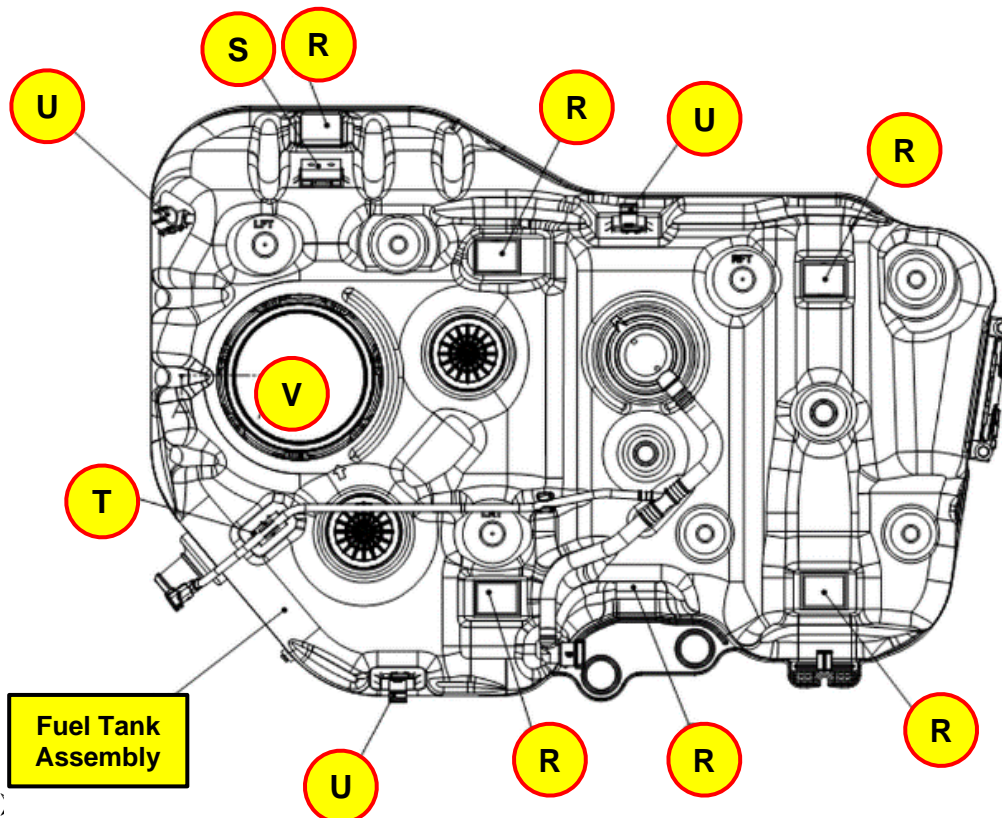
31. Reinstall the removed parts (fuel pump module, charcoal canister, FTIV, and bottom heat shield) onto the newly supplied fuel tank.

**NOTE:** Fuel Tank Assembly (P/N 31150-P4800QQH) includes the Service Kit with the following contents.

- 6x Fuel Tank Rubber Pads (R)
- 1x Clip Pad Assembly (S)
- 1x Clip (T)
- 3x Clips (U)
- 1x Fuel Pump O-Ring (V)
- ❖ Be sure to install all items of the Service Kit.

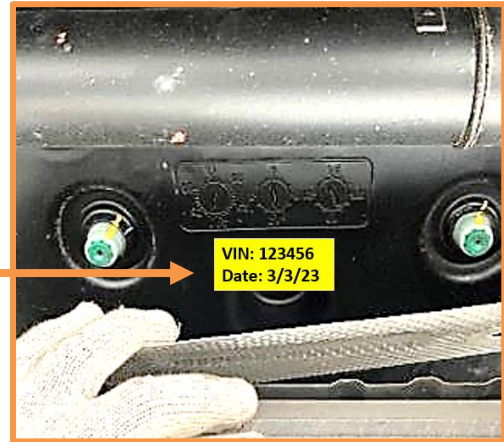
32. Record the LOT Code of the new fuel tank.

Using STUI in the GDS, take a picture of the **NEW** Fuel Tank LOT Code with last 6-digits of VIN and date of repair on a piece of paper.
