SAFETY RECALL NOTICE

Re: Rearview mirrors lenses may dislodge - Decreased visibility - Revision of Vehicles Involved

Can-Am® On-Road Spyder™

February 9, 2023 Subject: **Rearview Mirror Lenses May Dislodge - Decreased Visibility** No. **2022-19**

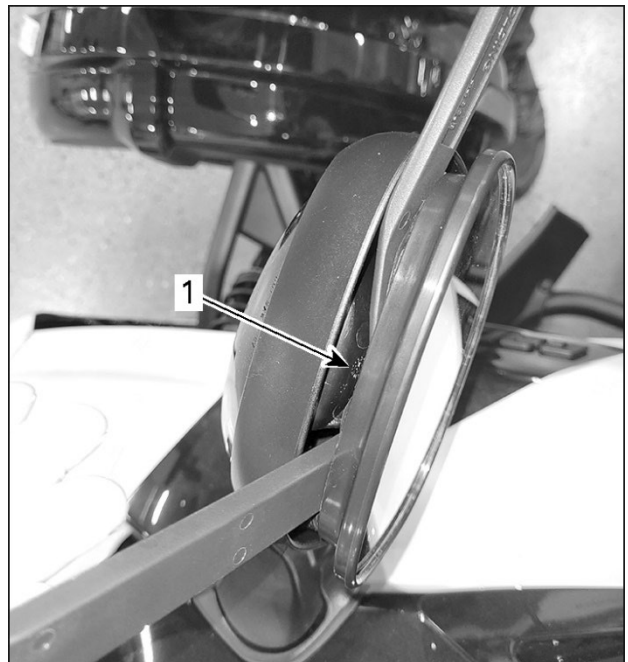
2. Gently pry open the plastic trim to allow reading the molding batch date code inside the housing.

1. Gently pry open.

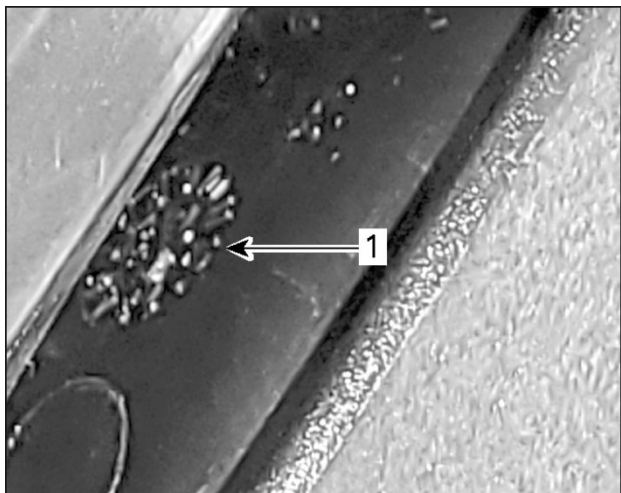
3. Use a magnifying glass to ease reading or take a picture of the molding date code to confirm reading.

1. Validate molding date code.

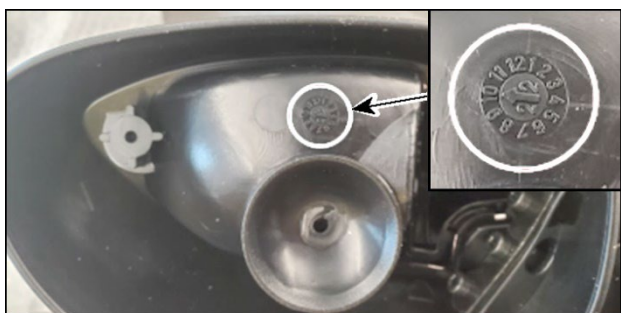
To read the date code, the center section indicates the year and the arrow points out to the month on the larger diameter.

4. If molding batch date code is 11/22 or prior, replace both mirror housing assemblies, otherwise mirror housing assembly is good.

Molding Batch Date	Status	Action
November 2022 and prior	Defective part	Proceed with MIRROR ASSEMBLY REPLACEMENT
December 2022 and after	Good part	Claim INSPECTION

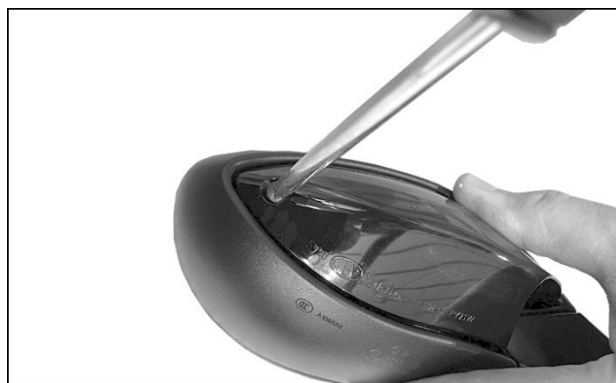
1. Remove and discard the mirror housing cap retaining screw.

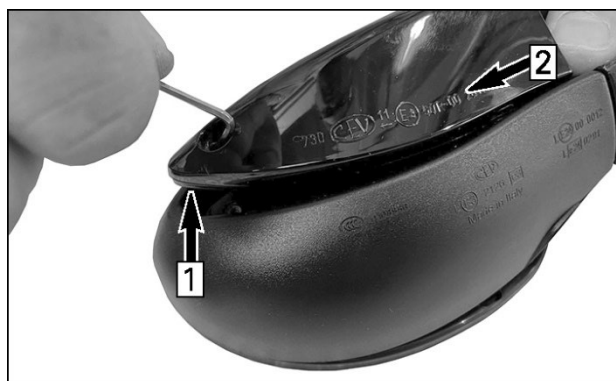
2. Gently lift the mirror cap using a small Allen Key, then push the cap out of location as shown on picture to remove it from assembly. Discard the cap.

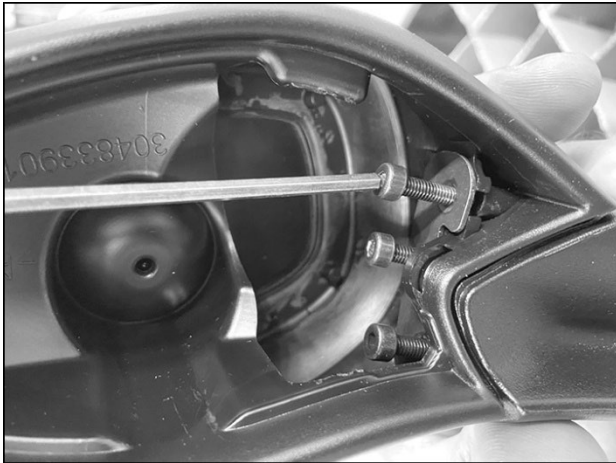
- Using a 3mm Allen Key, remove and discard the three (3) socket head screws and metal plate.

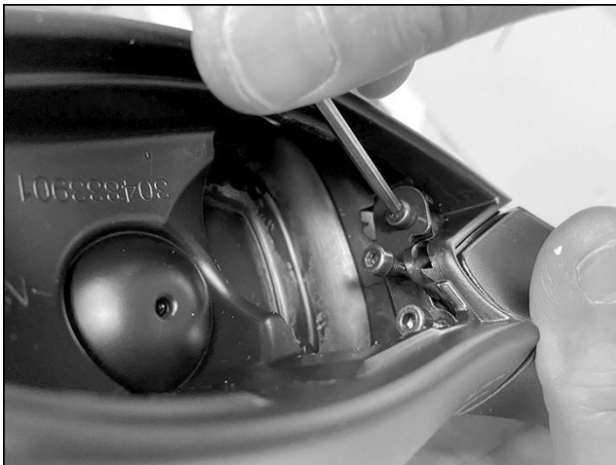
- Remove and discard the defective mirror assembly.
- Install new mirror assembly and secure in place using the three (3) new socket head screws and new plate from the kit.

NOTE: To ease installation, use a 3mm round head insert.

TIGHTENING TORQUE	
Mirror Assembly	2.5 N•m ± 0.5 N•m (22 lbf•in ± 4 lbf•in)
Retaining Screw

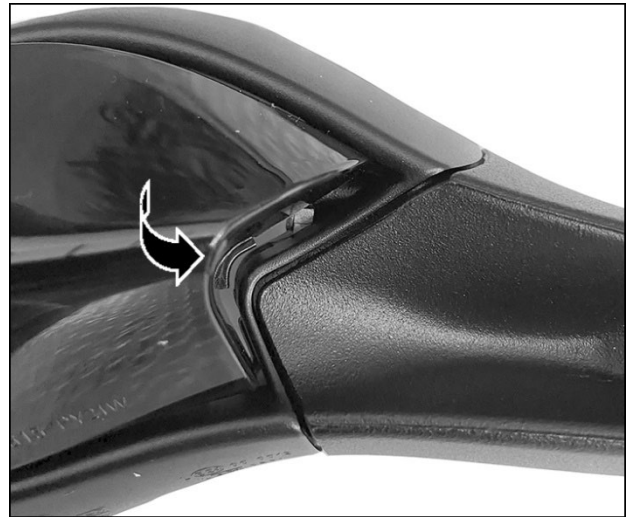
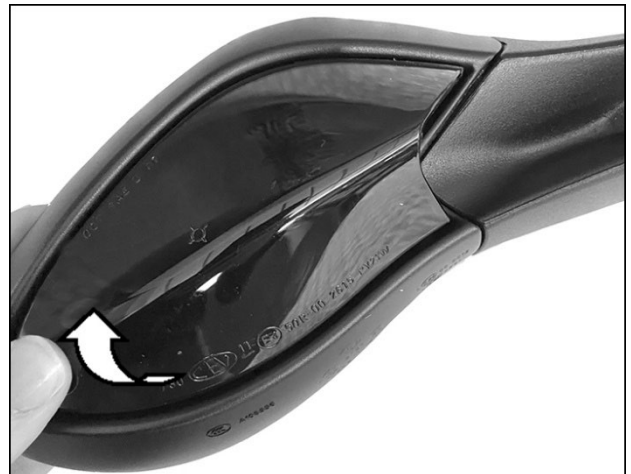
- Install the new mirror housing cap. Place the ridge of the cap in the cavity and press the cap to hook it.

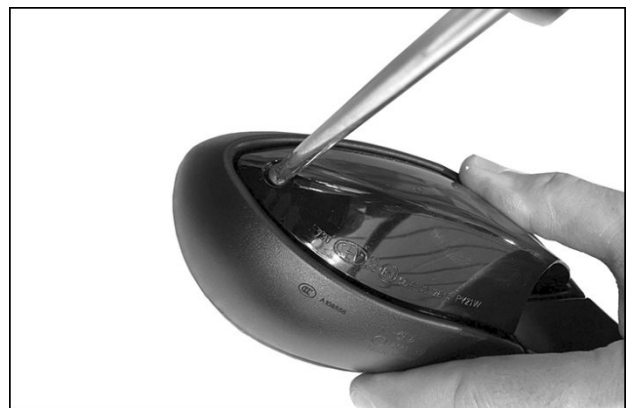
- Secure in place using the new retaining screw.

TIGHTENING TORQUE	
Mirror Cap	1.0 N•m ± 0.2 N•m (9 lbf•in ± 2 lbf•in)
Retaining Screw

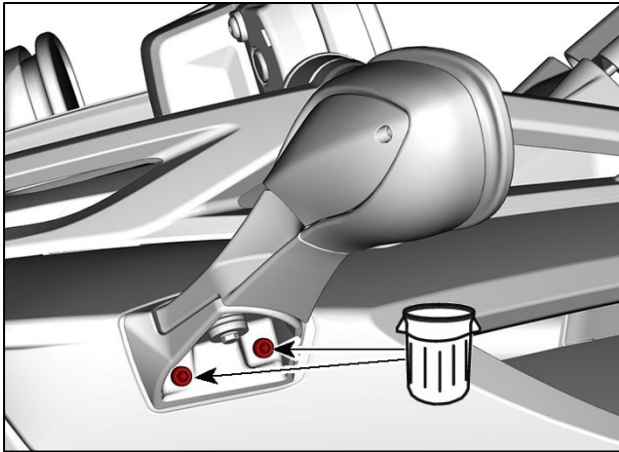
1. Remove and discard the two housing retaining screws.

TIGHTENING TORQUE	
Mirror Housing Retaining Screw	3.5 N•m ± 0.5 N•m (31 lbf•in ± 4 lbf•in)

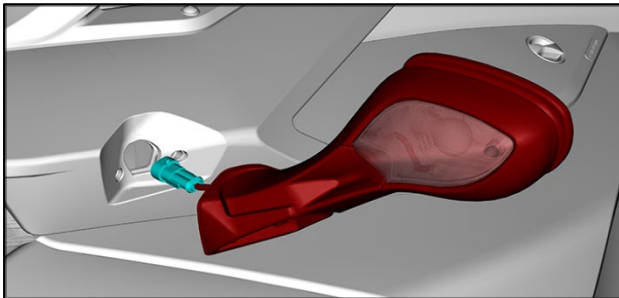
2. Gently pull the mirror housing and disconnect the mirror light harness connector.

NOTE: If the connector is hard to reach, remove body panels to allow access to the connector.

NOTE: Connect the new mirror housing light connector and verify proper operation.
