PRODUCT CAMPAIGN BULLETIN

APPLICABILITY: 2019-2022 Crosstrek Hybrid

NUMBER: WRD-23

SUBJECT: 12V Inverter Connector Corrosion

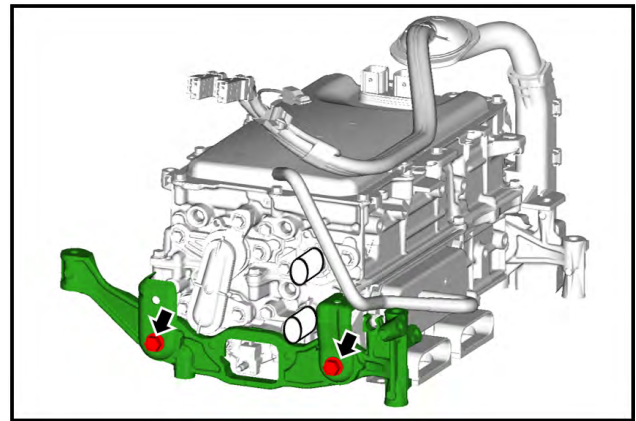
STEP 10: Install the NEW black painted rear inverter bracket using the NEW mounting bolts. Torque the mounting bolts to 18Nm (13.3ft-lbs).

CAUTION: DO NOT drop or hit the new mounting bracket. This can cause the painted surface to be damaged compromising its corrosion protective strength.

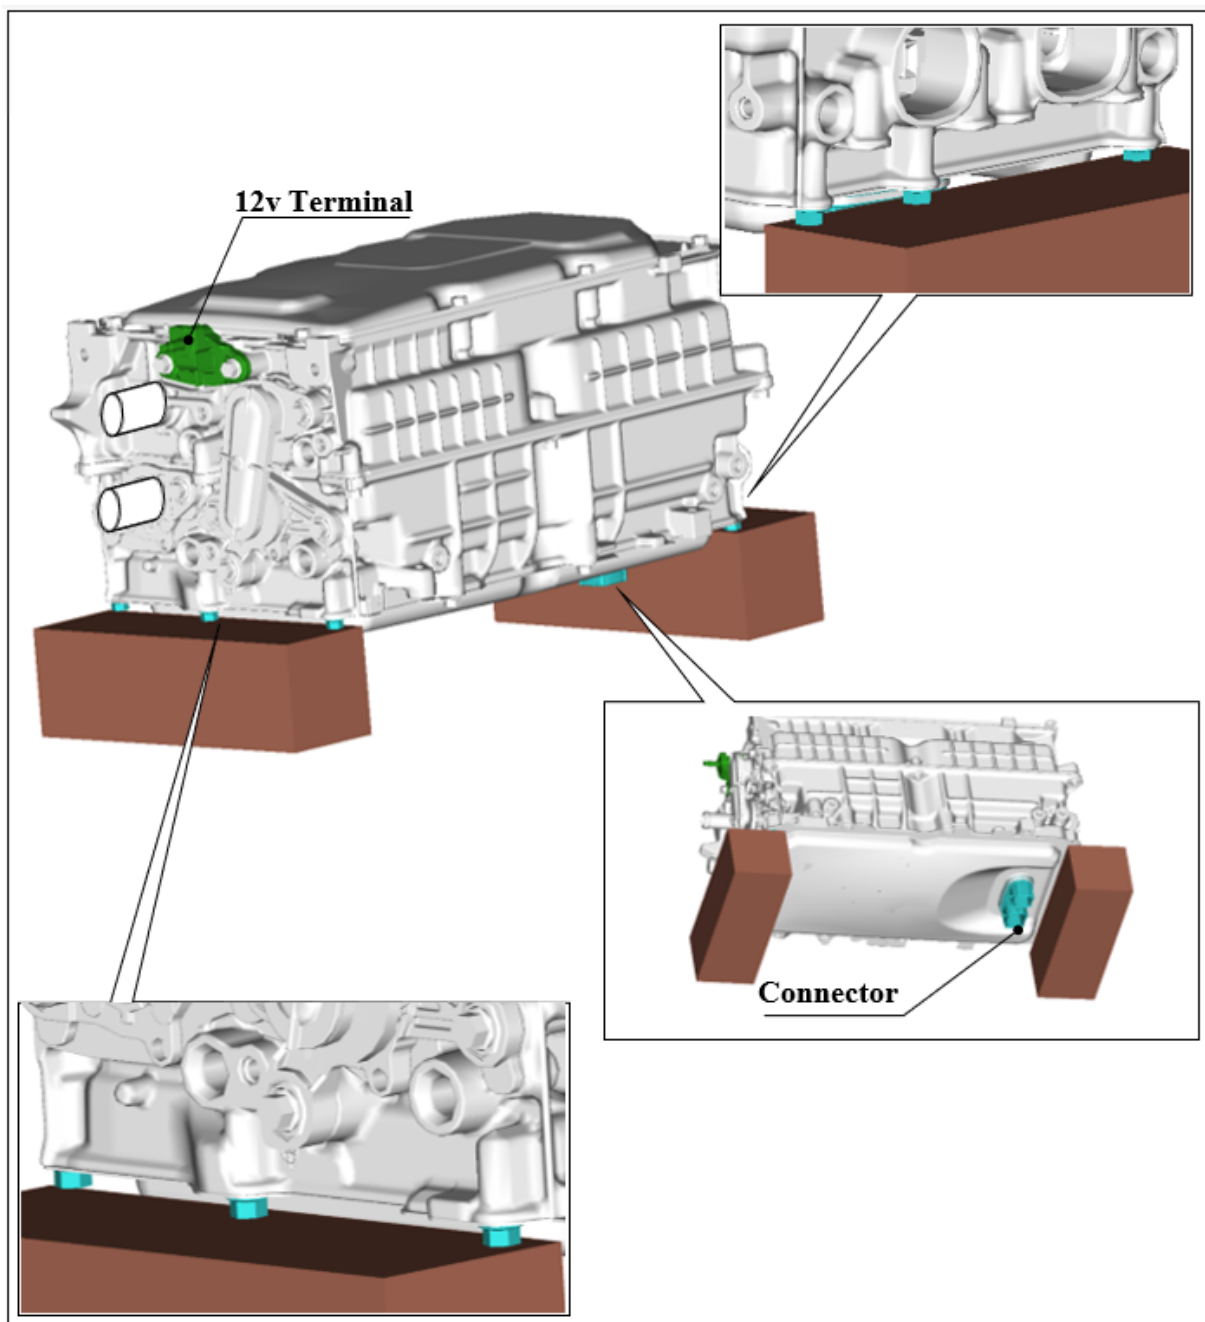
CAUTION: CAREFULLY place the inverter/converter assembly on the wooden blocks as shown in the images provided below in order to prevent any damage to the connector and cover.

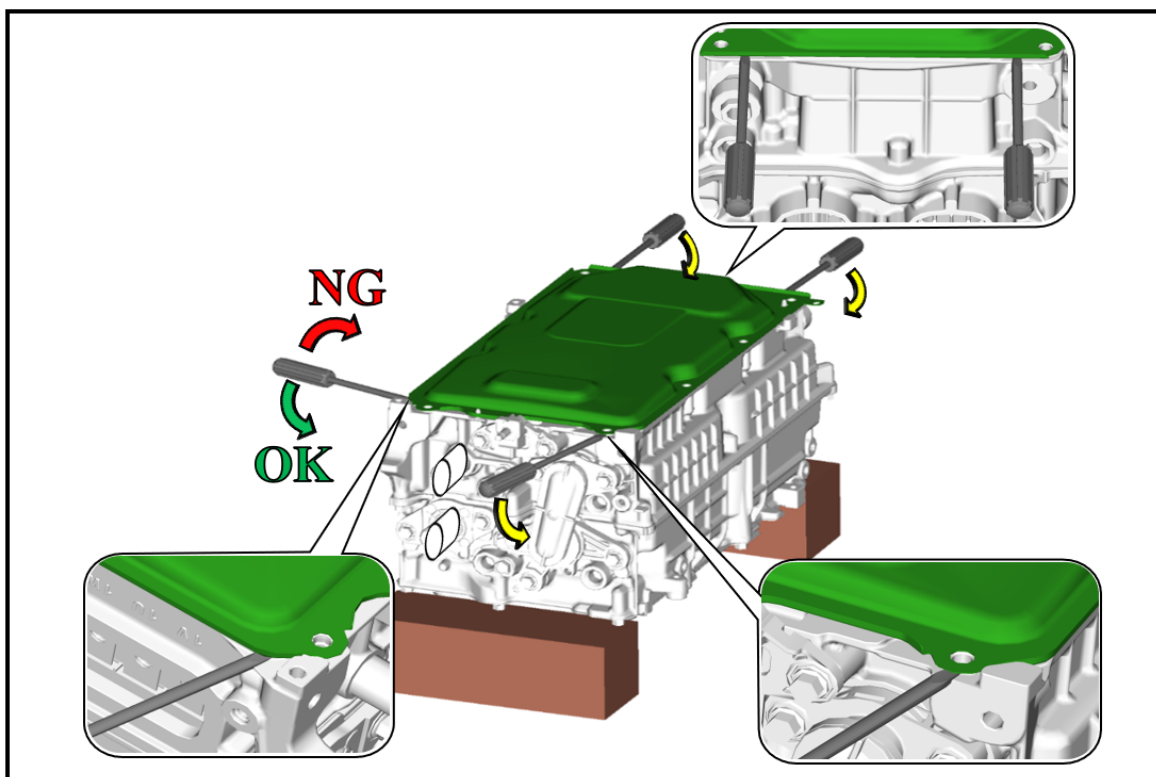
- **DO NOT** damage the sealing surface of the inverter/converter assembly.
- **DO NOT** lift the screwdriver handle in the upward direction. **ONLY** push the handle of the screwdriver in the downward direction when inserted between the lid and case.
- **ONLY** insert the blade portion of the screwdriver between the lid and case. Deep insertion of the screwdriver can cause damage to the case and internal components.
- **Work with bare hands or insulated gloves in order to prevent any static electricity and foreign mater intrusion into the internal electrical components.**

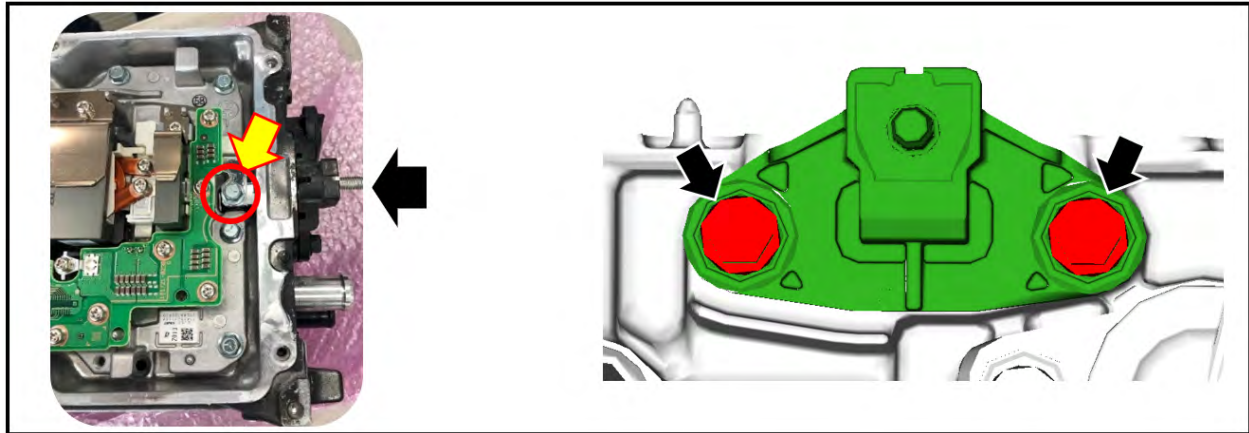
STEP 19: CAREFULLY retrieve any sealant that may have dropped into the case. **DO NOT** touch any of the internal components. Remove the three mounting bolts for the 12v terminal.

Once the mounting bolts are removed, pull the terminal away from the case to remove.

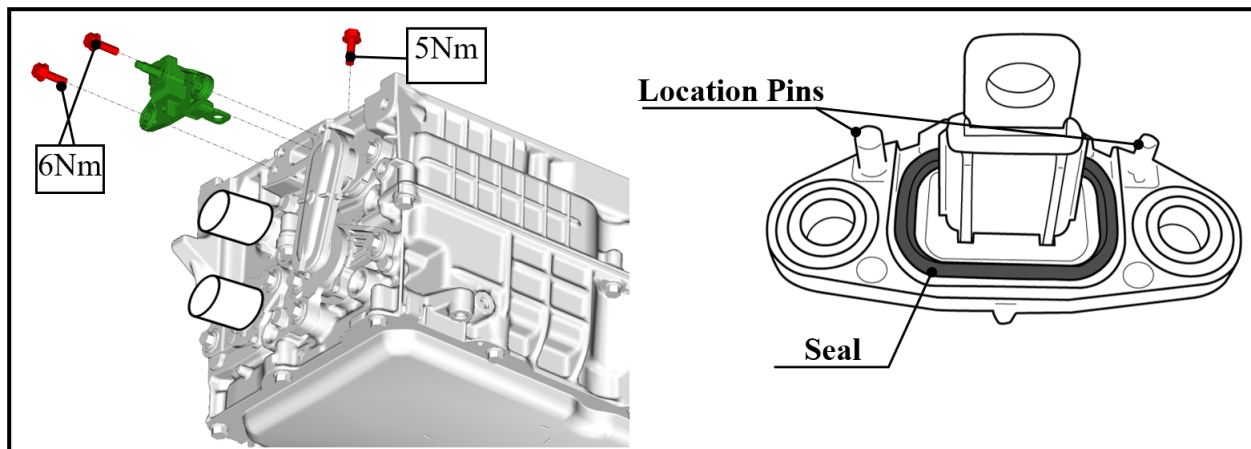
STEP 20: CONFIRM the seal is free of debris then install the NEW 12v terminal supplied in the terminal output kit (p.n. SOA635176) by aligning the location pins on the terminal. Torque the **INNER** mounting bolt to 5Nm (3.7ft-lbs). Torque the **OUTER** mounting bolts to 6Nm (4.4ft-lbs).

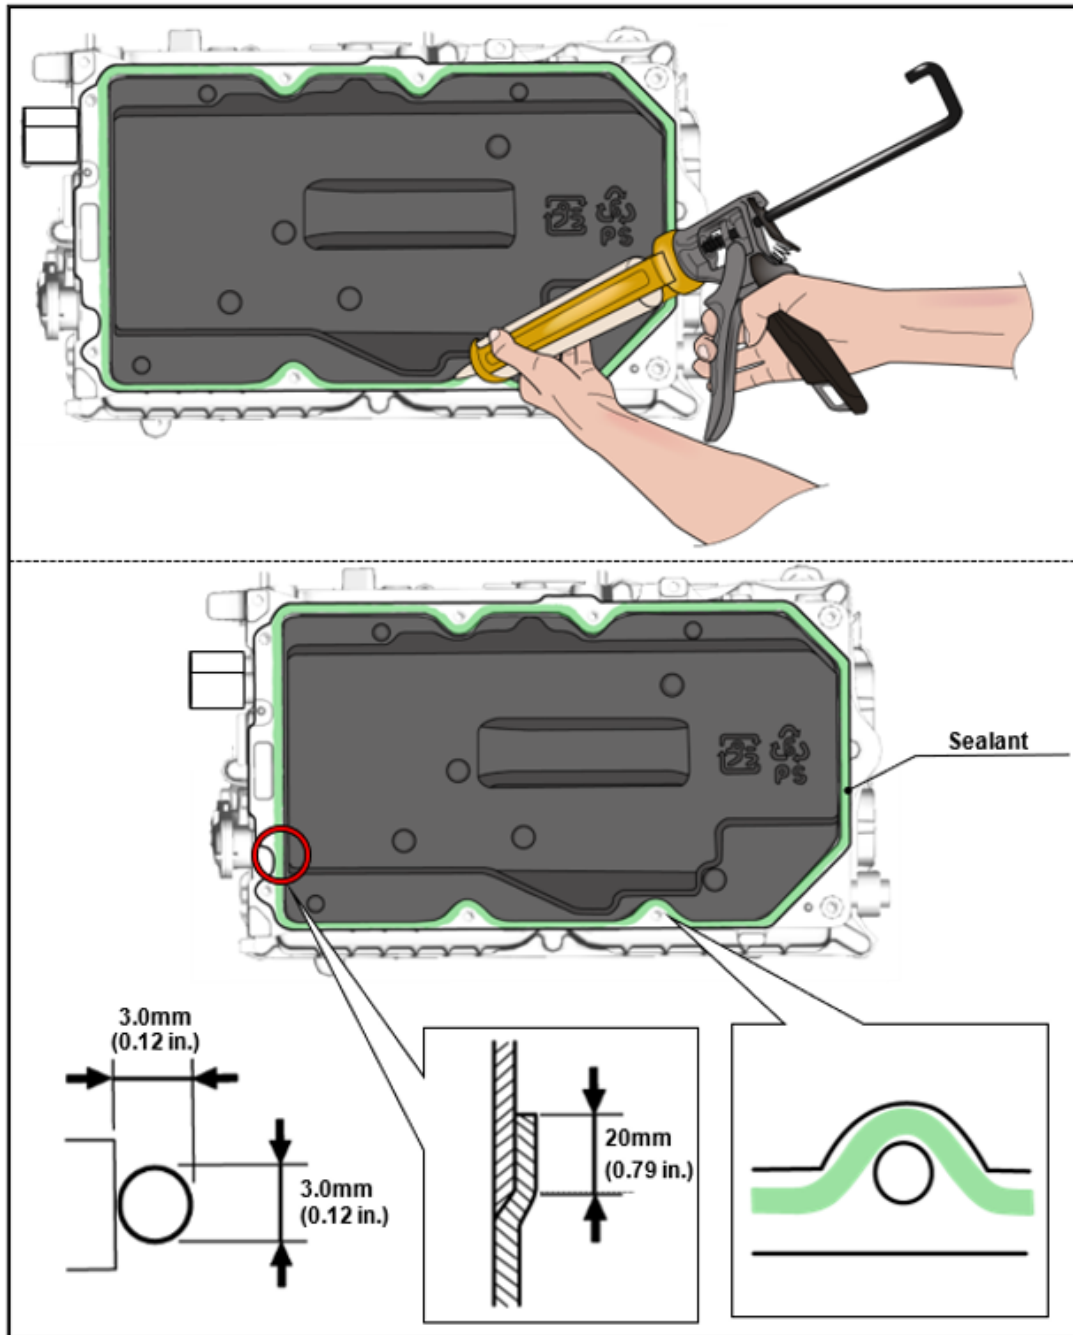
STEP 30: Apply a 3mm (0.12in) diameter bead of Three Bond 1207F as detailed in the images below.

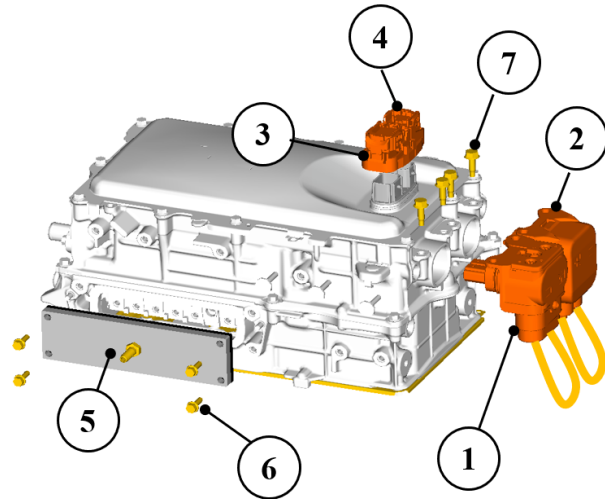
1. Connector Holder 1 (p.n.81911FL010)
2. Connector Holder 2 (p.n.81911FL050)
3. Connector Holder 3 (p.n.81911FL030)
4. Connector Holder 4 (p.n.81911FL030)
5. Repair Tool (p.n.99804AN030)
6. Flange Bolts (p.n.010406200)
7. Flange Bolts (p.n.010406120)

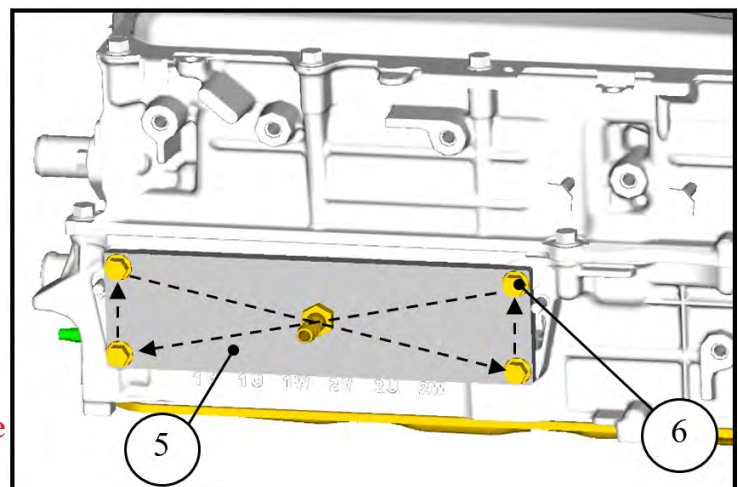
STEP 37: Install the Repair Tool (p.n.99804AN030) using the four Flange Bolts (p.n.010406200) in place of the motor cable terminal block connection. Tighten the bolts in an X-Pattern and torque to 5Nm (5Nm (3.7ft-lbs).

CAUTION: DO NOT use the originally supplied bolts used for the motor cable terminal block. CAREFULLY tighten the bolts evenly. Uneven tightening may cause incorrect leak detection results.
