SAFETY RECALL CAMPAIGN 2A99

2022 Hayabusa Front Brake Master Cylinder Body Replacement

Affected Models:	Certain 2022 Hayabusa (GSX1300RR/RRZM2) motorcycles
Affected Departments:	Management, Service, Warranty, Sales, Parts, Accessories
Attachments:	Sales Bulletin 21-093 (Hayabusa Stop Sales) & Customer Notification Letter
Reference:	Hayabusa GSX1300R Service Manual (99500-10L00-03E)

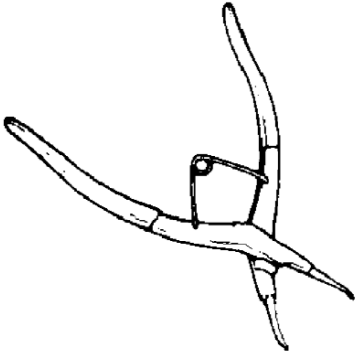
Tool or item	Size or capability
Snap ring pliers	Suzuki special tool 09900-06108 (or equivalent)

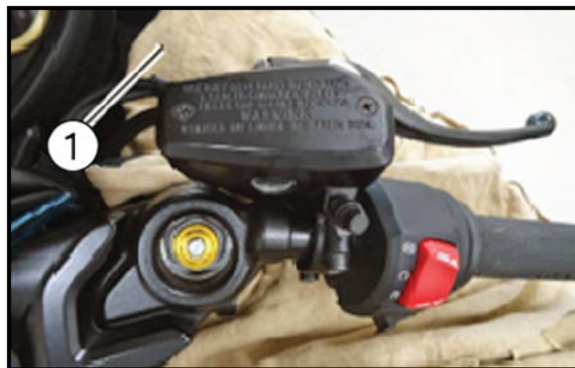
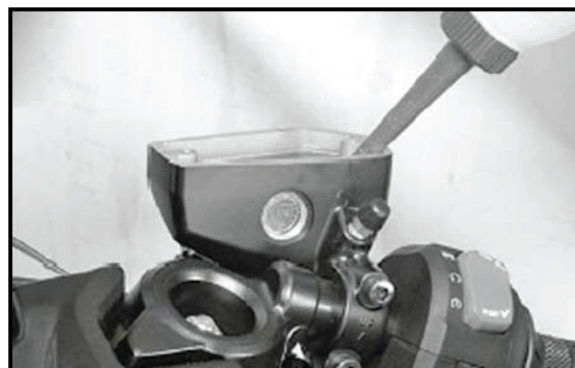
1. Turn the ignition switch OFF.
2. Position the motorcycle on a level surface and adjust the handlebars so the front brake master cylinder is level.
3. Place a clean absorbent cloth ① underneath the master cylinder as shown in the image at right. This helps prevent brake fluid from getting on other parts if it is spilled or splashed during the repair.
4. Remove the reservoir cap screws ②, the reservoir cap ③, and the plate ④, and diaphragm ⑤ from the front brake master cylinder.
5. Using a syringe or squeeze bottle, suck up as much of the brake fluid out of the reservoir as possible.
6. Unscrew and remove the brake hose union bolt ⑥ and disconnect the brake hose ⑦.

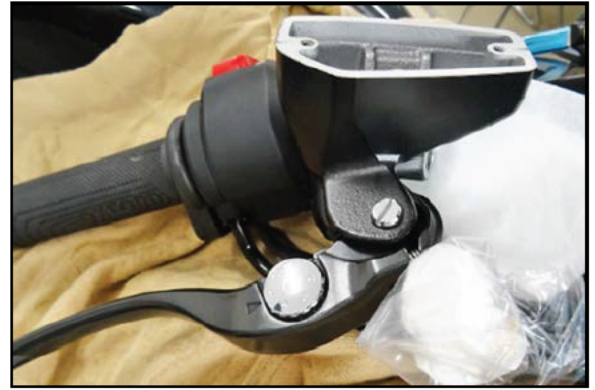
Cover the end of the disconnected brake hose with a plastic bag and tie it closed with a rubber band or twist tie to prevent brake fluid from spilling out from the brake hose.

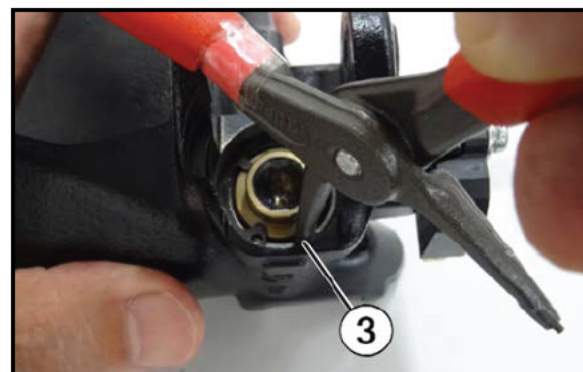
Make sure the snap ring ③ is completely seated in the groove in the master cylinder.

If the snap ring is properly seated in the groove, it can be rotated (using the tip of the snap ring pliers)

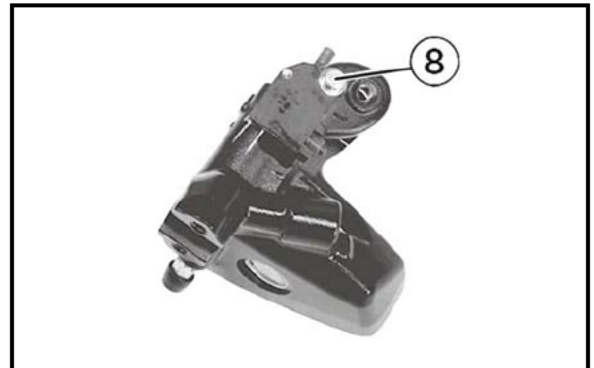
15. Install and tighten the front brake light switch screw ⑧ to the specified torque.

Front brake light switch screw ⑧:
0.9 lb.-ft (1.2 N.m, 0.12 kgf-m)

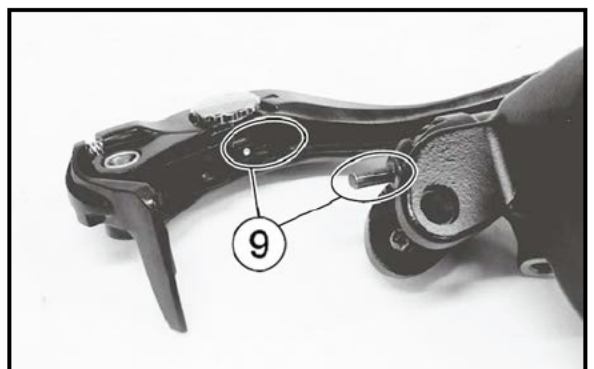
16. Apply grease to the contact points ⑨ between the push rod and the brake lever.

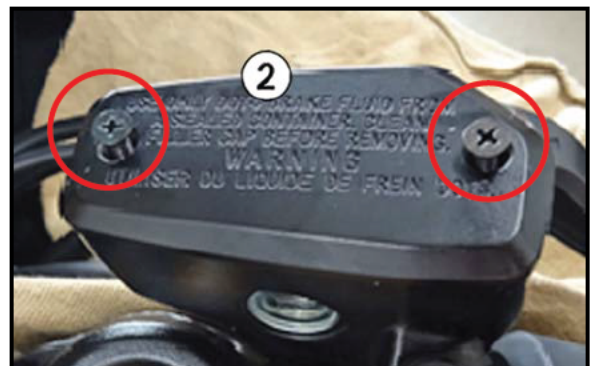
3. Install the reservoir cap ② and lightly hand thread the reservoir cap screws in to hold the cap in place.

Using the partially inserted screws to hold the reservoir cap in place helps prevent debris from getting into the brake fluid and reduces the chance of fluid spilling onto the motorcycle or other surfaces.

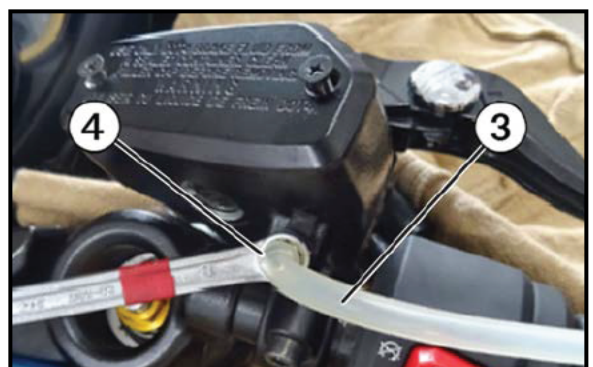
4. Attach a clear hose ③ to the front brake master cylinder air bleeder valve ④.

Make sure the opposite end of the clear hose is inserted into a receptacle (to catch expelled brake fluid so it will not spill onto the motorcycle or other surfaces).

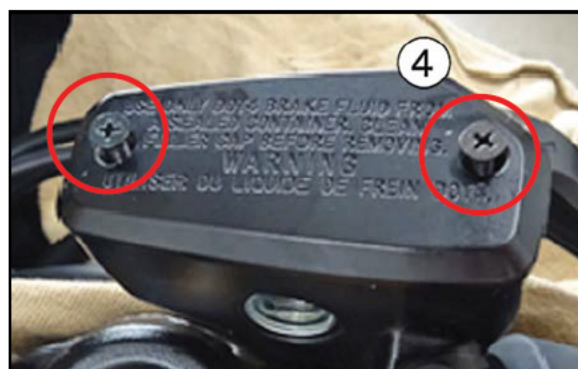
12. Loosen the right front brake caliper air bleeder and squeeze the brake lever several times until the brake fluid surface in the reservoir reaches the lower level mark. As each squeeze of the brake lever expels brake fluid into the receptacle, tighten the right front brake caliper air bleeder valve.
13. Repeat steps 11 and 12 three times.

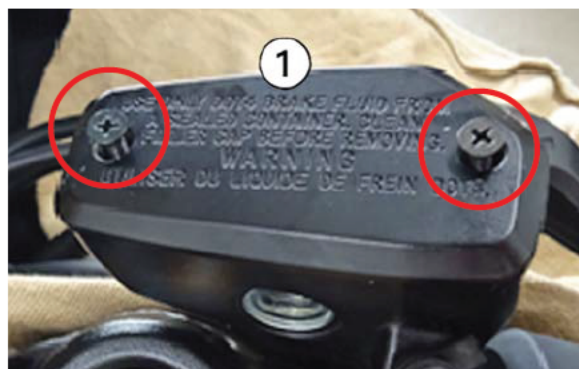
15. Squeeze the brake lever several times and, while holding the lever as close to the grip as possible, loosen the front brake master cylinder air bleeder valve to allow brake fluid and air bubbles to be expelled into the receptacle.
16. Tighten the front brake master cylinder air bleeder valve and release the brake lever slowly.
17. Repeat steps 15 and 16 until the brake fluid is flowing out without air bubbles.
