## Technical Service Bulletin

GROUP	NUMBER
RECALL	23-01-022G-1
DATE	MODEL(S)
MAY 2023	GV60 (JW1) GV70 (JK1) GV80 (JX1) G80 (RG3)

**SUBJECT:** FRONT SEAT BELT PRETENSIONER PROTECTION  
CAP INSTALLATION (RECALL 012G)

**Description:** The front seat belt pretensioner may deploy abnormally in the vehicles described below, causing the MGG (Micro Gas Generator) to detach from the assembly. This bulletin describes the procedure to install front seat belt pretensioner anti-separation protection caps.

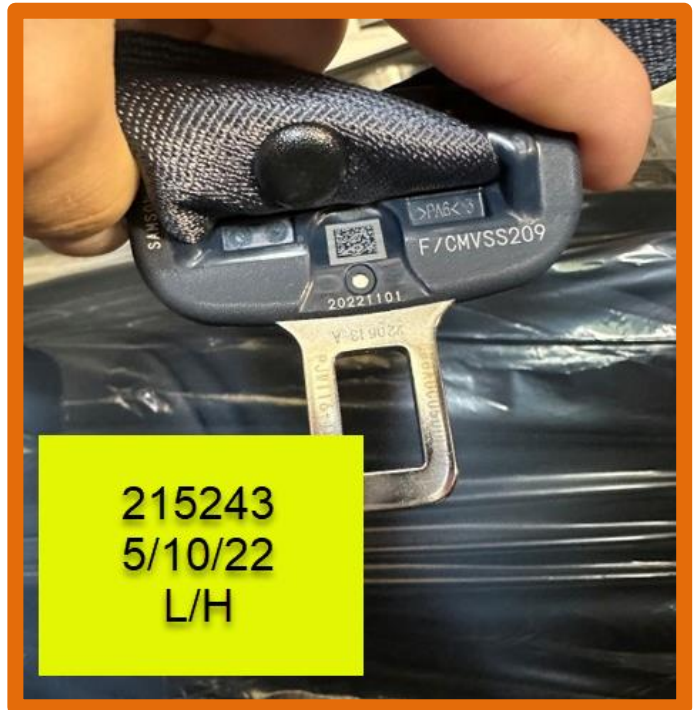
1. For GV60 (JW1) only, inspect both front seat buckle tongue (left and right).

Check the date code on the front seat belt buckle tongue. If the date code is **on or after** 5/20/2022 (20220520 labeled on the buckle tongue), seat belt pretensioner caps installation is not needed. Proceed to step 2.

If the date code is **before** 5/20/2022 (20220520 labeled on the buckle tongue), continue the cap installation process at step 3 below.

Using STUI, please take photos of both sides (LH and RH) of the seat belt buckle tongue with the date code. Within the picture, ensure date code is legible, include a piece of paper with the last 6 digits of the VIN, date of the repair, and Driver (LH) side or Passenger (RH) side.

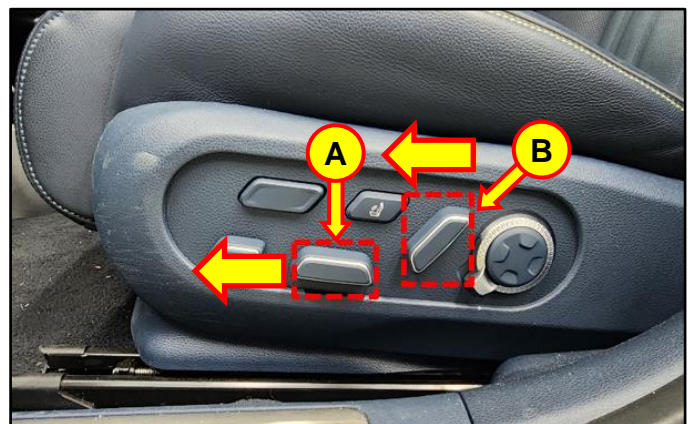
3. If applicable, record the customer's radio preset stations for AM / FM / SXM.

Move the front/rear switch (A) seat of the seat as far forward as possible.

Press the seat back switch (B) to move as far forward as possible.

Turn OFF the ignition key of the vehicle.

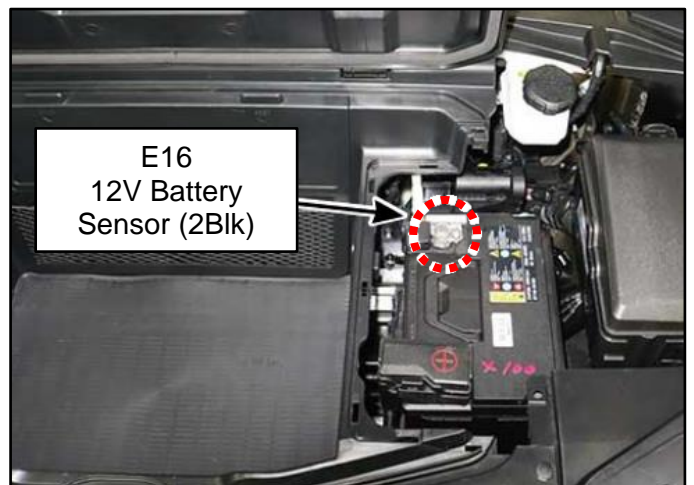
4. Disconnect the negative (-) battery terminal. Battery is located under luggage board.

**Tightening Torque:**

lb-ft	6.5
lb-in	78
N.m	8.8

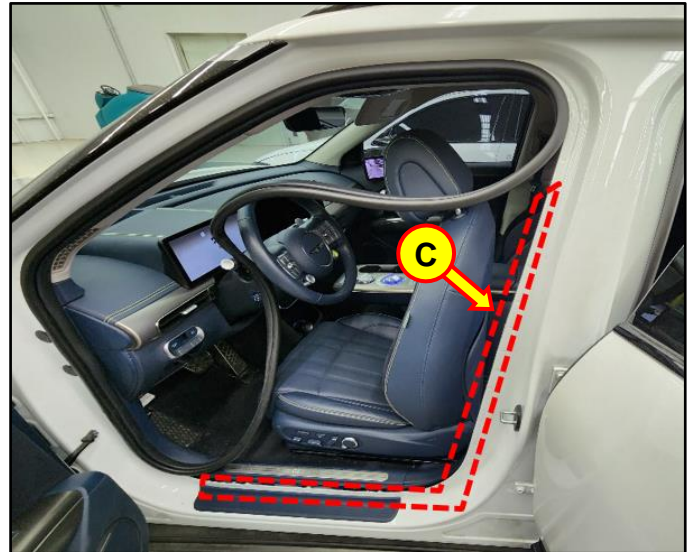
5. Partially remove the front door body side weather strip (C).

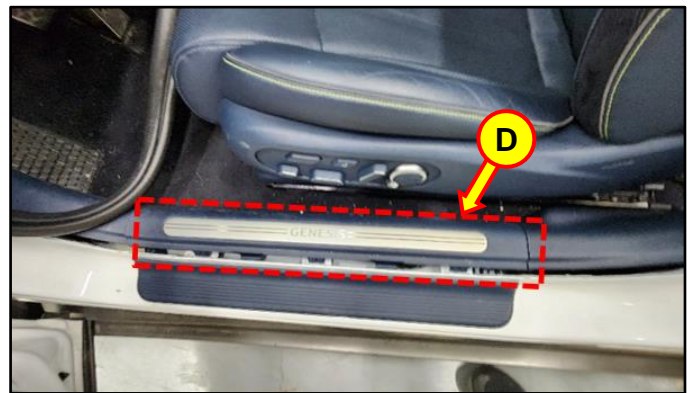
6. Remove the front door scuff trim (D) using the trim tool.

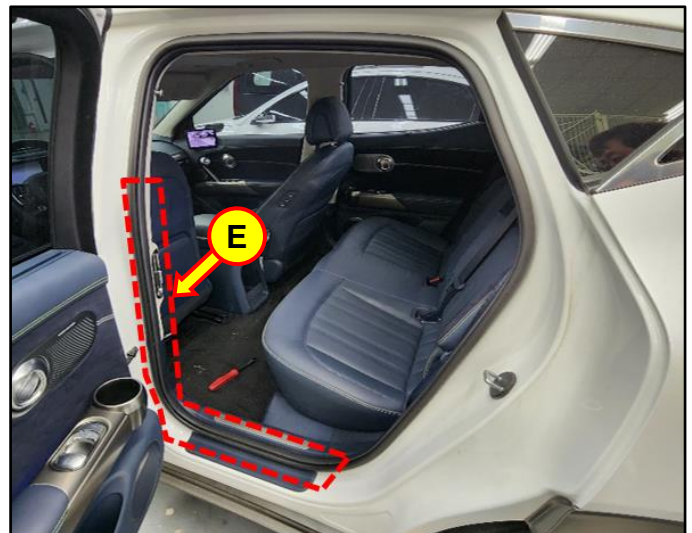
7. Partially remove the rear door body side weather strip (E).

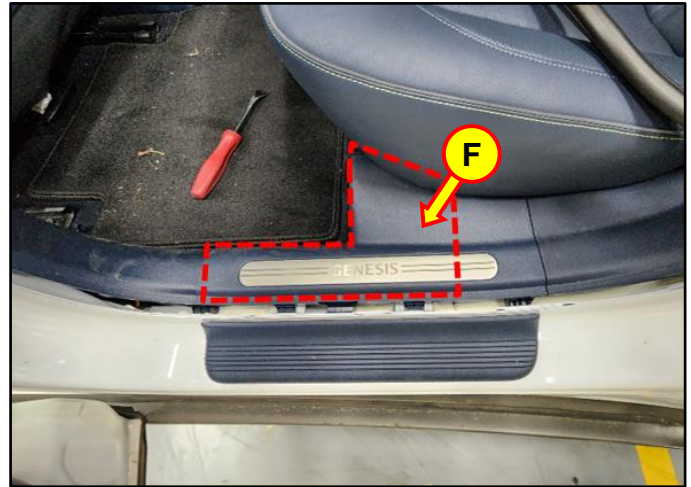
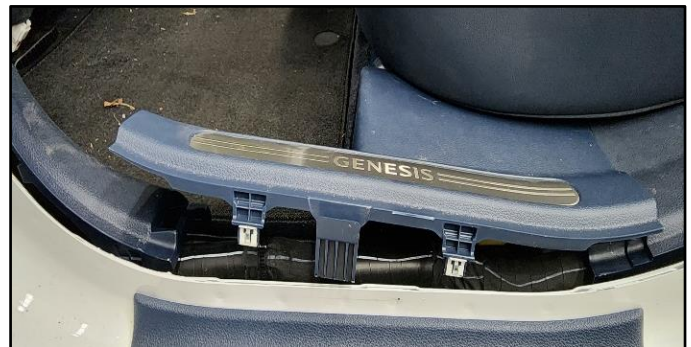
8. Partially remove the rear door scuff (F) using the trim tool.

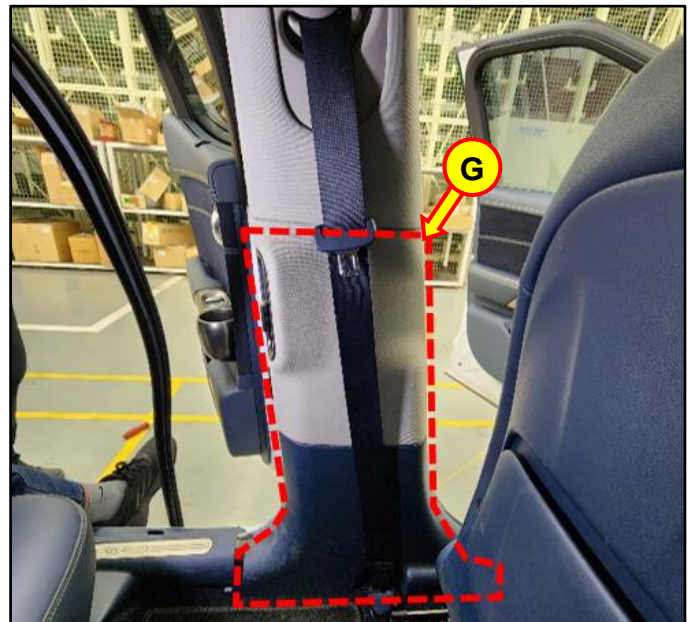
9. Remove the center pillar lower trim (G).

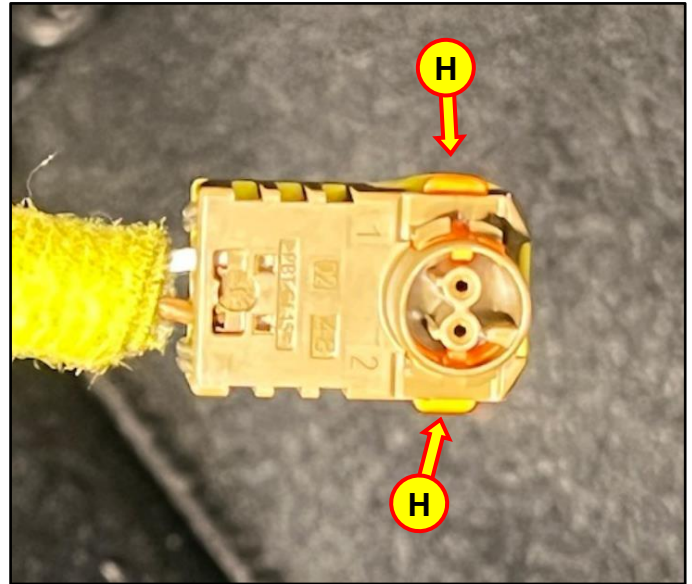
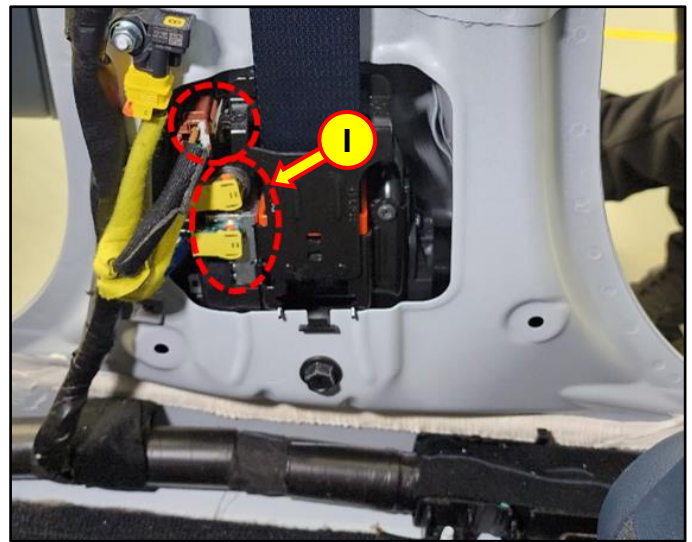
10. Press the lock pins (H) to disconnect the front seat belt pretensioner connectors (I).

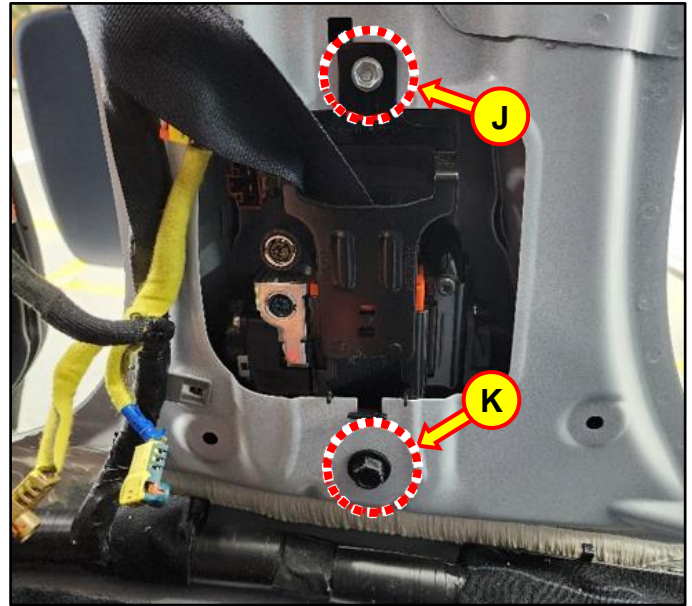
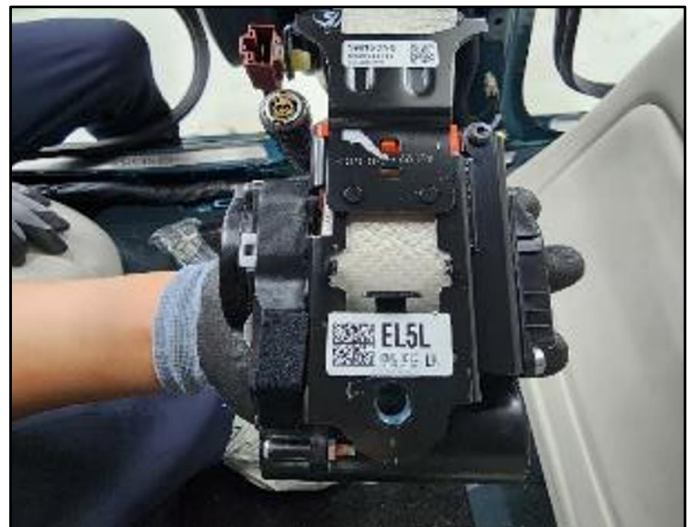
11. Loosen the mounting bolts (J & K) and remove the front seat belt pretensioner.

**Tightening Torque – Bolt (J):**

lb-ft	7.3
lb-in	87
N.m	9.8

**Tightening Torque – Bolt (K):**

lb-ft	39
N.m	53

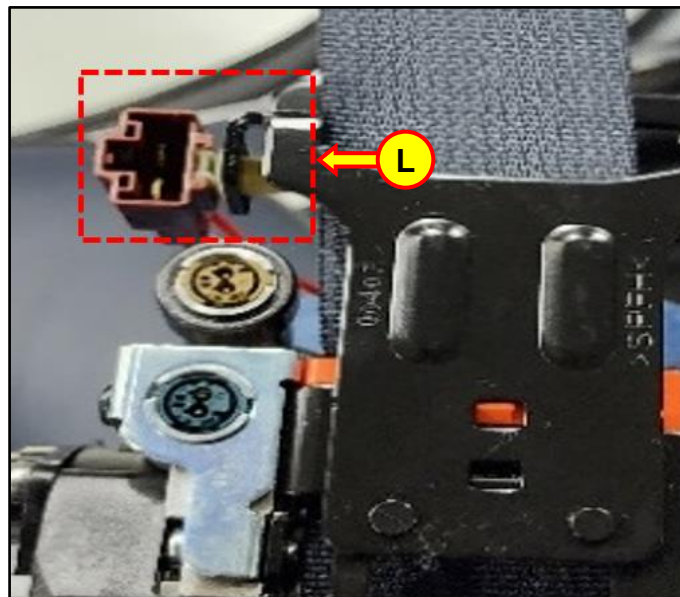
12. Disconnect the ARL connector (L).

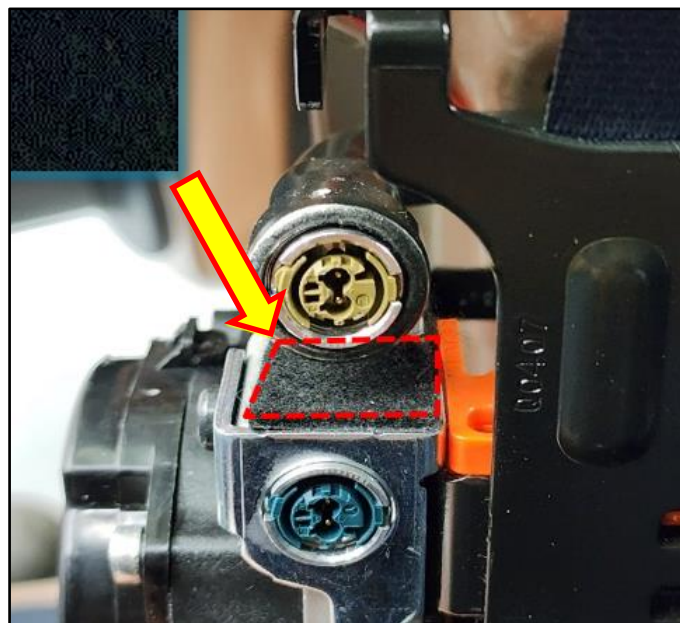
13. Attach the pad.

Make sure the installation direction matches the photo at right.

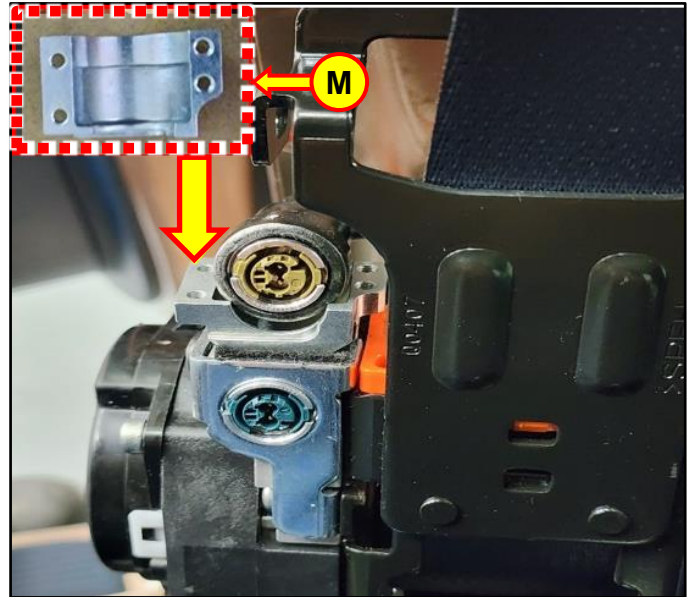
14. Install Cap B (M).

Make sure the installation direction of the cap matches the photo at right.

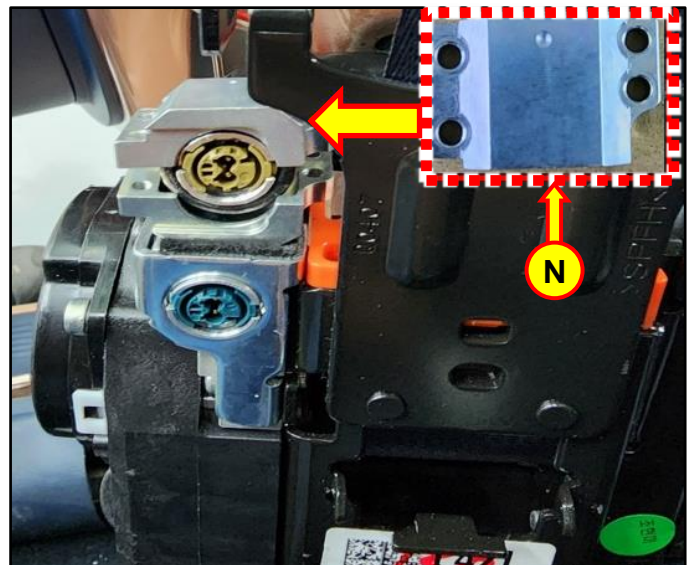
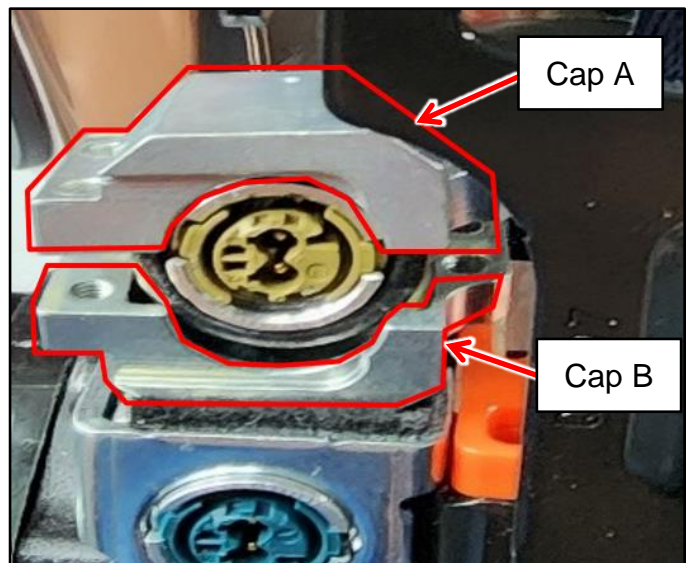
15. Install Cap A (N).

Make sure the installation direction of the cap matches the photo at right.

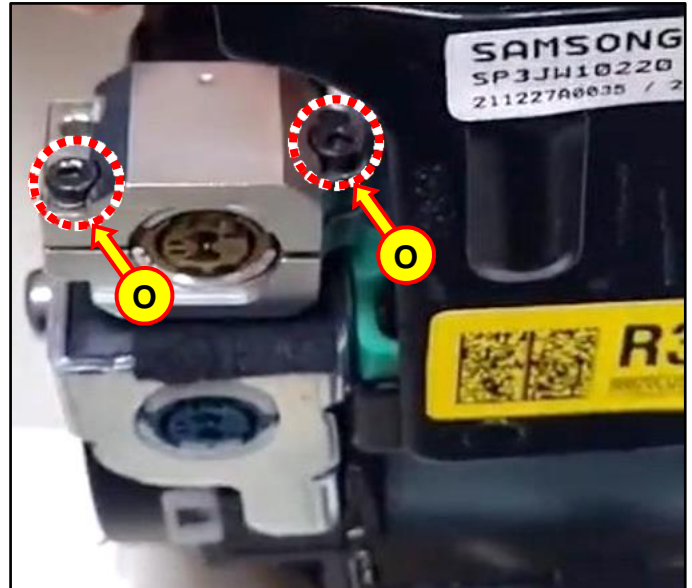
16. Tighten the cap top bolts (O).

lb-ft	1.7
lb-in	21
N.m	2.4

When tightening the bolts, hold the bottom of the cap securely by hand.

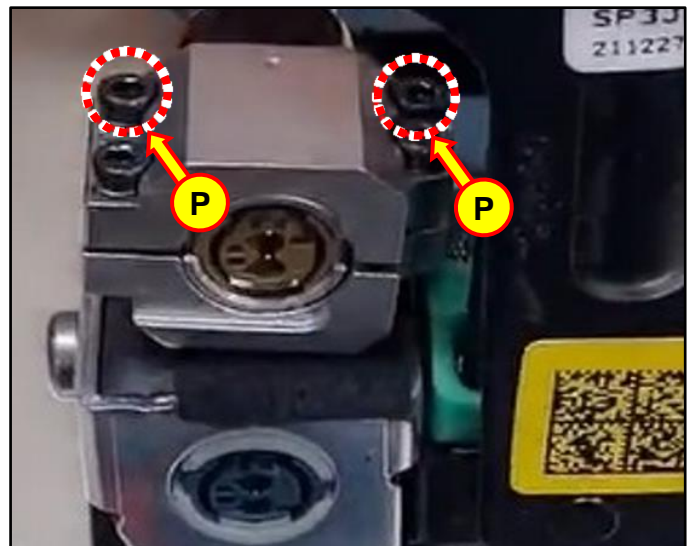
17. Tighten the cap bottom bolts (P).

lb-ft	1.7
lb-in	21
N.m	2.4

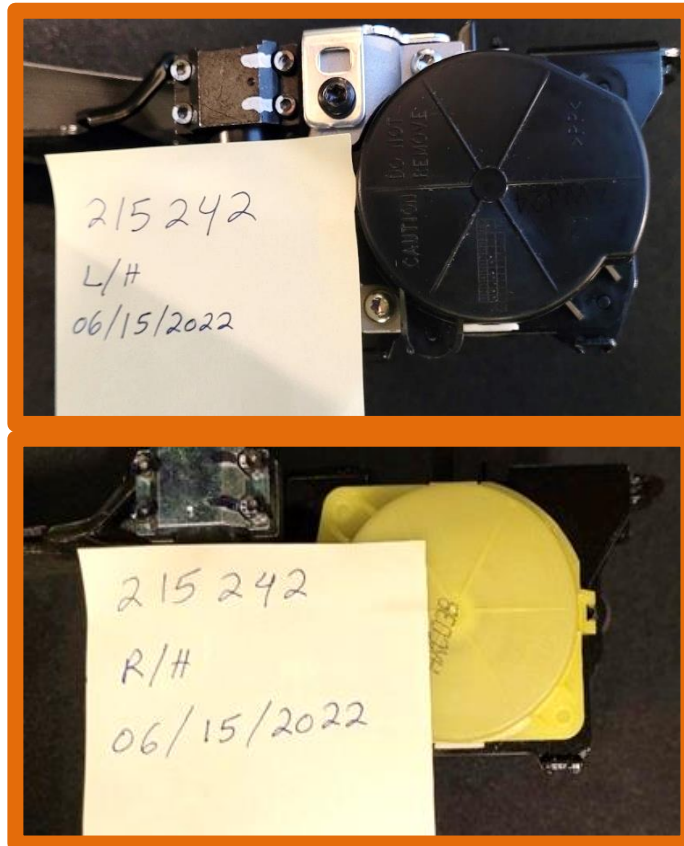
18. Mark all 4 bolts with paint after installing.

Using STUI, please take photos of the completed pretensioner assembly with the caps installed. Within the picture, include a piece of paper with the last 6 digits of the VIN, date of the repair, and Driver (LH) side or Passenger (RH) side.

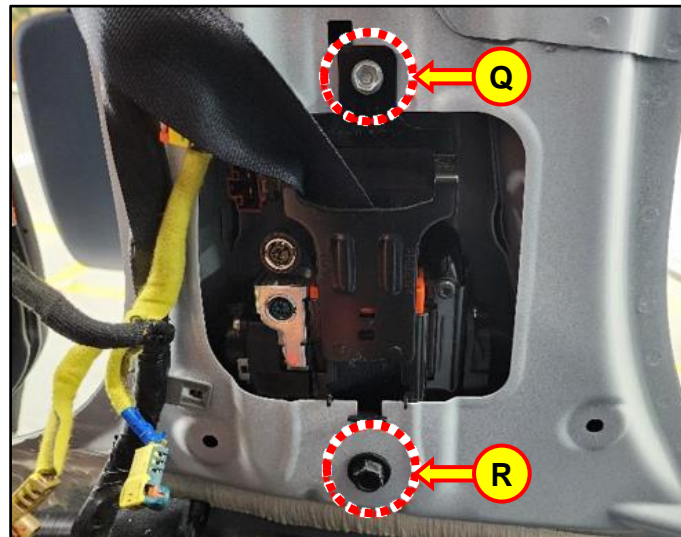
19. Torque the seat belt pretensioner mounting bolts (Q & R) to specifications.

**Tightening Torque – Bolt (Q):**

lb-ft	7.3
lb-in	87
N.m	9.8

**Tightening Torque – Bolt (R):**

lb-ft	39
N.m	53

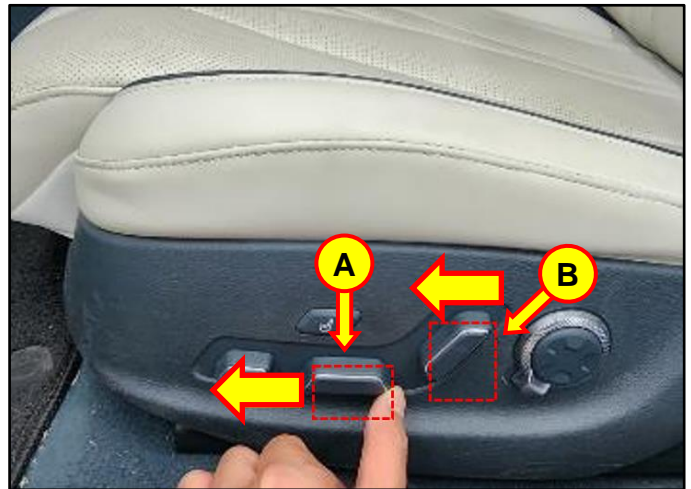
1. If applicable, record the customer's radio preset stations for AM / FM / SXM.

Move the front/rear switch (A) seat of the seat as far forward as possible.

Press the seat back switch (B) to move as far forward as possible.

Turn off the ignition key of the vehicle.

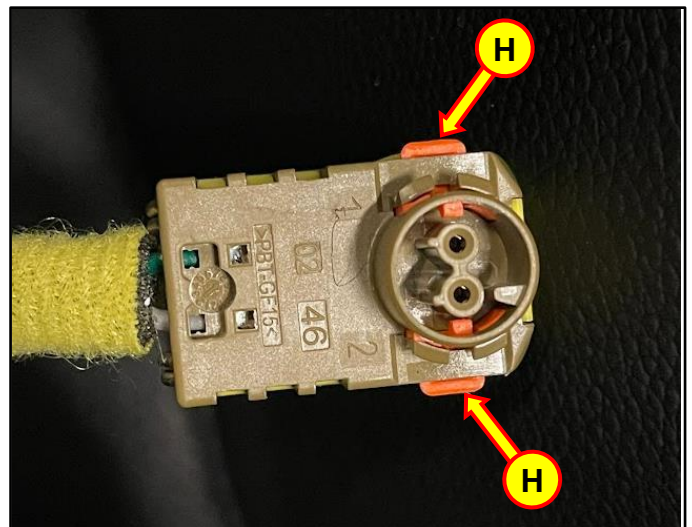
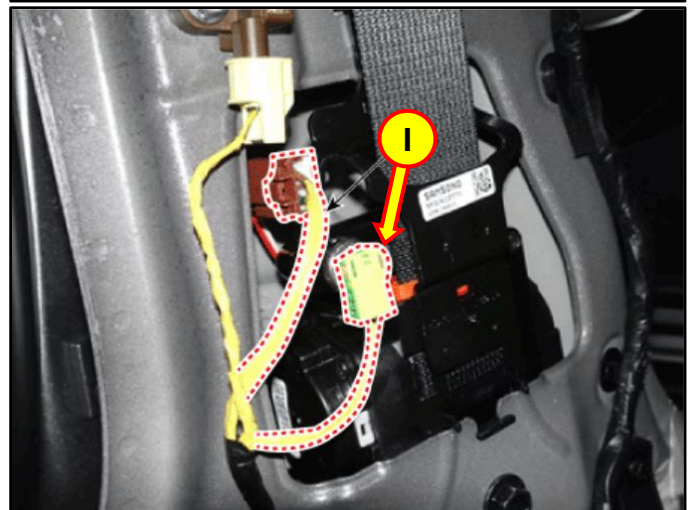
8. Press the lock pins (H) to disconnect the front seat belt pretensioner connector (I).

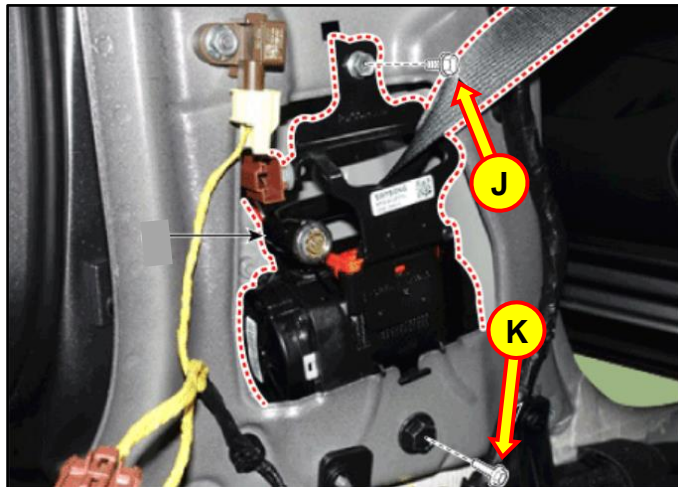
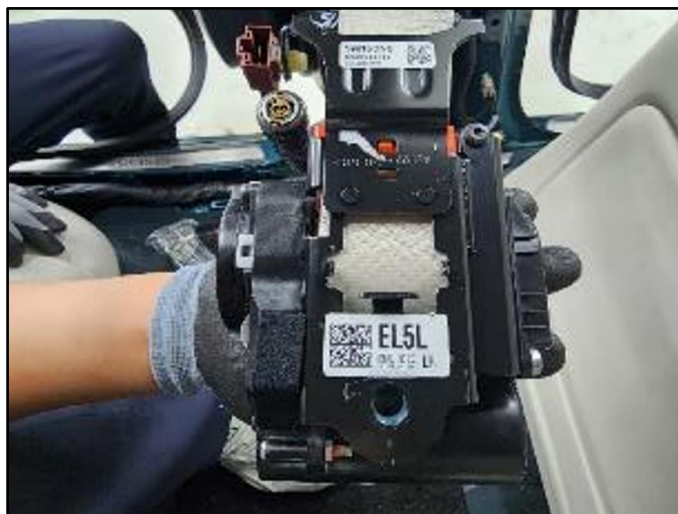
9. Loosen the mounting bolts (J & K) and remove the front seat belt pretensioner.

**Tightening Torque – Bolt (J):**

lb-ft	7.3
lb-in	87
N.m	9.8

**Tightening Torque – Bolt (K):**

lb-ft	35
N.m	47

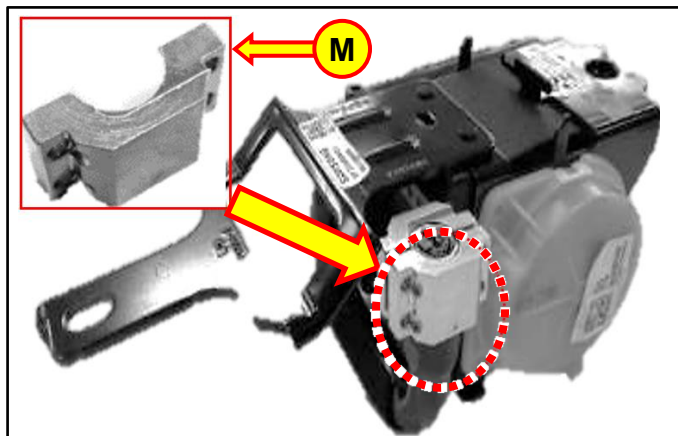
11. Install Cap B (M).

Make sure the installation direction of the cap matches the diagram at right.

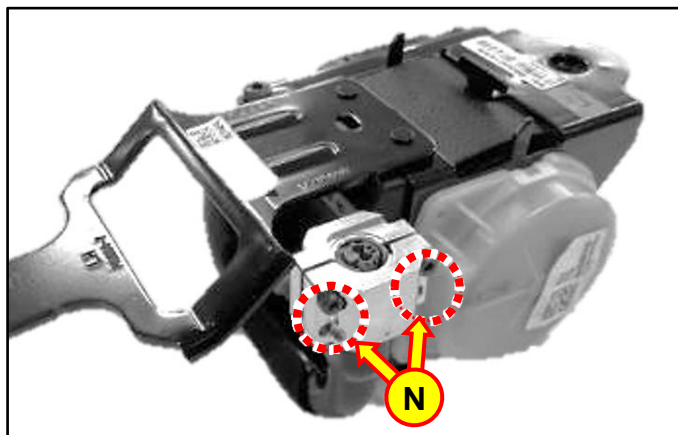
12. Tighten the cap top bolts (N).

lb-ft	1.7
lb-in	21
N.m	2.4

When tightening the bolts, hold the bottom of the cap securely by hand.

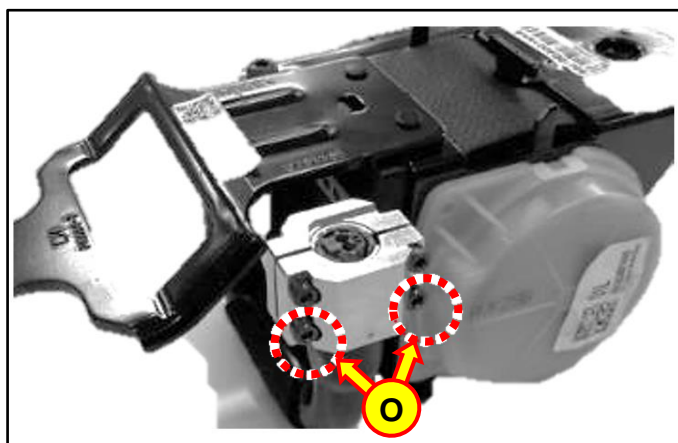
13. Tighten the cap bottom bolts (O).

lb-ft	1.7
lb-in	21
N.m	2.4

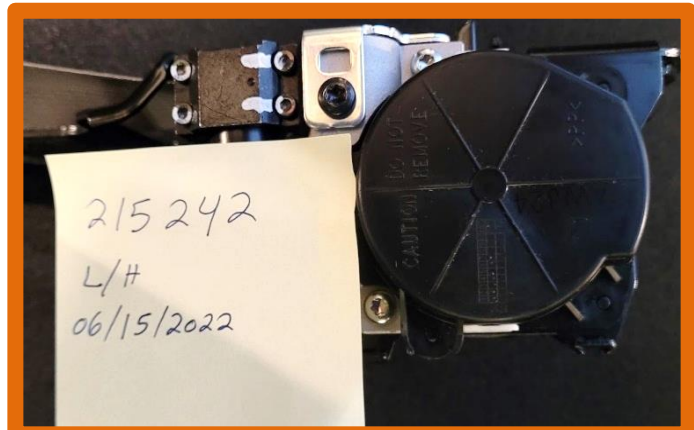
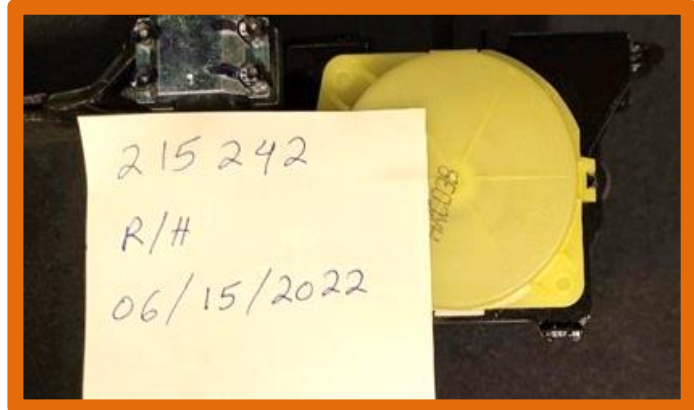
14. Mark all 4 bolts with paint after installing.

Using STUI, please take photos of the completed pretensioner assembly with the caps installed. Within the picture, include a piece of paper with the last 6 digits of the VIN, date of the repair, and Driver (LH) side or Passenger (RH) side.

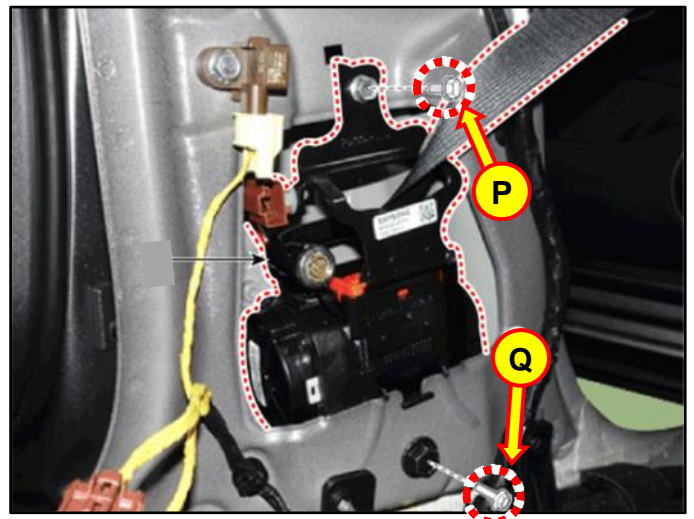
15. Torque the seat belt pretensioner mounting bolts (P & Q) to specifications.

**Tightening Torque – Bolt (P):**

lb-ft	7.3
lb-in	87
N.m	9.8

**Tightening Torque – Bolt (Q):**

lb-ft	35
N.m	47

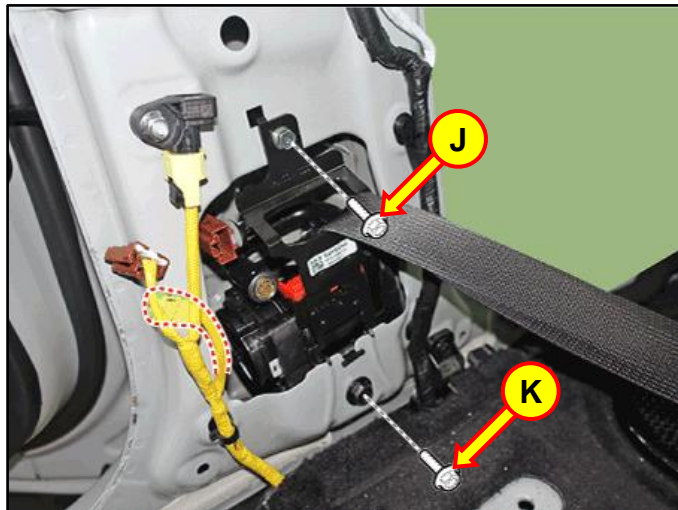
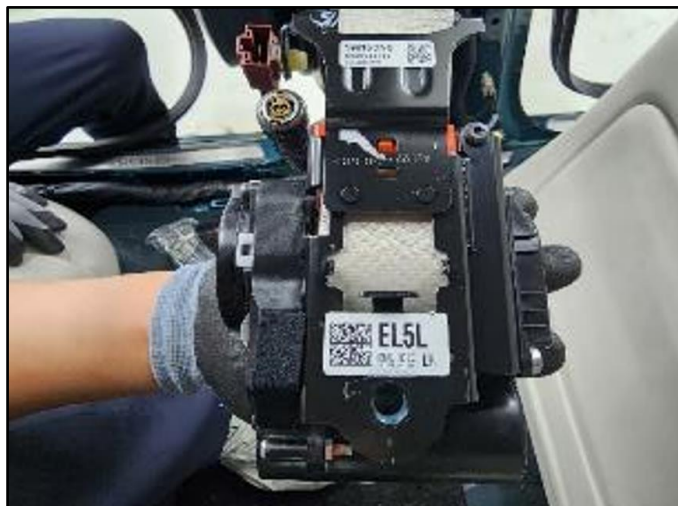
9. Loosen the mounting bolts (J & K) and remove the front seat belt pretensioner.

**Tightening Torque – Bolt (J):**

lb-ft	7.3
lb-in	87
N.m	9.8

**Tightening Torque – Bolt (K):**

lb-ft	35
N.m	47

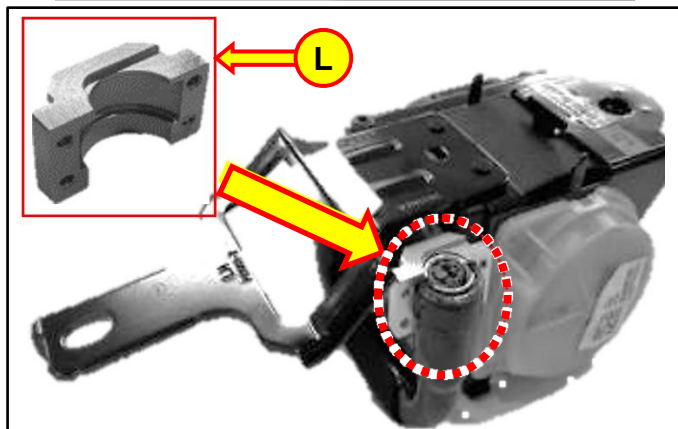
10. Install Cap A (L).

Make sure the installation direction of the cap matches the diagram at right.

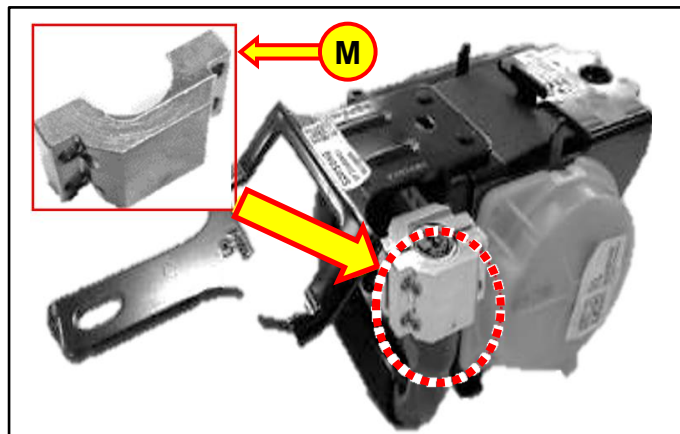
11. Install Cap B (M).

Make sure the installation direction of the cap matches the diagram at right.

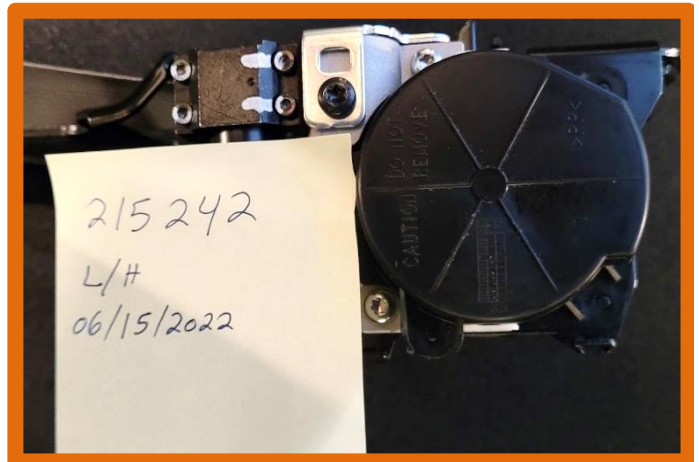
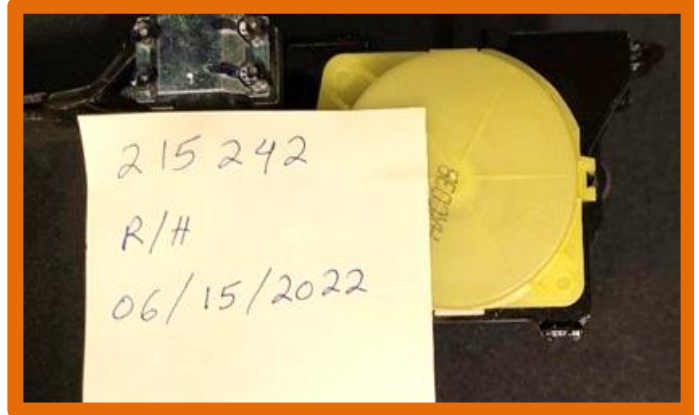
14. Mark all 4 bolts with paint after installing.

Using STUI, please take photos of the completed pretensioner assembly with the caps installed. Within the picture, include a piece of paper with the last 6 digits of the VIN, date of the repair, and Driver (LH) side or Passenger (RH) side.

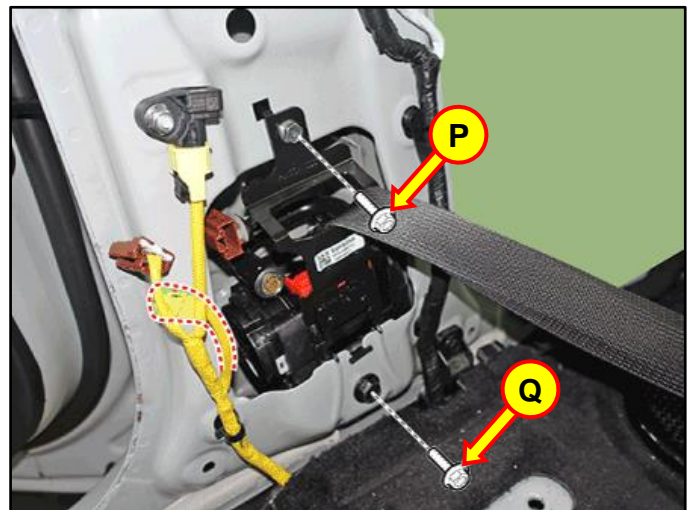
15. Torque the seat belt pretensioner mounting bolts (P & Q) to specifications.

**Tightening Torque – Bolt (P):**

**Tightening Torque – Bolt (Q):**

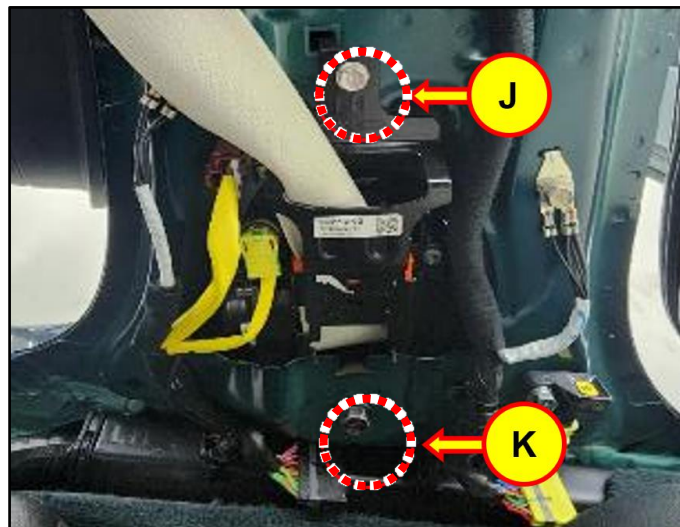
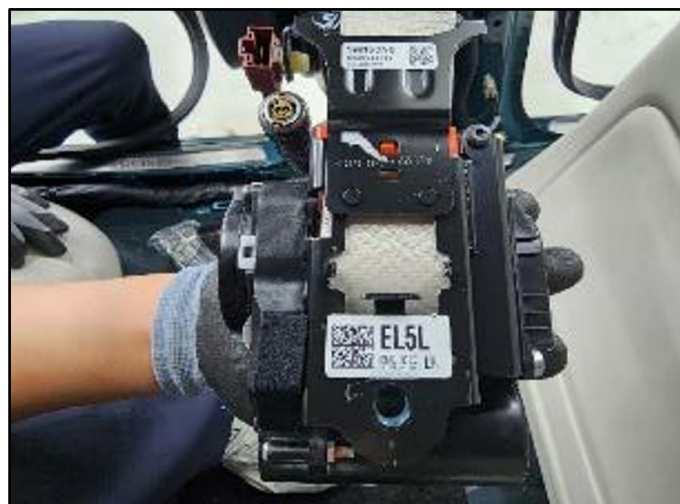
9. Loosen the mounting bolts (J & K) and remove the front seat belt pretensioner.

**Tightening Torque – Bolt (J):**

lb-ft	7.3
lb-in	87
N.m	9.8

**Tightening Torque – Bolt (K):**

lb-ft	35
N.m	47

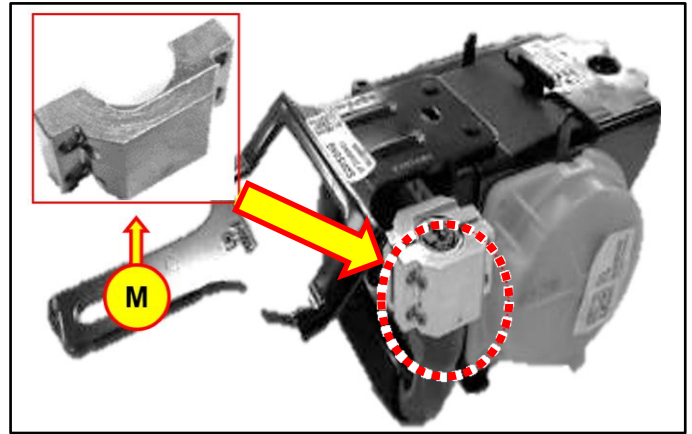
11. Install Cap B (M).

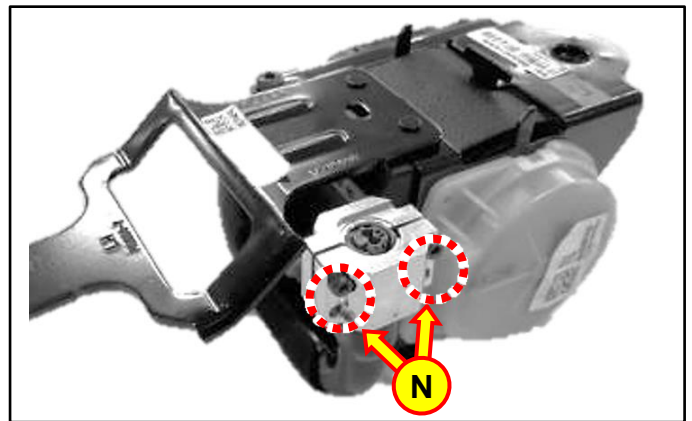
12. Tighten the cap top bolts (N).

lb-ft	1.7
lb-in	21
N.m	2.4

When tightening the bolts, hold the bottom of the cap securely by hand.

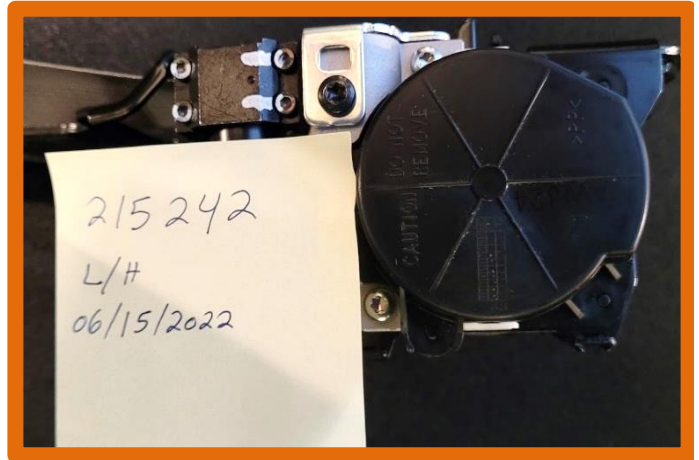
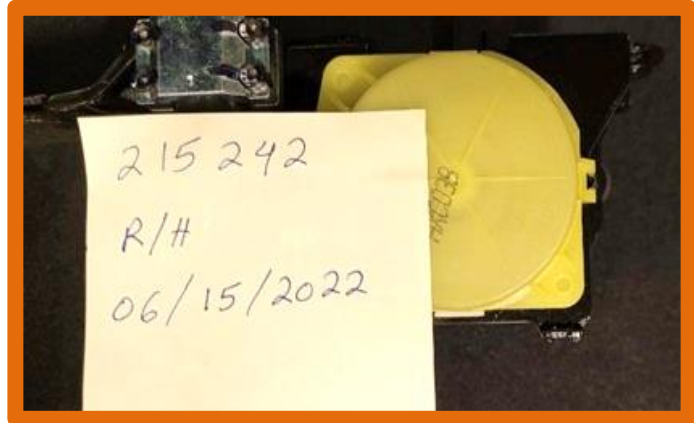
14. Mark all 4 bolts with paint after installing.

Using STUI, please take photos of the completed pretensioner assembly with the caps installed. Within the picture, include a piece of paper with the last 6 digits of the VIN, date of the repair, and Driver (LH) side or Passenger (RH) side.

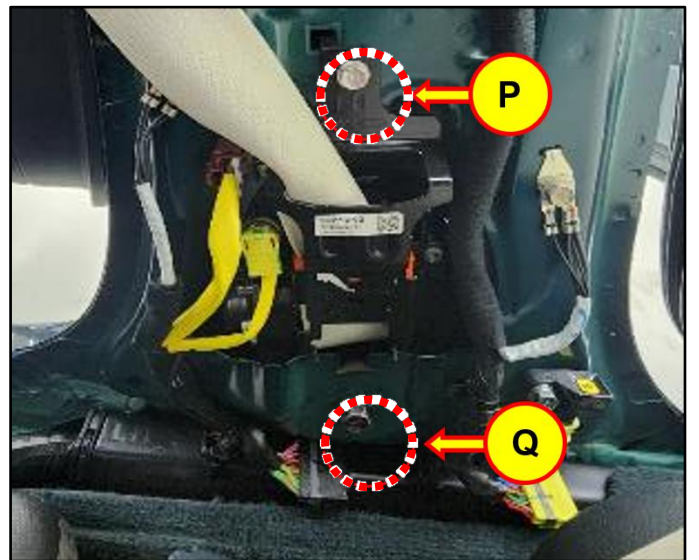
15. Torque the seat belt pretensioner mounting bolts (P & Q) to specifications.

**Tightening Torque – Bolt (P):**

lb-ft	7.3
lb-in	87
N.m	9.8

**Tightening Torque – Bolt (Q):**

lb-ft	35
N.m	47
