Recall Inspection and Repair Instructions

Cahaba Suspension Springs

NHTSA Recall # 23V-104

Tiffin Motorhomes Recall # TIF-128

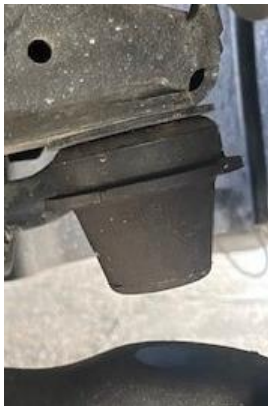
Front Stock Spring

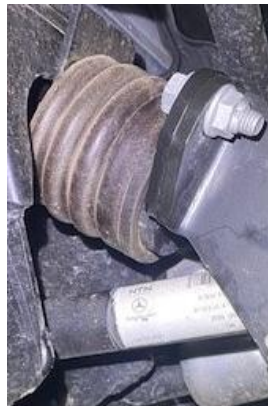
Rear Stock Spring

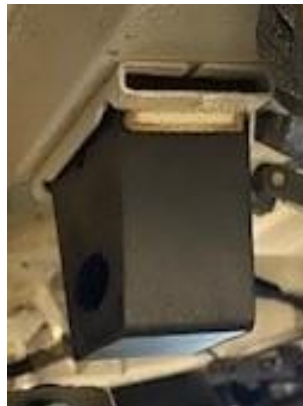
Front Upgraded Spring

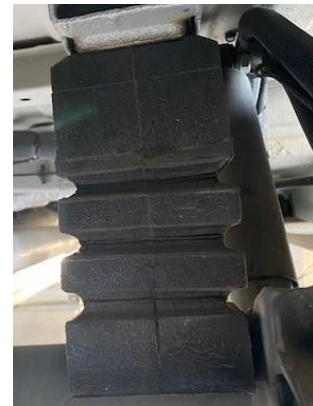
Rear Upgraded Spring
