Dealer Service Instructions for:

Safety Recall 20A / NHTSA 23V-115

Rear Spoiler

2021-2023 (WD) Dodge Durango

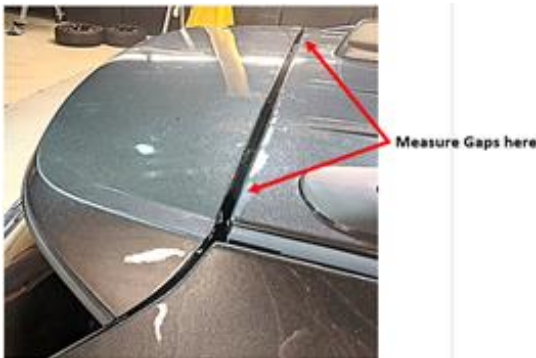
**Figure 3 – Gap from Spoiler to Roof**

3. Measure the gap between the spoiler and roof on the right and left ends. This gap must be 6mm or greater. If not, the upper spoiler must be replaced (Figures 3 and 4).

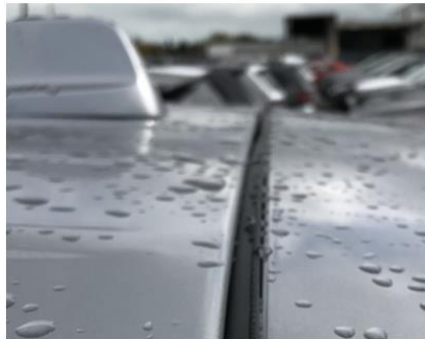
**Bad****Figure 5 – Lip Seal Inspection**

4. Visually inspect the lip seal. The seal must be sitting tight to the spoiler and not catching on the roof. The seal must not be distorted. If the seal does not pass inspection, the upper spoiler must be replaced (Figure 5).

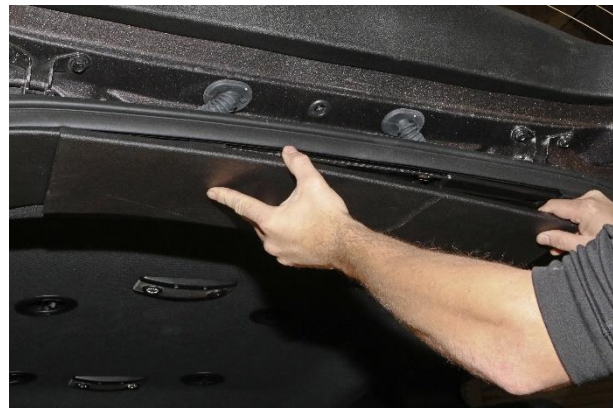
Figure 7 – Headerliner Trim

1. Move the passenger seat forward.
2. Disconnect and isolate the negative battery cable. If equipped with an Intelligent Battery Sensor (IBS), disconnect the IBS connector first before disconnecting the negative battery cable.
3. Open the liftgate.
4. Remove the header trim (Figure 7).
4. Disconnect the electrical connector to the courtesy light, if equipped.
5. Disconnect the washer solvent supply hose and the CHMSL electrical connector (Figure 8).

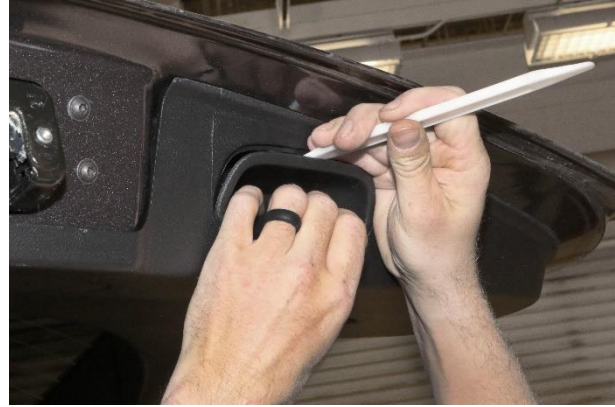
Figure 9 – Liftgate Pull Cup

6. Press down on the pull cup on the liftgate trim (Figure 9).
7. Using a Trim Stick C-4755 or equivalent, at the top in the center, release the cup from the trim panel (Figure 9).

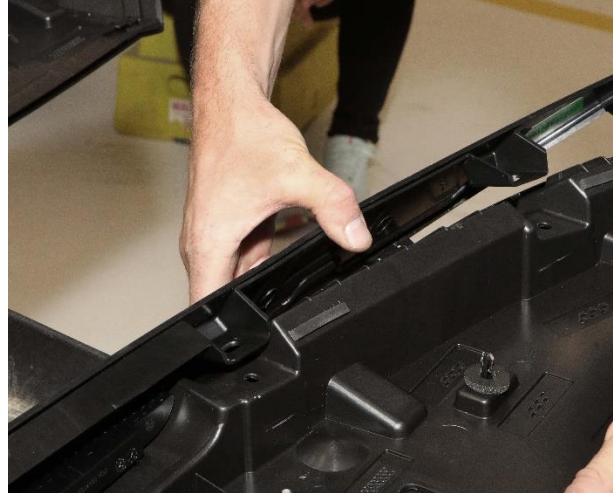
Figure 18 – Release Center Tabs

3. Release eight additional tabs by gently pulling the two spoiler halves apart (Figure 18).

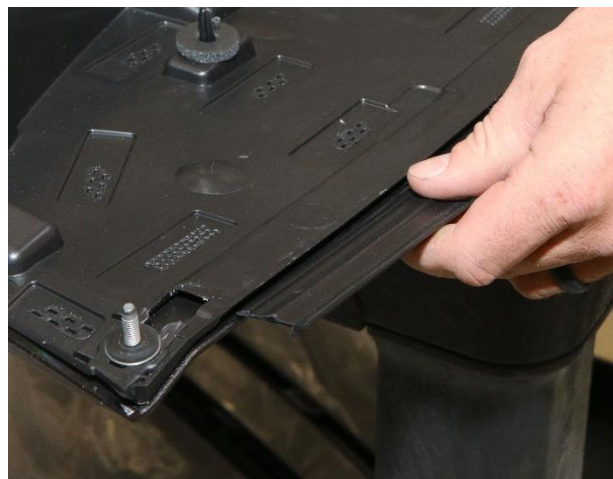
Figure 21 – Spoiler Lip Seal

15. Install the new lip seal to the channel on back edge of the upper spoiler. Compare to the old part for proper orientation (Figure 21).
