SUBJECT: **NEW VEHICLE DEMONSTRATION / DELIVERY HOLD - Safety Recall 23S07**
 Certain 2023 Model Year F-150 and Expedition Vehicles Equipped with 4x4 and 3.73:1 Gear Ratio Axles
 Front Axle Pinion Gear Inspection

CERTAIN 2023 MODEL YEAR F-150 AND EXPEDITION VEHICLES EQUIPPED WITH 4X4 AND 3.73:1 GEAR RATIO AXLES — FRONT AXLE PINION GEAR INSPECTION

SERVICE PROCEDURE

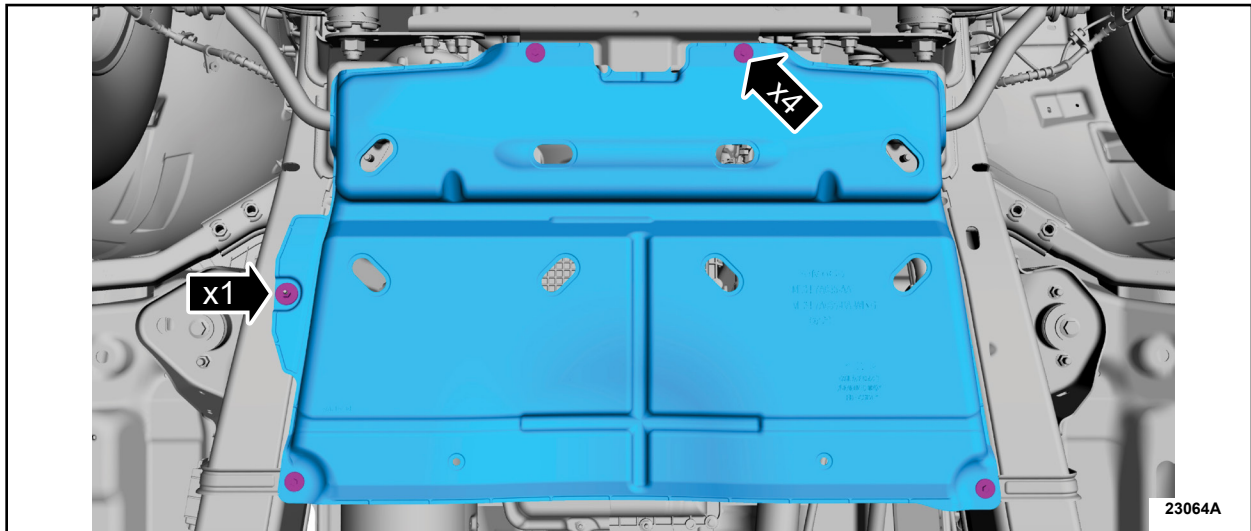
FIGURE 1

1. If equipped remove the nut, bolts and the transmission shield. See Figure 1.

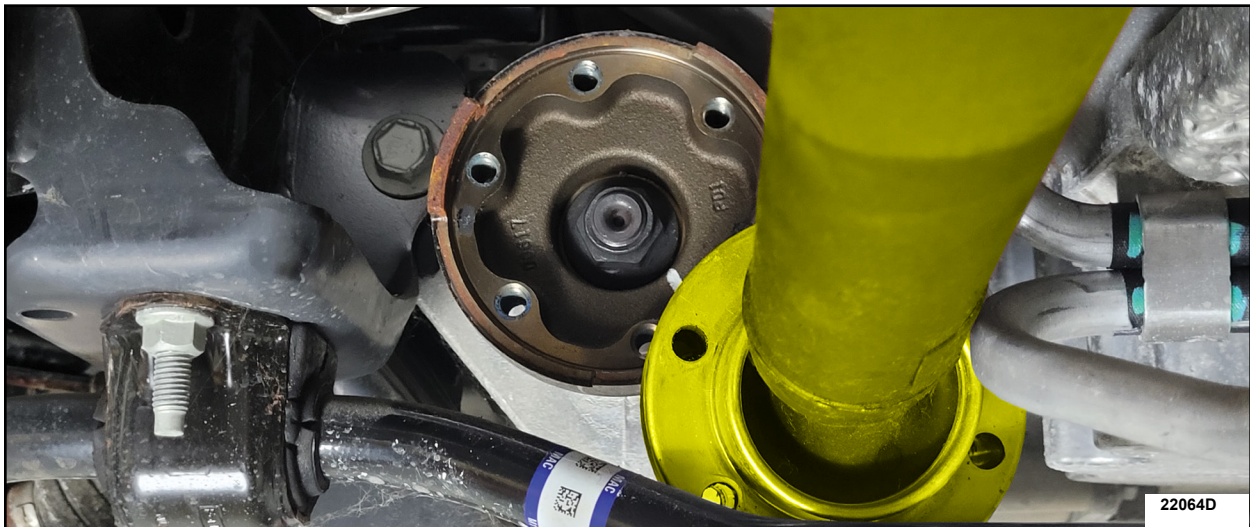
FIGURE 4

4. Position the front driveshaft aside. See Figure 4.
