Tesla, Inc. Service Bulletin		<h2 style="margin: 0;">Inspect Second-Row Seat Frame Bolts</h2>	
SB-23-13-001 March 10, 2023			
Classification Recall Bulletin		Section/Group 13 - Seats	Mobile Service Can Perform (where permitted)
			Configuration 5 Seat
Model Year 2022 - 2023	Model Model Y	Country/Region United States, Canada	Build Location Fremont, Giga Austin
<small>The model(s) and model year(s) listed are a general approximation of the affected VIN list. Refer to the VIN/Bulletin Tracker or Customer/Vehicle profile to determine applicability of this bulletin for a particular vehicle.</small>

Certain Model Y vehicles may require install or retorque of the LH and/or RH second-row seat frame bolts.

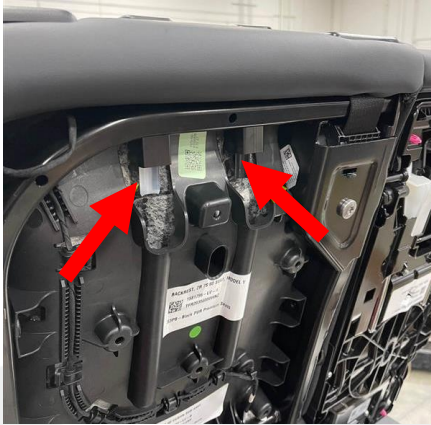
Figure 1 – Seat removed from the vehicle to aid clarity

**NOTE:** On each headrest guide, pull back on the lower portion of the headrest guide (Figure 1) to release the tab while also pushing up to remove the headrest guide from the seat assembly (Figure 2).

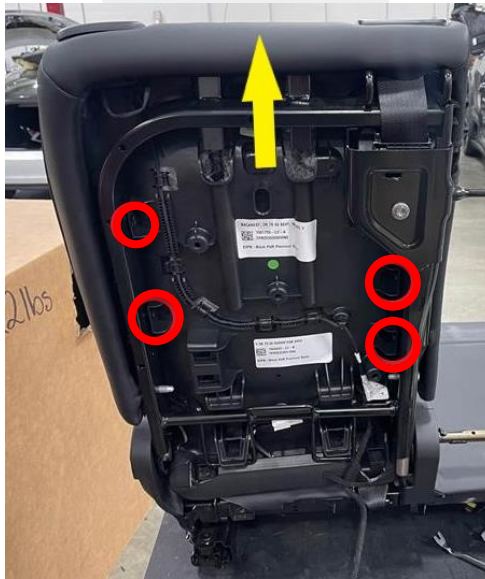
Figure 3 – Seat removed from the vehicle to aid clarity

- Release the clips (x4) (Figure 3) that attach the LH second-row seatback trim assembly to the seat assembly, and then lift the trim assembly with the foam pad upward to remove them from the seat.

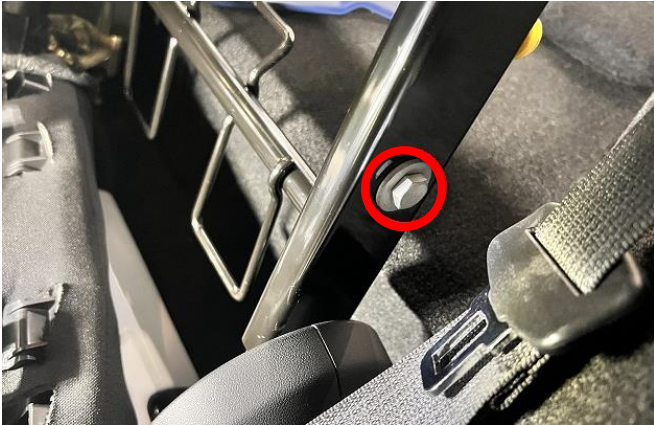
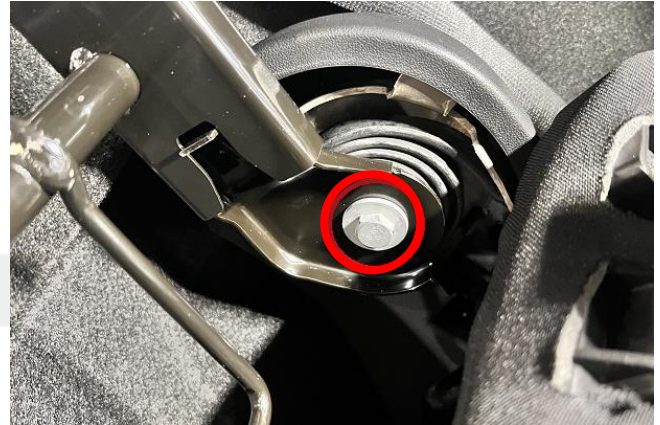
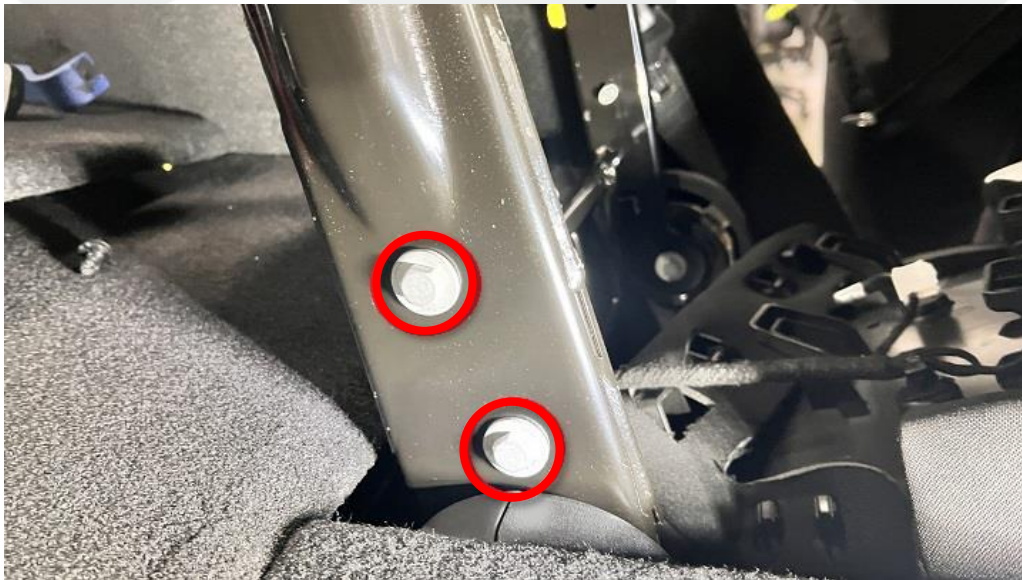
9. Inspect the second-row seat frame bolts (x4) (Figures 4, 5, and 6). Check that each bolt is fastened to 56 Nm using a torque wrench.
- If any of the bolts are fastened to less than 56 Nm, continue to the next step.
 - If all bolts are fastened to 56 Nm, the bolts are fastened to specification. Skip to step 11.

10. For any frame bolt(s) that were **NOT** fastened to specification (56 Nm), or any bolts that need to be installed, perform these sub steps:
- a. Remove the bolt(s). If a bolt is needed, obtain a new bolt (1057091-00-D).
 - b. Apply Loctite 222 threadlocker to the bolt threads.
 - c. Fasten the bolt(s) to 56 Nm.

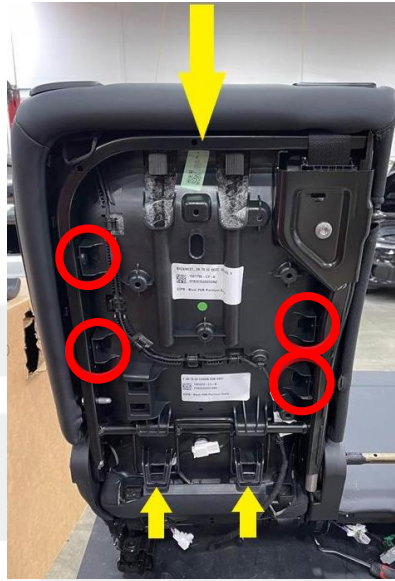
Figure 7 – Seat removed from the vehicle to aid clarity

11. Slide the LH second-row seatback trim and foam pad assemblies onto the seat, and then fasten the clips (x4) (Figure 7).

**NOTE:** Make sure the bottom retainers slide into place (Figure 7).

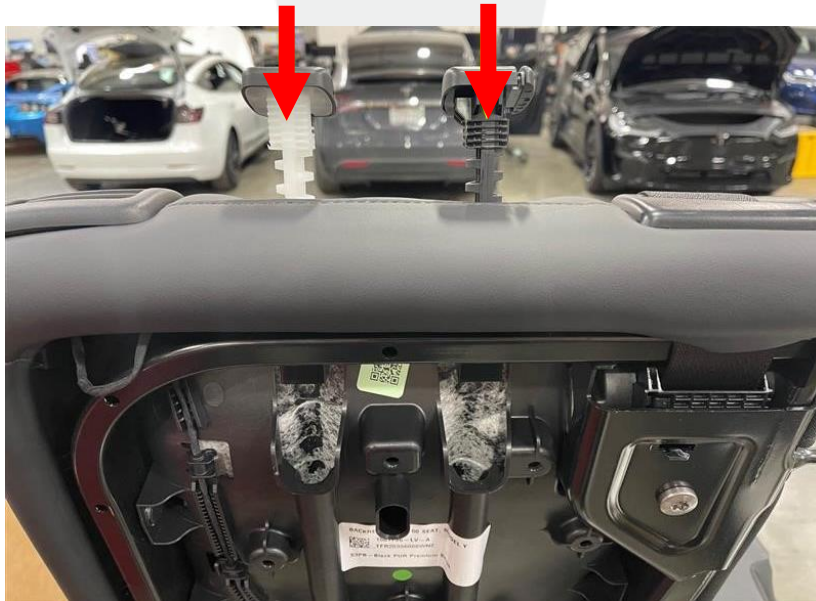
Figure 8 – Seat removed from the vehicle to aid clarity

12. Install the headrest guides (x2) onto the LH second-row seat. Pressing each guide downwards until the lower tab is fastened.
