**Safety Recall – 2023 CX-50 Trailer Tow Hitch Harness May Detach**

## B. REPAIR PROCEDURE

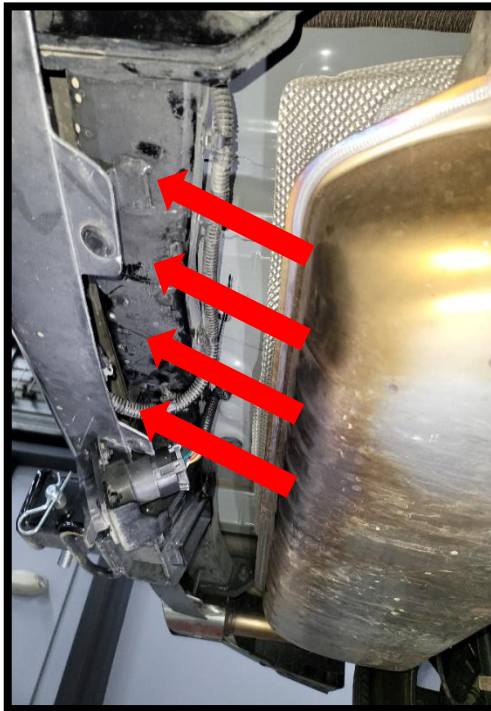
- Using a fork style panel clip removal tool ② to remove the harness cable mount clips from tow bar.

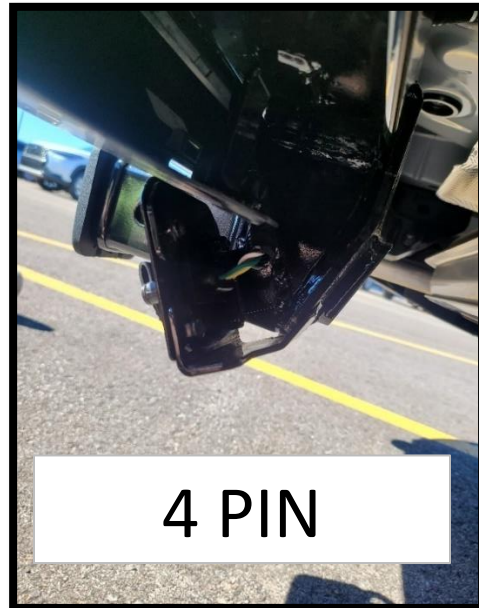
Or remove the 4 pin connector from tow bar bracket and discard exterior harness.

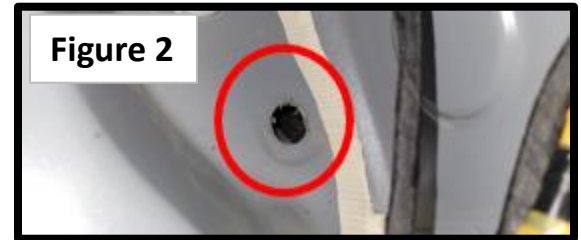
10. Locate the exposed hole where the hitch harness used to go through, under the vehicle near the exhaust.
  - a. Remove any silicone around the hole if present with a plastic scraper tool ③.
  - b. Using isopropyl alcohol ④ and a shop towel ⑤, thoroughly clean the hole surface area to be covered. Let alcohol dry completely (30 to 60 seconds).
  - c. Figure 1. Apply body frame tape ⑥ from new harness kit over hole. Press firmly to ensure complete coverage and adhesion. Use 2 pcs if hole is not completely covered.
  - d. Figure 2. On the inside of the vehicle, apply a silicone-based, anti-corrosion sealer ⑧ to edge of hole from interior side of vehicle.

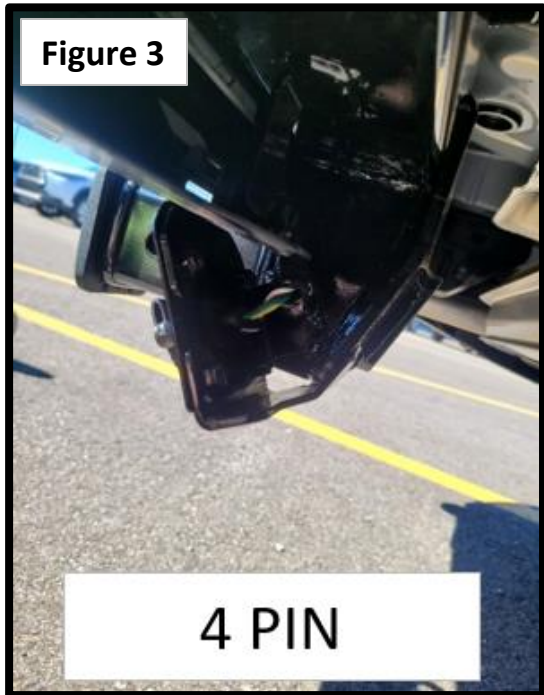
2. Install 4 pin or 7 pin harness connectors.
  - a. Figure 3. Attach 4 pin harness with attachment plate included in main towbar kit with supplied bolts and nuts.
  - b. Figure 4. Plug harness connector into back of connector of 7 pin connector.

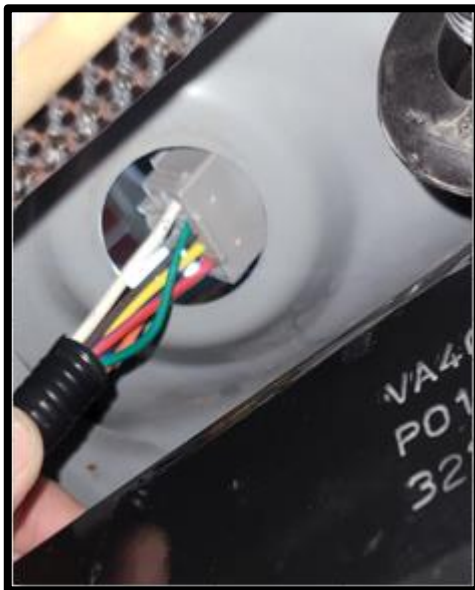
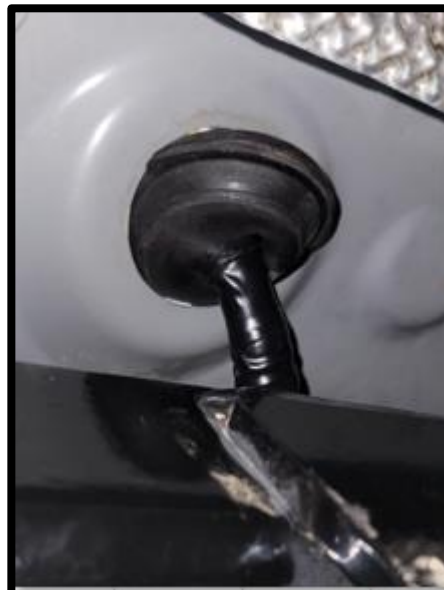
5. Locate the female connector for the new harness. Insert the harness up through drain hole and push grommet attached to new harness through hole.

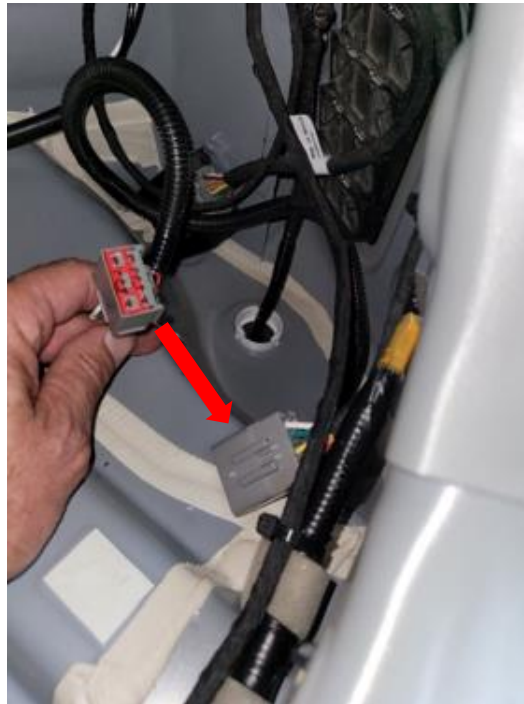
7. Plug exterior harness female connector into interior male harness connector.

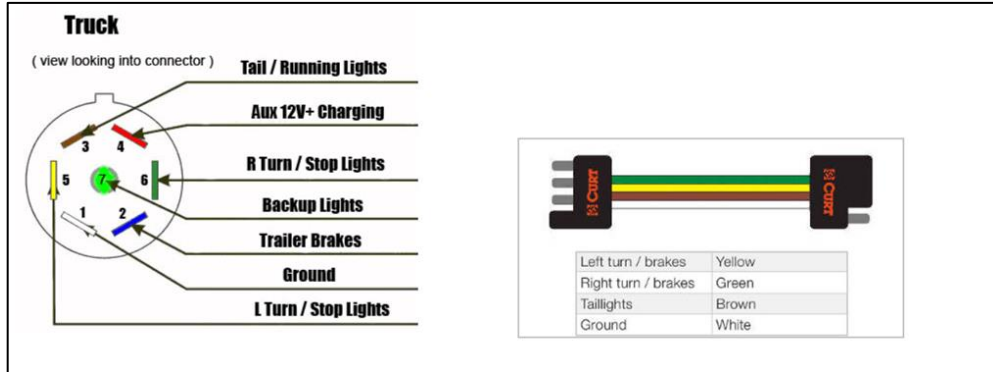
- a. Standard Test Light: With the vehicle running, test the following connections in the figure below to make sure they are working. Test each item in the 7-pin and 4-pin connector for

voltage or test to ground as required.

- i. Perform check of the brake lights.
- ii. Perform check of the backup lights (not needed with 4-pin).
- iii. Perform check of right and left turn signals.
