This work instruction provides steps on how to inspect and replace hubs, hub studs and lug nuts to prevent damage to components caused by not torquing lug nuts to specifications.

This document is to be referenced in the case that loose lug nuts have been discovered on a chassis to determine whether any repairs need to be done and the procedures to follow if repairs are needed.

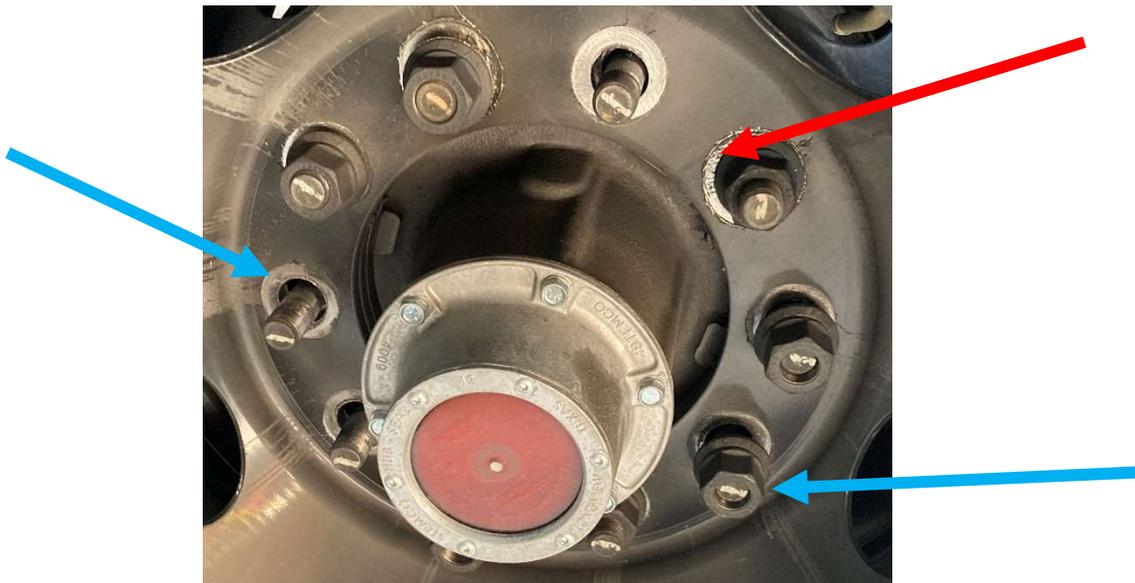
2.1. Wear on wheel/paint defects, **Red Arrow**

2.1.1. The lug nut can appear tight upon inspection, but any defects in paint or inconsistent paint alignment marks are a sure sign that lugs are not fully torqued. If any defects are noticed, the wheel must be removed for hub/perform hub/stud inspection. If no damage is found, torque all lug nuts to specifications and continue to check consistently.

2.2. Lugs have backed off or are missing, **Blue Arrow**

2.2.1. If Lugs appear loose upon inspection or are missing, the wheel must be removed to check hub/hub studs for damage.

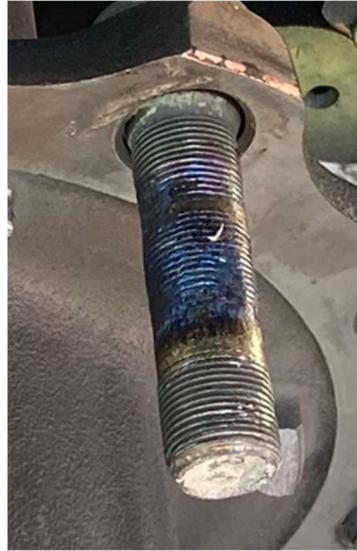
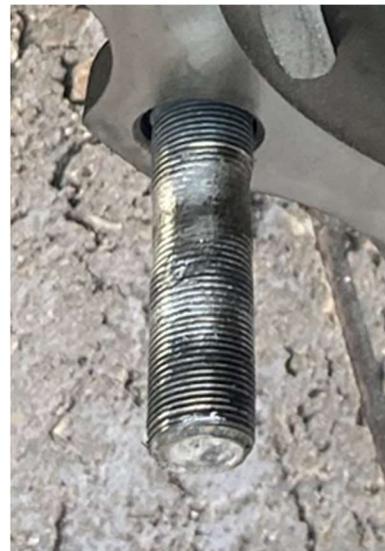
- 3.1. Visual Inspection. Remove wheel. Once the wheel is off, visually inspect studs for any signs of wear, discussed below.
- 3.2. Physical Inspection. Test for thread damage by installing a lug nut by hand on each stud until it bottoms out on the hub. If any noticeable resistance is found, replace the stud. Signs of thread damage can be seen below.

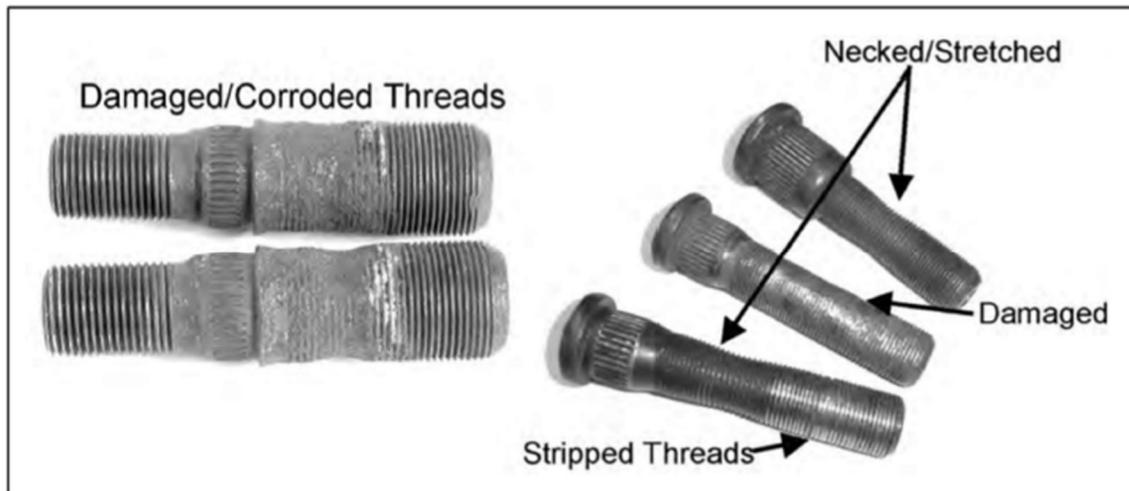
Upon inspection, if any stud appears to have been bent, unseated, necked, stripped, broken or is missing from the hub, it must be removed, and further inspection of the hub must follow. An example of damaged, corroded, stripped and necked studs is shown below.

3.3. Stud Replacement. If any wear is present, the damaged stud and one stud on either side of it at the minimum must be replaced (3 studs). NOTE: Two or more damaged studs requires all studs to be replaced and hub inspected.

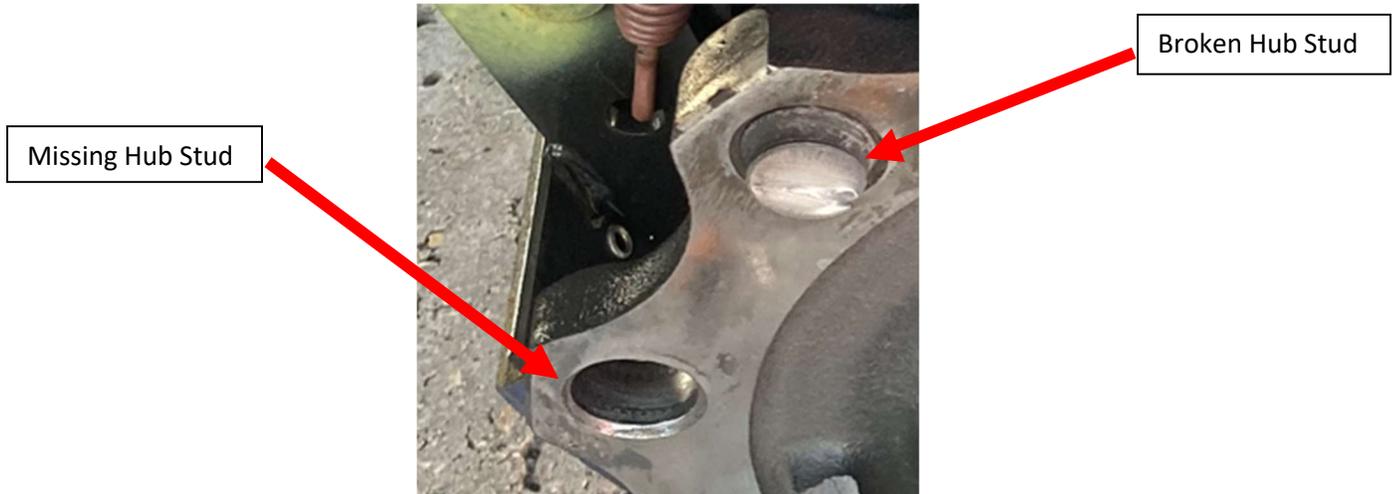
Physically feel each stud by attempting to move it to check that they are tight in the hub. If any studs are loose in the hub, see section 4. A missing and broken hub stud can be seen below.

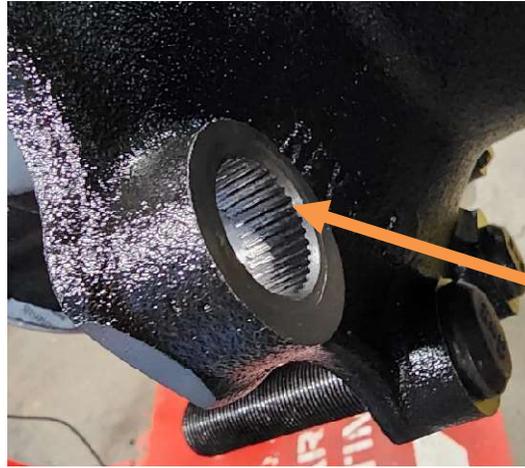
Hub Stud
 Internal Spline
 Pattern

4.2. Visual Inspection. Look over the outside of the hub for any sign of damage such as fractures, a damaged mounting face, excessive corrosion etc. If damage is done to so much as one stud seat, pictured below, there is a risk of compromising the whole hub assembly which could lead to a wheel off event and significant damage and/or safety concerns. After removing each stud, inspect the spline pattern on each of the stud seats for the corresponding stud. If these internal splines are chipped, broken, worn, or missing, the replacement stud will not seat properly.

4.3. If as little as one stud seat is found to be damaged after visual inspection, **replace the hub.**

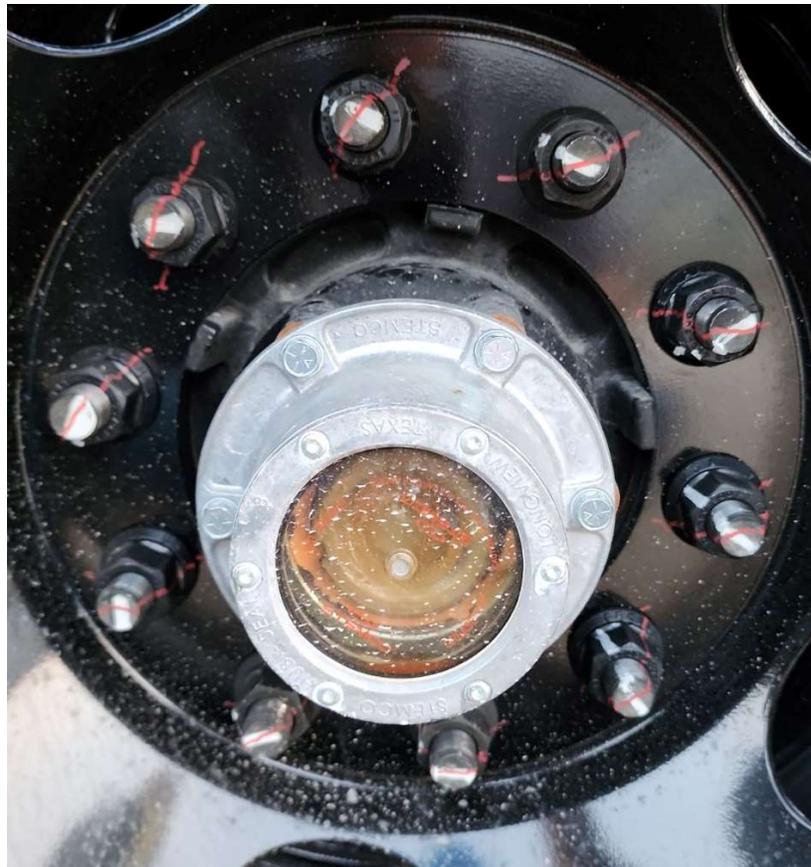
5.1. When lug nuts are torqued to the required value found in the manufacturer's specifications in section 7, mark with a red mark as shown below.

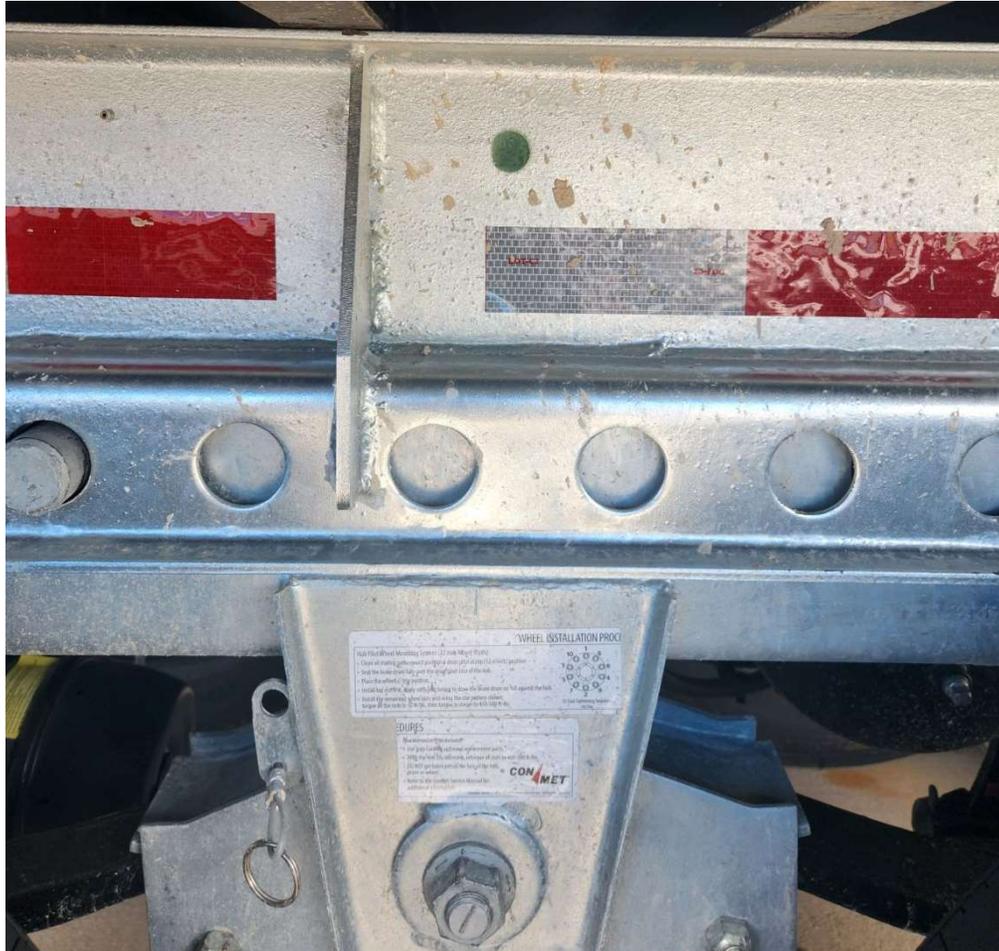
5.2. Paint a small green dot on the body of the chassis on the roadside suspension as shown below.

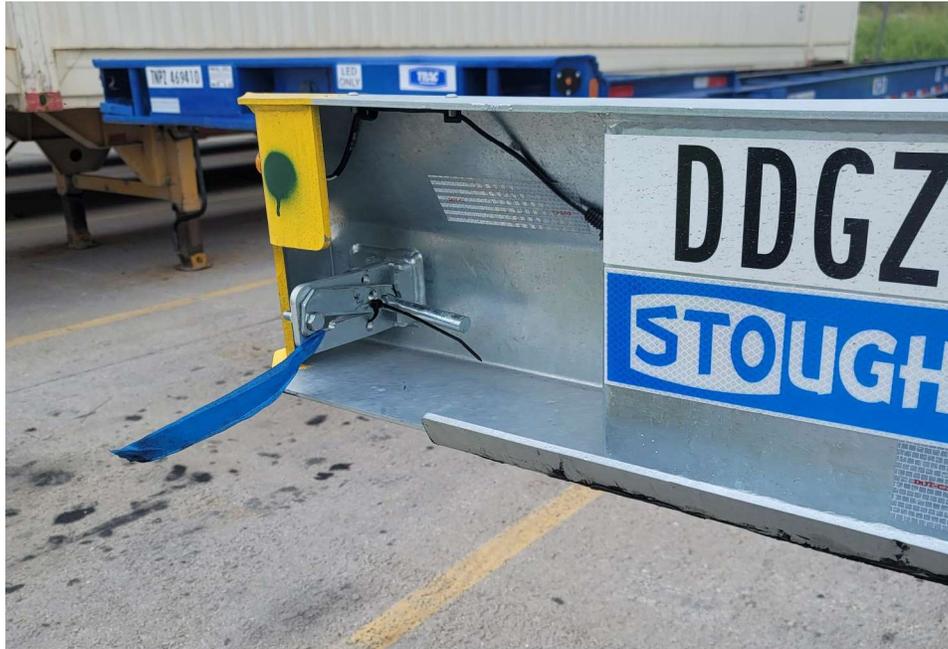
6.1. Once the unit has been inspected and repaired, secure a blue ribbon to the curbside front as shown in the photo below.
