RECALL 23V503 / 2023-402 REMEDY INSTRUCTIONS

Make(s): IMPRESSION
 Model(s): MPF235RW, MPF290VB & MPF330BH
 Model Year(s): 2023

Concern:
 The exterior griddle may be stowed while still connected to LP Gas.

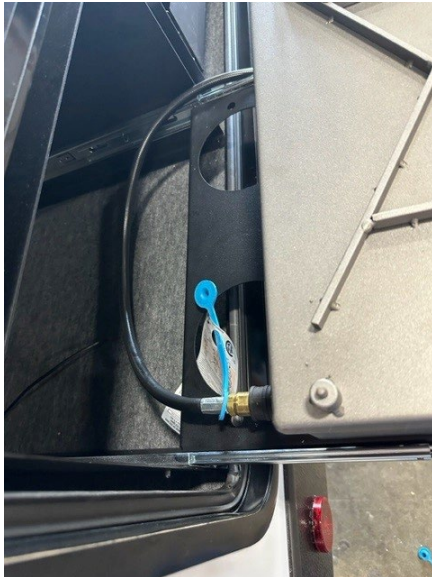
FIGURE 1 - BAD

PHOTO LOOKING DOWN ONTO GRIDDLE (GRIDDLE TOP IS UPSIDE DOWN)
 THIS SHOWS THE LP GAS HOSE CONNECTED BUT ALLOWS THE GRIDDLE TO STOW AWAY WHICH IS BAD.

- STEP 1: REMOVE EXTERIOR GRIDDLE FROM VEHICLES EXTERIOR KITCHEN;
- STEP 2: REMOVE BRASS FITTING DEPICTED IN FIGURE 1:
- STEP 3: REMOVE ANY RESIDUAL SEALANT (PASTE OR TAPE) FROM GRIDDLE PIPE FITTING;

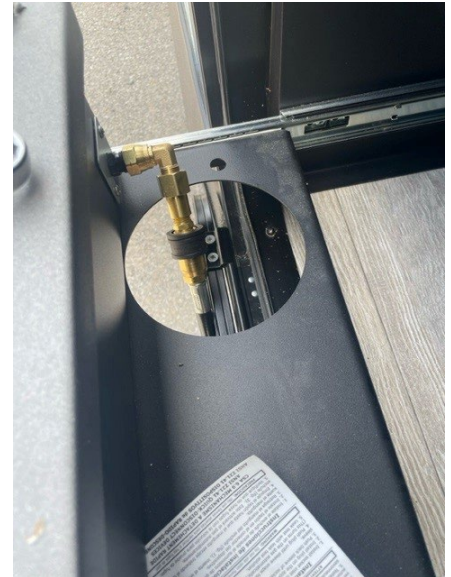
FIGURE 2 - GOOD

PHOTO LOOKING DOWN ONTO GRIDDLE (GRIDDLE TOP IS UPSIDE DOWN)
 THIS SHOWS THE LP GAS HOSE CONNECTED BUT DOES NOT ALLOW THE GRIDDLE TO STOW AWAY.

- STEP 4: APPLY NEW SEALANT RATED FOR LP GAS TO THE GRIDDLES PIPE FITTING;
- STEP 5: THREAD ON THE 90° BRASS FITTING ASSEMBLY AT AN ANGLE AS DEPICTED IN FIGURE 2;

- STEP 7: PUSH THE GRIDDLE TRAY "IN" TO ENSURE THE CONNECTED LP GAS LINE **DOES NOT** ALLOW THE GRIDDLE TO BE STOWED;
- STEP 8: TURN ON LP GAS AT THE LP TANKS;
