**July 28, 2023**

## Noncompliance Recall: 2017, 2020, 2022 CR-V Incorrect Certification Label

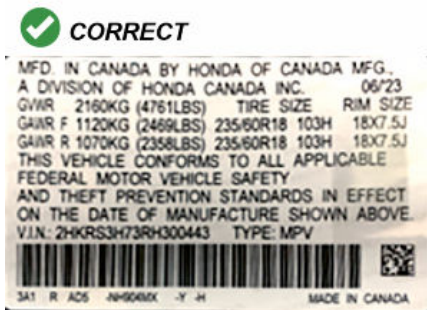
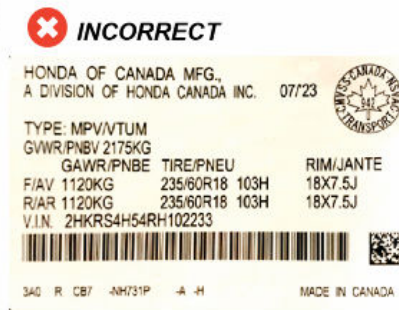
- Open the driver's door and locate the vehicle's certification label.
  - If the certification label has the correct label as shown, this service bulletin does not apply.
  - If the certification label has the incorrect label as shown, go to REPAIR PROCEDURE.

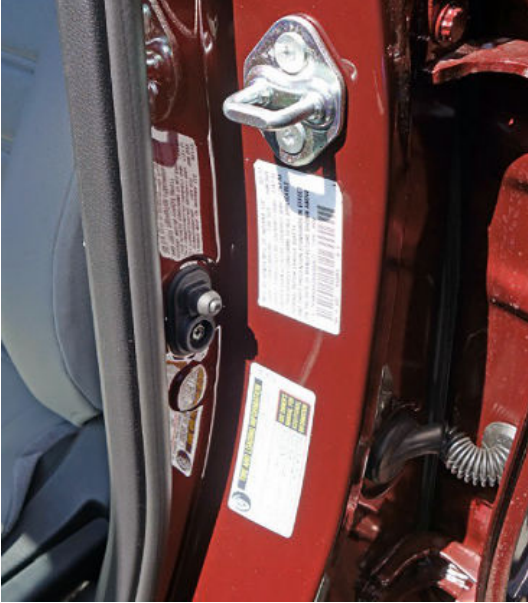
1. Open the driver's side door to locate the certification label.

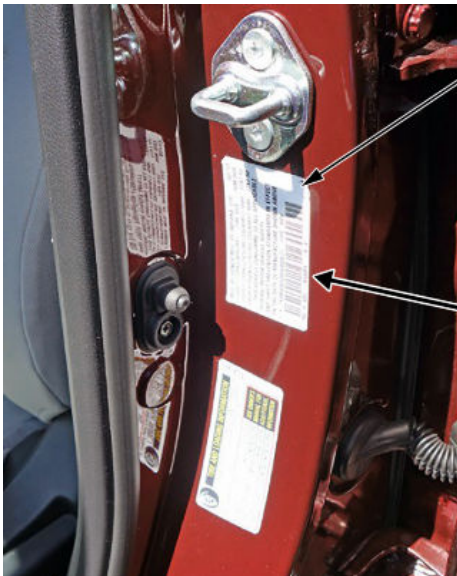
**CERTIFICATION LABEL**  
The certification label is located on the driver's side doorjamb below the striker.

2. Confirm that the VIN on the dashboard matches the VIN on the new certification label.

- As a secondary confirmation, have another person confirm the VIN on the new certification label with the VIN on the dashboard.
- Make sure the VIN and manufacture date on the new label matches the old label.

**MANUFACTURE DATE**

MFD. IN CANADA BY HONDA OF CANADA INC. (10/23)  
A DIVISION OF HONDA CANADA INC. (10/23)  
GVWR 2160KG (4761LBS) TIRE SIZE RMF 5J  
GAWR F 1120KG (2469LBS) 235/60R18 103H 18X7.5J  
GAWR R 1070KG (2358LBS) 235/60R18 103H 18X7.5J  
THIS VEHICLE CONFORMS TO ALL APPLICABLE  
FEDERAL MOTOR VEHICLE SAFETY  
AND THEFT PREVENTION STANDARDS IN EFFECT  
ON THE DATE OF MANUFACTURE SHOWN ABOVE.  
VIN: 2HKRS3H73RH300443 TYPE: MPV

**VIN**

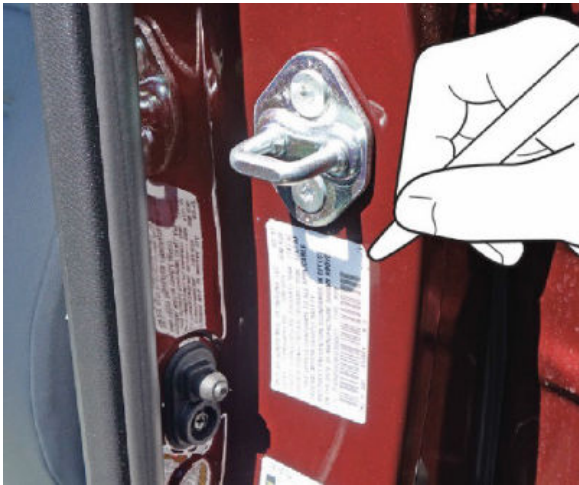
- Using the plastic trim tool, remove the label.

- Applying heat with a heat gun may make the label easier to remove.
- Be careful not to scratch or damage the paint.
- The original misprinted label must be destroyed after removal from the vehicle.**

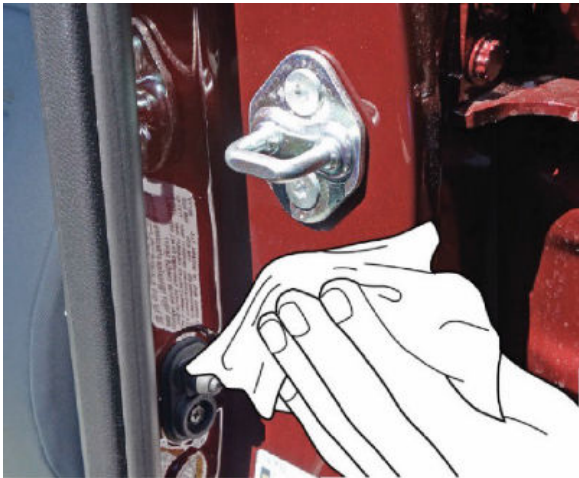
- Use isopropyl alcohol on a lint free cloth to thoroughly clean the area for the new label, removing all remaining residue. Allow the alcohol to dry for **2-3 minutes**.
