EBB-60 TRAILERS manufactured between 2020 and 2022: Tongue Deformation at the Trailer Crossmember

Background

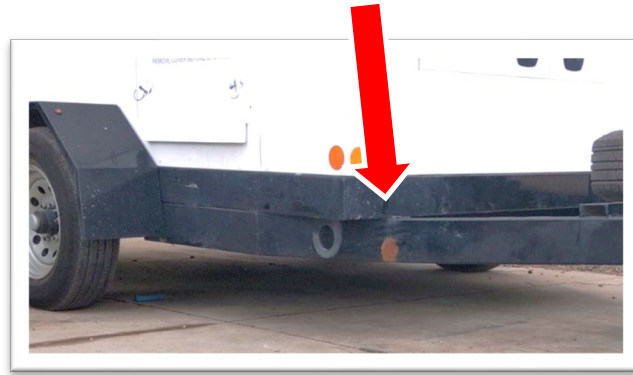
Structural deformation of the tongue assembly is possible near where the trailer tongue meets the front trailer crossmember. Visible evidence of deformation may be suggested by buckled or flaked protective coating (powder coat) at the affected area. This service bulletin provides the steps necessary to inspect an EBB Trailer for tongue deformation.

IMPORTANT: For EBB-60 Trailers manufactured between 2020 and 2022, **NONE ARE TO BE USED** until the trailer has been retrofit with the new EBB trailer tongue assembly. A redesigned and strengthened tongue assembly (65327.400) is being manufactured and will be available this summer.

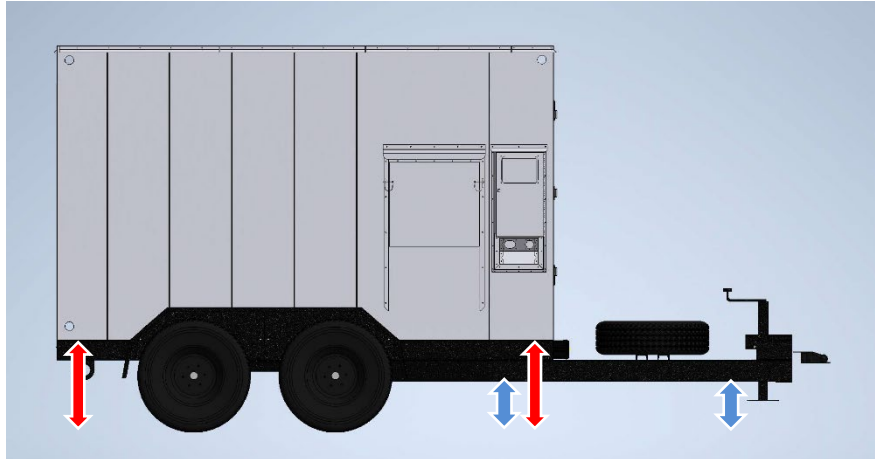
RED ARROWS

1. Park the EBB Trailer so that it is on a level surface. Using the tape measure, record the distance from the GROUND to the TOP OF THE TRAILER FRAME in the two (2) spots noted in the drawing with **RED ARROWS**.

NOTE: If these two measurements are not identical, disconnect the trailer from the tow vehicle and use the tongue jack to get the two (2) distances to measure the same.

**Measure to
TOP of FRAME
RAIL**

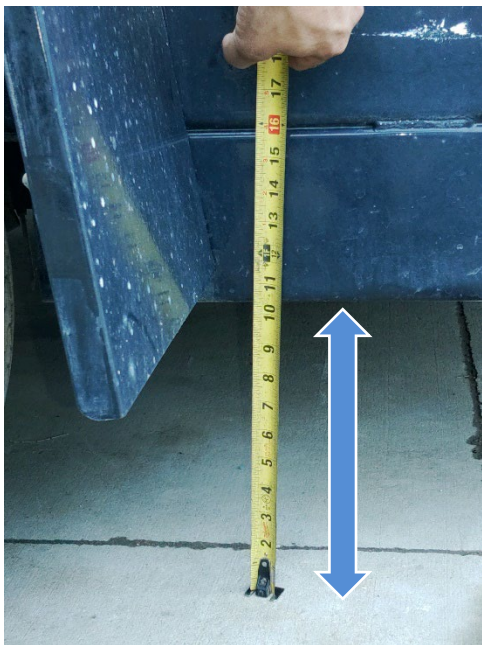
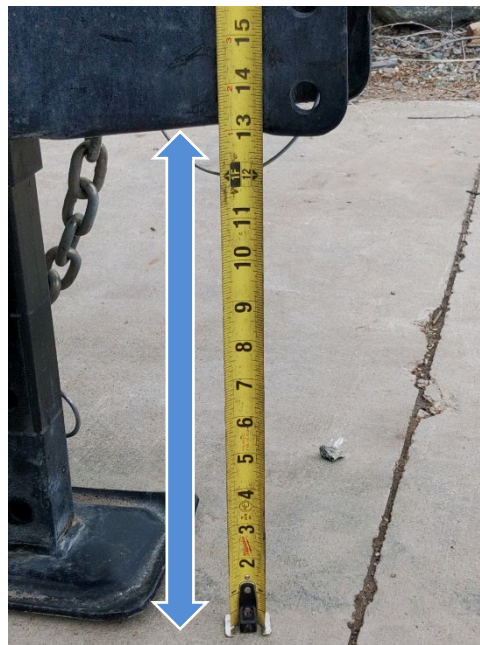
BLUE ARROWS

2. With the trailer level, use the tape measure to check the distance from the GROUND to the BOTTOM OF THE FRAME RAIL just behind the tongue and from the GROUND to the BOTTOM OF THE HITCH POINT at the end of the tongue as shown with **BLUE ARROWS**. In these photos, the tongue has deformed by over three (3) inches.

IMPORTANT: If this distance at the hitch point is not the same as the distance from the ground to the bottom of the frame rail, the trailer tongue has deformed and the trailer must not return to service until the deformation is repaired.

**Measure to BOTTOM of
FRAME RAIL and
BOTTOM of HITCH
POINT**

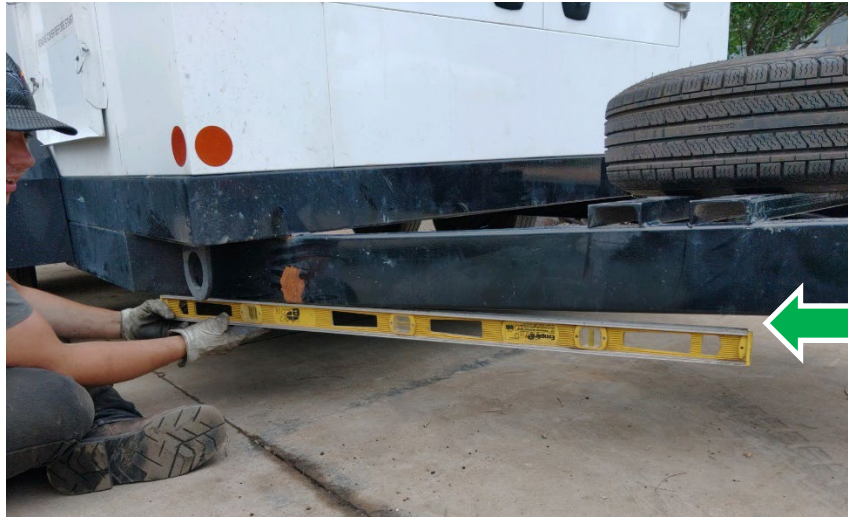
3. To verify that deformation has occurred, hold a long straight edge (of at least 4 feet) along the BOTTOM EDGE OF THE TRAILER to beyond where it meets the tongue. If there is a gap between the straight edge and the bottom of the tongue, the trailer tongue has deformed.
