Compliance Recall

Code: 90W7

Subject: Compliance Recall 90W7 - No Audible Key in Ignition Warning

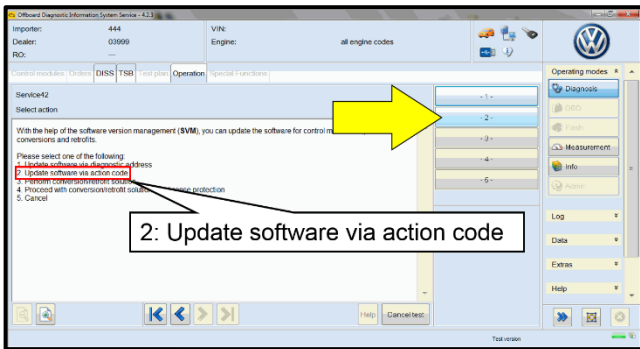
- Select the correct option to “Update software via action code” OR “Software update via measured code”.

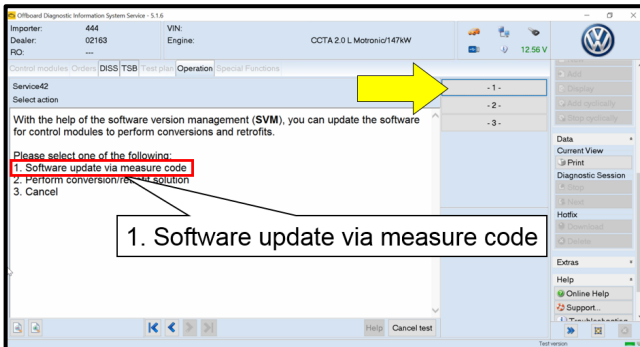
NOTE
The different options to perform the SVM operation may vary based on model.

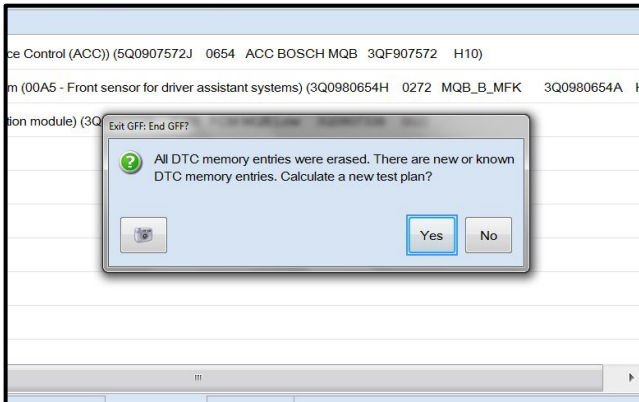
Static communication faults may store in various control modules during the flash. These faults can only be cleared by following one of these steps:

- Drive the vehicle a short distance (around the parking lot, for example).
 - After selecting “Yes”, turn the ignition off for 30 seconds, turn it back on and repeat the GFF exit program.
 - Clear faults using OBD (an additional key cycle may also be required).
- Release the parking brake.
 - Disconnect the VAS tester.
 - Switch off and disconnect the battery charger.
 - Reinstall the battery cover.
