Safety Recall

N232420460 B-Pillar Trim May Interfere with Roof Rail Airbag Deployment

Release Date: October 2023 Revision: 00

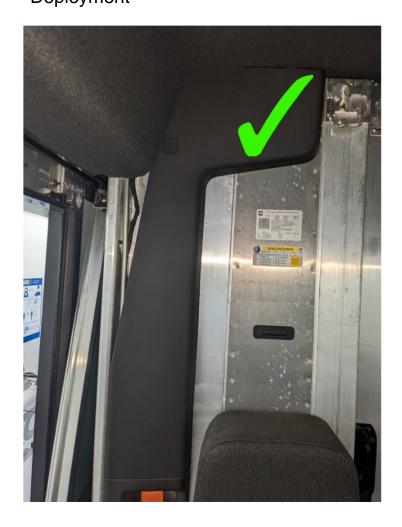
6463214

- Inspect the B pillar trim panel on the passenger's side to determine if it is the correct variant per the above pictures.
 - If the B pillar trim panel is smoothly trimmed starting at the **bottom** of the seat belt pass-through panel and going all the way up, as shown by the green check mark, no further action is required.
 - If the B pillar trim panel is not trimmed at the top, OR if the trim starts at the top of the seat belt passthrough, as shown by the red Xs and circles, replace the trim panel. Refer to Center Pillar Upper Trim Panel Replacement - Right Side in SI.

Condition	General Motors has decided that a defect which relates to motor vehicle safety exists in certain 2023 -			
	2024 model year BrightDrop Zevo 600 vehicles equipped with an optional passenger jump seat. These			
	vehicles may have been assembled with an incorrect passenger-side upper B-pillar trim panel. An			
	incorrect panel could interfere with proper deployment of the right-side roof-rail airbag ("RRAB") in certain			
	side-impact crashes. In certain side impact crashes in which the RRAB deploys, there is increased risk			
	of injury to an occupant in the passenger seat.			
Correction	Dealers will inspect the right side B-pillar trim and replace if necessary.
